W-1 REACH SUMMARY

LOCATION: Waterloo Lane to Muller Lane Bridge

BROCKLISS SLOUGH REACH SUMMARY

LOCATION: Highway 88 to Genoa Road

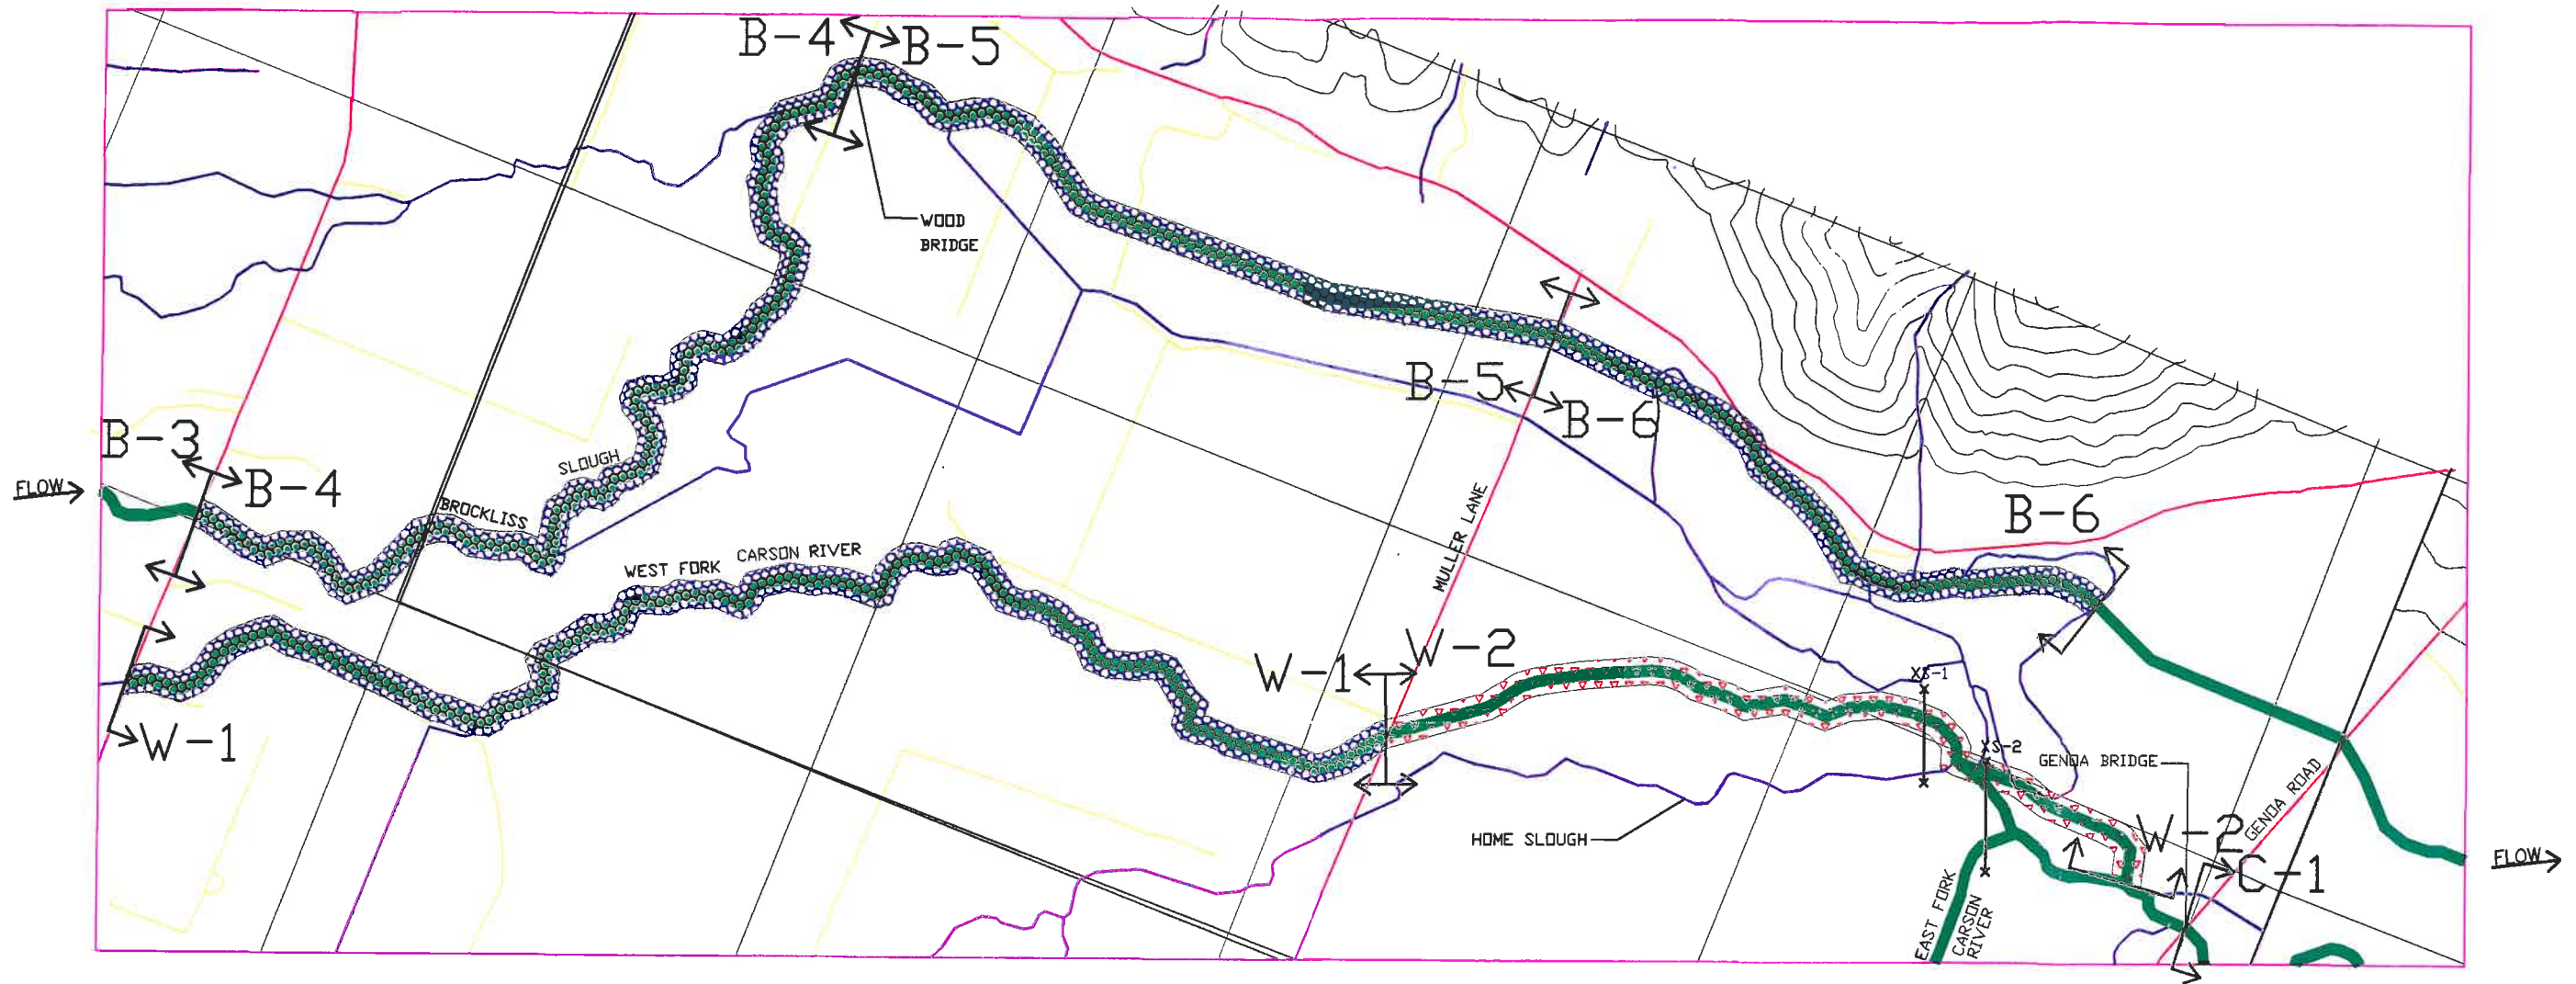
REACH W-1 - W-2
 APPROX. SCALE: 1" = 2100'

stable

Ground surveys and observations of Reach W-1 were not possible. However, observations from the Waterloo Lane bridge and recent aerial video footage indicated well vegetated and stable banks.

Observations were limited to one point at the Waterloo Lane Bridge. From this vantage, W-1 exhibited a thick and healthy, but narrow (approximately 10-20 feet) riparian zone. Adjacent lands are largely irrigated pasture land and agricultural land.

Relative Stability
Moderately Unstable

The grade in W-2 appears stable. However, there is evidence of bank erosion and moderate lateral instability. Because much of the flow of the West Fork is diverted to the Brockliss Slough, high flow impacts are reduced. Additionally, the confluence with the East Fork may be reducing high flow velocities by backwatering the West Fork. However, this same confluence and backwatering can create new cutoff channels or reinstate historic cutoff channels between the two forks. This said, lateral instability is likely related to land management and grazing impacts. Banks are sparsely vegetated and unprotected from grazing.

Banks in this reach are from 4-7 feet high and range in slope from 1:1 to 3:1. The predominant mode of bank failure is due to undercutting of banks at outside bends. Bank materials are primarily silt and fine grained materials. The primary bank stability issues appear to be related to grazing impacts and lack of riparian vegetation.

Bank and floodplain vegetation is mostly grasses and sparse shrubs. The condition of vegetation is closely correlated with the degree of irrigation implemented. W-2 has no riparian corridor or riparian species present and little or no sprout or young plants along the channel margins.

Channel stability in W-2 would be greatly enhanced by riparian fencing and grazing management. Such activities should be supplemented with planting of riparian species, as little is available for generation, even with a rigorous grazing exclusion plan.

- Implement riparian fencing and grazing management which encourages development of a riparian corridor which will increase channel stability and encourage existing channels to maintain their present configuration.
- The entire area adjacent to W-2, from the East Fork to the Brockliss Slough above the Genoa road has tremendous potential for natural development of wetland habitat and flood water retention and storage, if allowed to flow across the floodplain (by removing levees or portions of levees).
- Allowing the various channels to migrate and shift according to natural processes may, in the long run, provide greater stability, habitat, floodwater storage, and reduced backwatering than efforts to control the channels and maintain them in their present configuration. Bridge and channel hydraulics at Genoa road crossings should be evaluated.

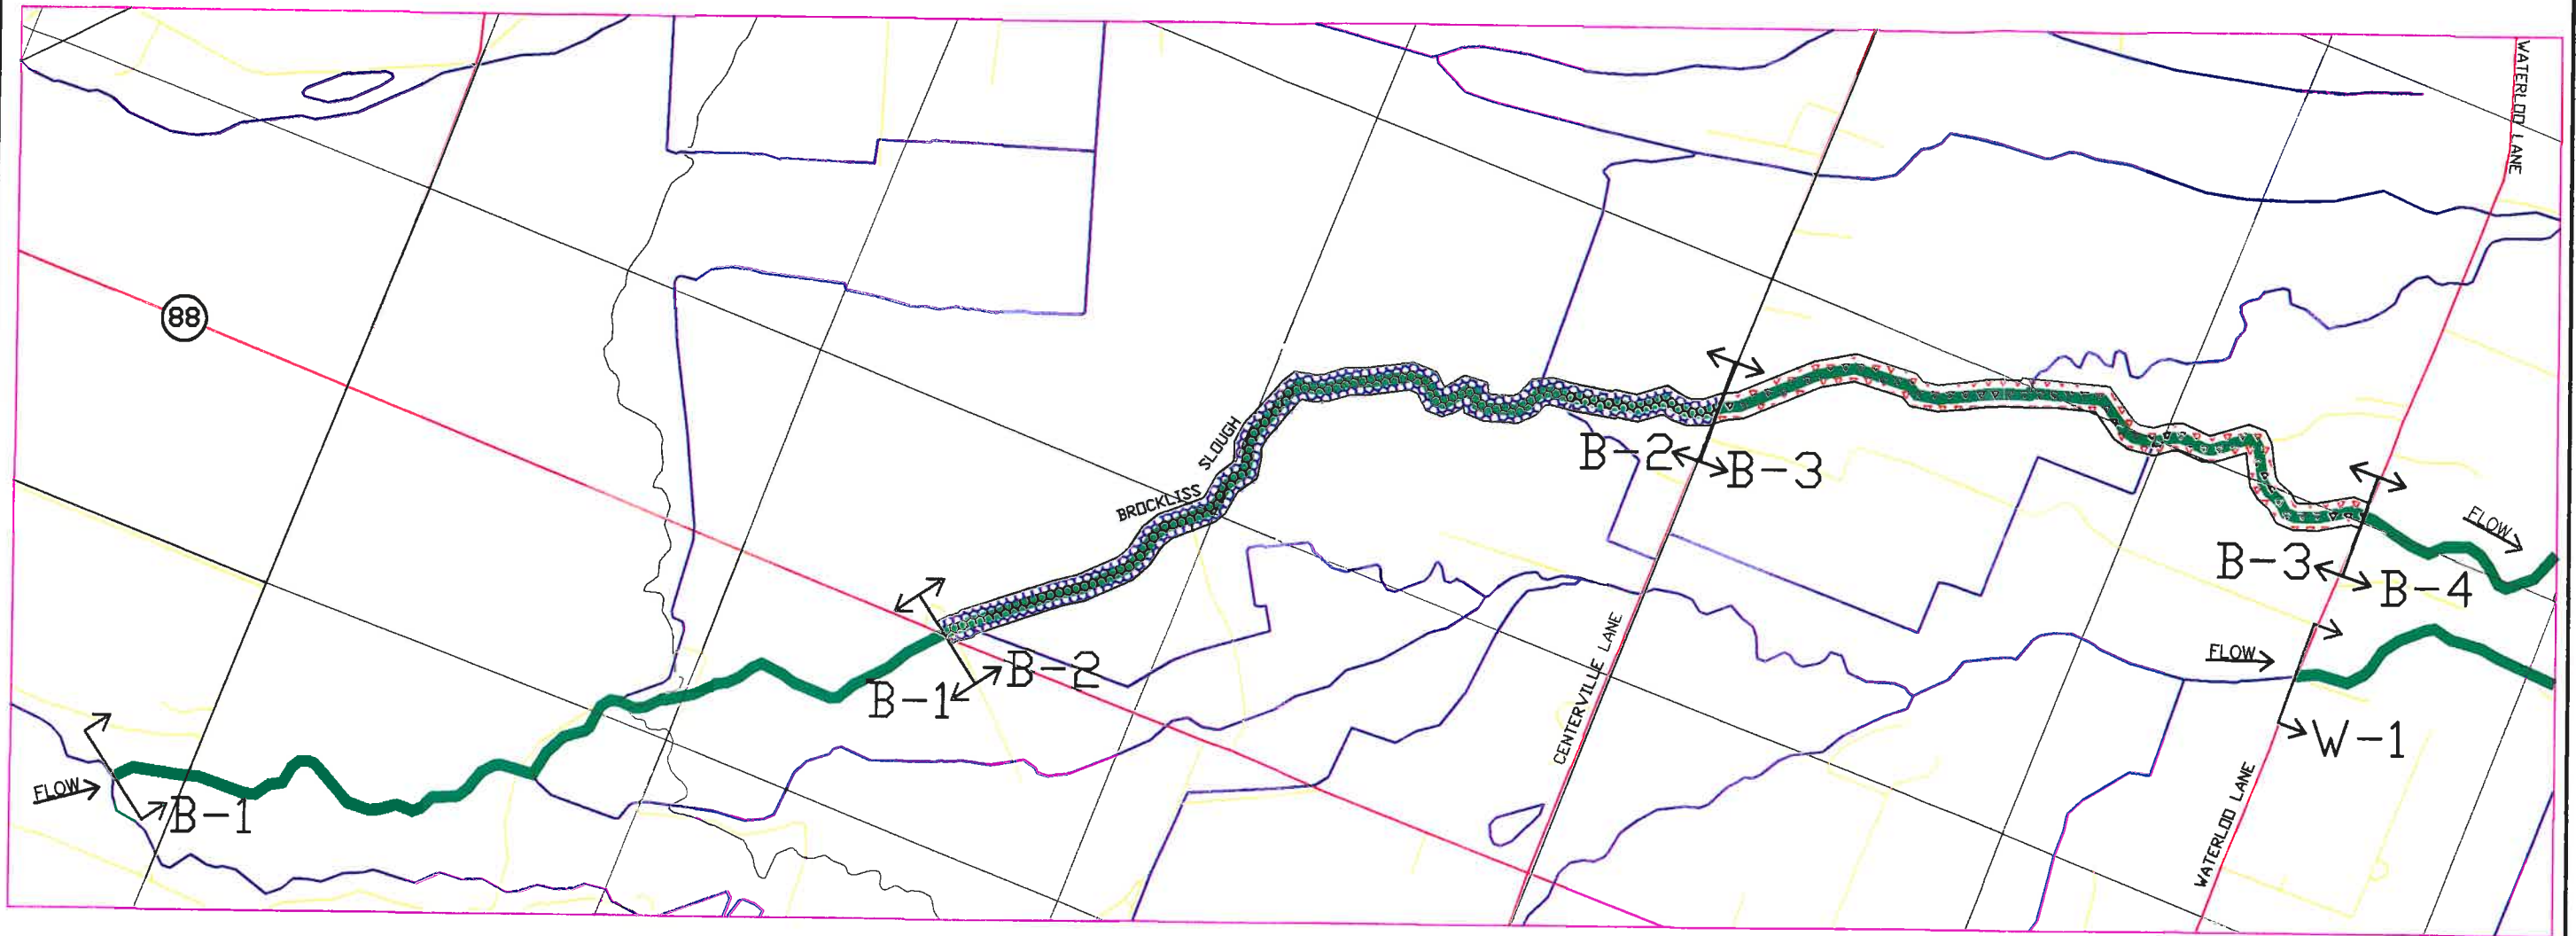
REACHS B-1 - B-3
 APPROX. SCALE: 1" = 2100'

The majority of Brockliss Slough reaches are considered stable. The exception to this is Reach B-3 which is moderately unstable. This reach exhibited some channel incision and widespread bank instability associated with straightening and channelization as evidenced on air photos taken in 1938 and 1990. At some point during this time frame, a very sinuous reach was channelized and displaced. Subsequent land use has allowed grazing of channel banks and eliminated riparian vegetation. While the current grade appears stable, the channel is migrating laterally to gain length. Irrigation return ditches are perched and headcutting through pasture land to meet the degraded channel elevation.

corridors. B-3 was largely unstable due to an absence of riparian vegetation and active grazing and trampling of banks. B-4 exhibited moderate stability and isolated sections of unstable banks, again associated with grazing practices and absence of riparian vegetation.

Bank heights throughout the Brockliss Slough reaches ranged from 2 to 7 feet, with the highest banks in Reach B-3 where the channelized section is moderately incised. Bank slopes ranged from 3:1 or flatter in the upper reaches, to 1:1 in areas of bank instability in downstream reaches. Riparian zones were largely limited to channel banks. As discussed above, additional areas of isolated bank instability are associated with diversion structures. Banks below these structures, where the channel is moderately incised, are unstable.

- Where riparian corridors are fenced there is a healthy riparian corridor in all reaches of the Brockliss Slough. Furthermore, these areas exhibit little to no lateral channel stability problems. For this reason, it is recommended that fencing of a riparian corridor be implemented throughout the B Reaches. Furthermore, as existing fences are replaced or repaired, they should be located to allow a 20-30 foot riparian corridor at a minimum.

- The majority of diversion structures in the Brockliss Slough are causing aggradation upstream and bed degradation downstream. In some areas this has contributed to lateral stability problems as well. Diversion structures should be redesigned and constructed to allow bedload transport, particularly during high flow periods. Due to apparently low sediment transport rates during low flows, this should relieve the majority of problems associated with diversions.

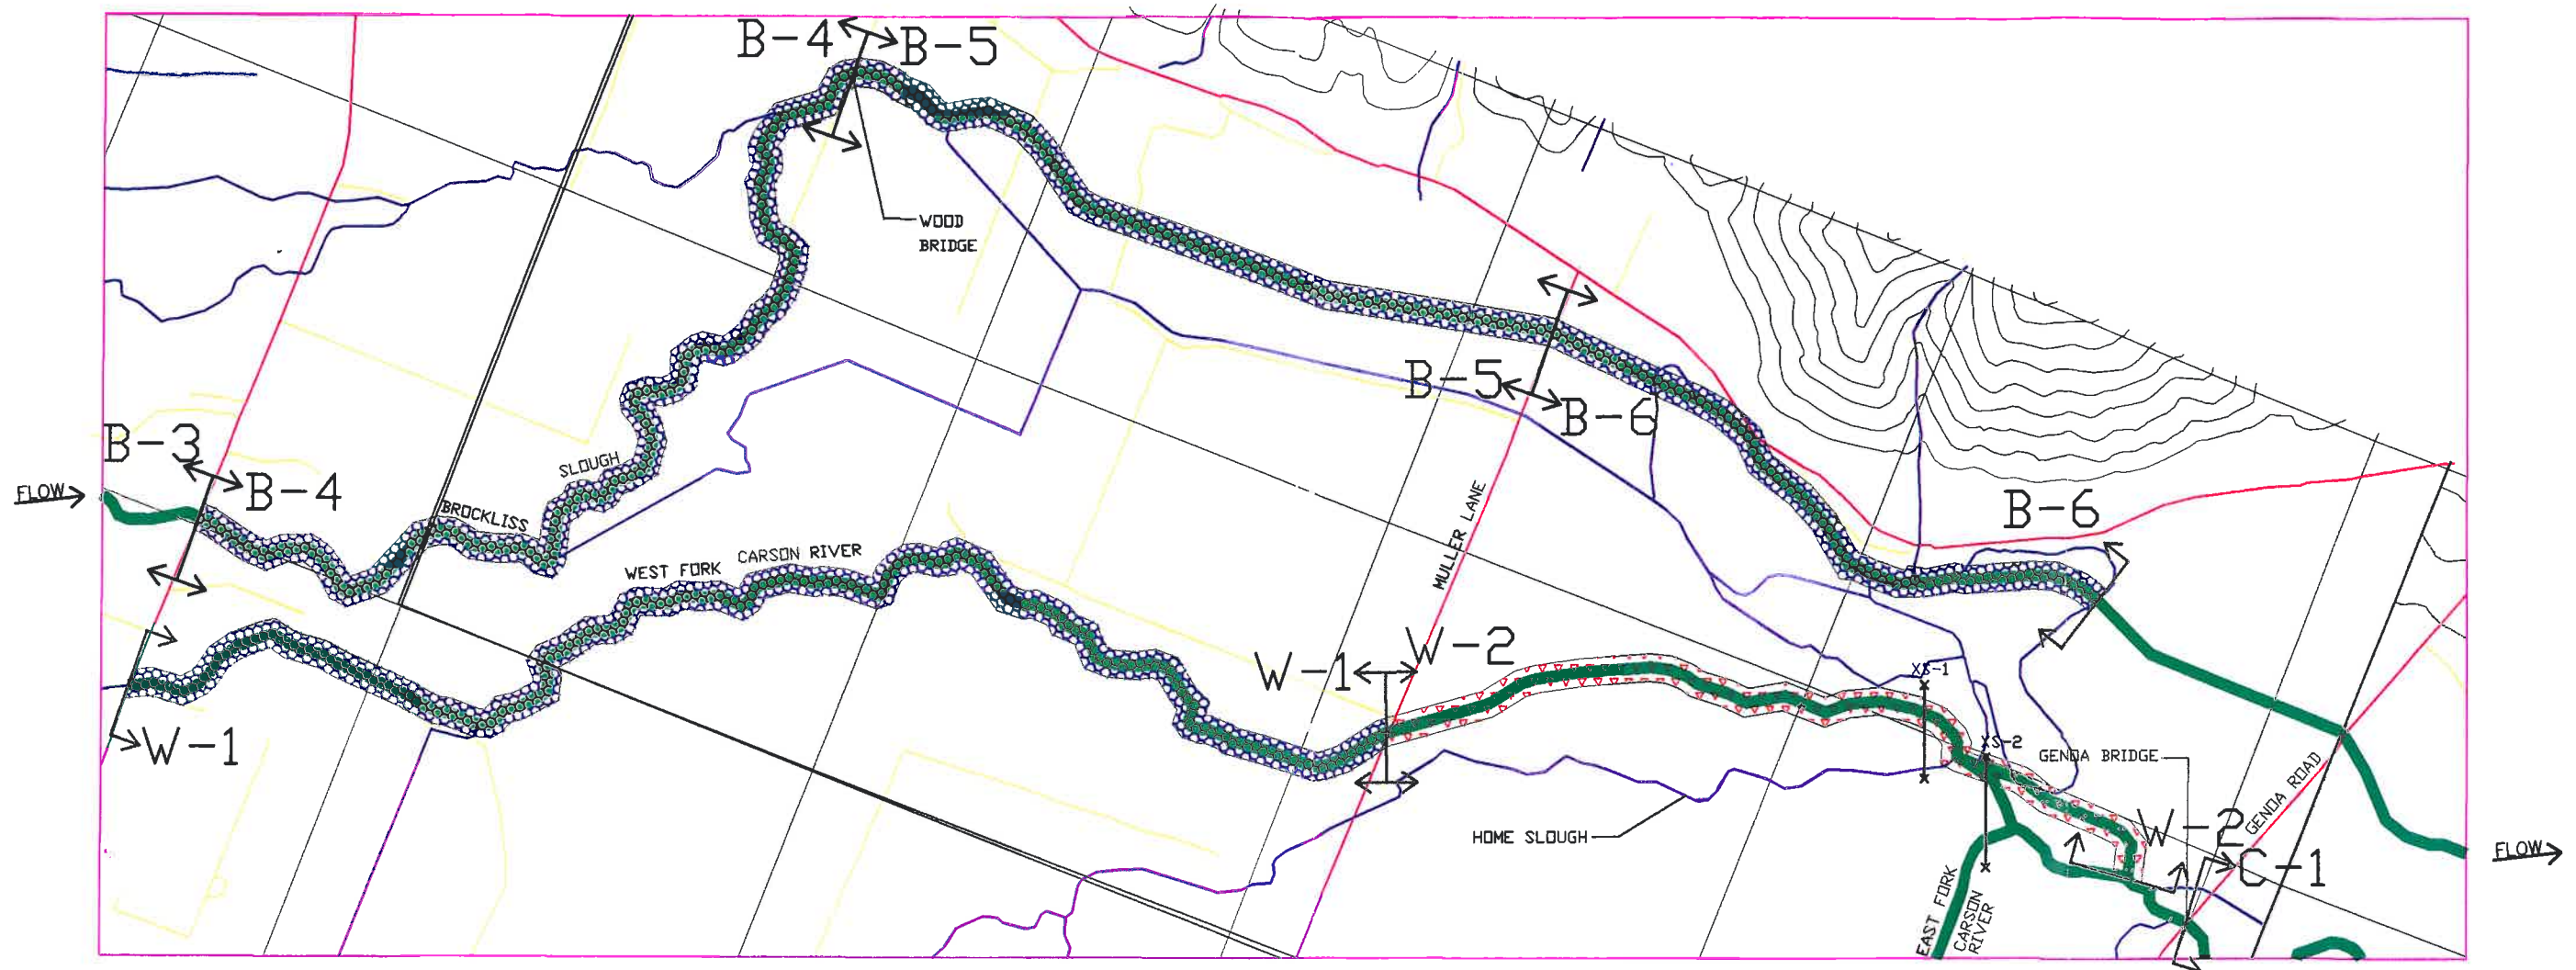
REACH B-4 - B-6

Bank stability throughout the Brockliss Slough reaches is closely related to riparian condition and grazing practices. The observed sections of reaches B-2, B-5, and B-6 appeared stable with healthy, though narrow, riparian

All reaches of the Brockliss Slough exhibit narrow riparian zones. The width and condition of the riparian zone are highly variable within reaches. Riparian zone widths range from 0 to 30 feet. Average widths in the upper reaches range from 10 to 20 feet, while average widths in B-5 and B-6 are only 2 feet. In these latter reaches, riparian zones are confined to channel banks. With the exception of Reach B-3, most riparian zones show sprout, young and mature age classes of riparian vegetation, but little to no dead or decadent vegetation.
