C-1 REACH SUMMARY

LOCATION: Genoa Road to Cradlebaugh Bridge

Geomorphic Setting

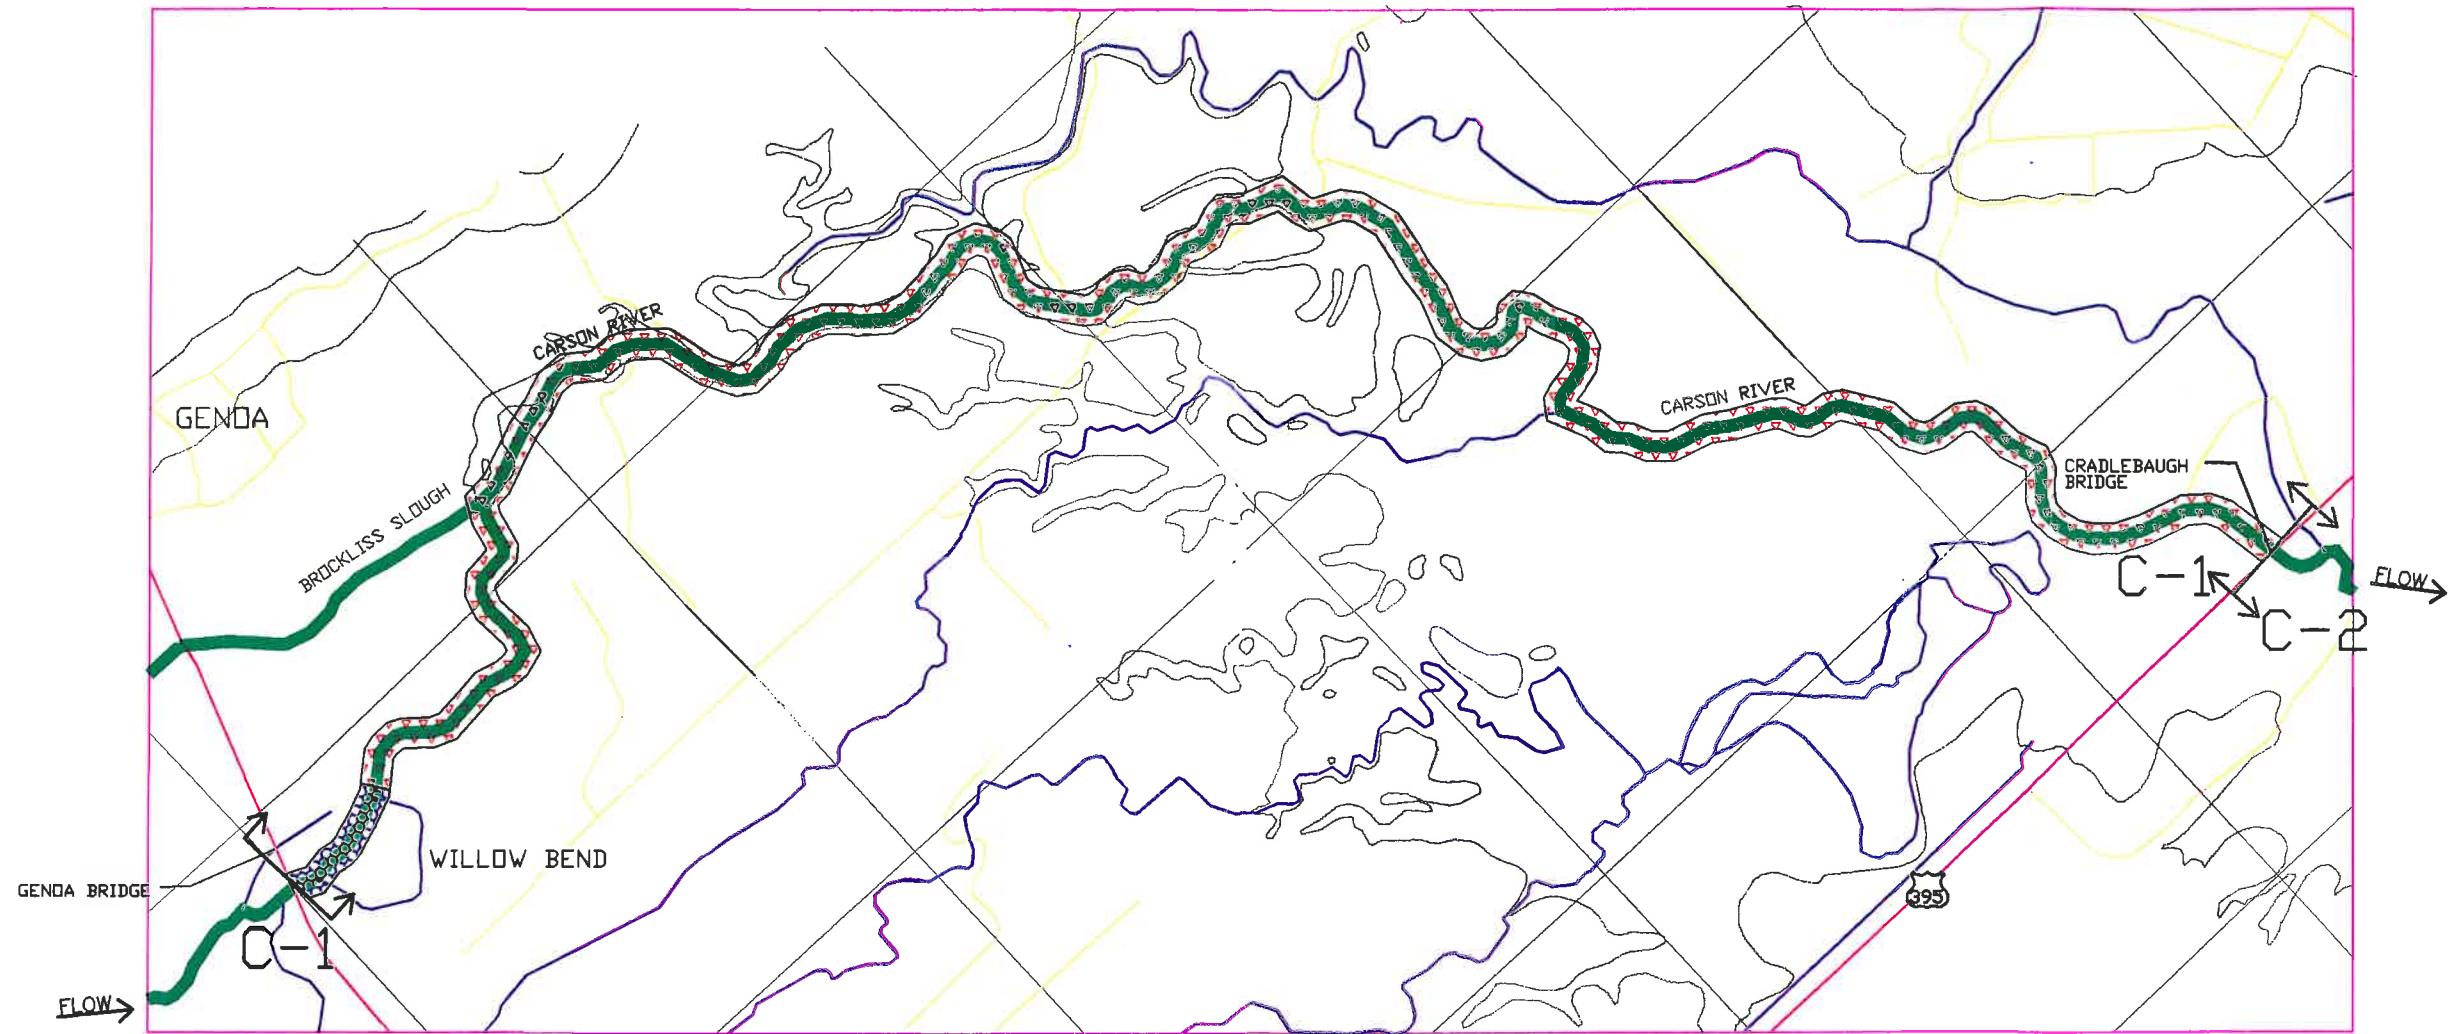
REACH C-1
 APPROX. SCALE: 1" = 2100'

With the exception of the well-vegetated and stable banks in the uppermost half mile of C-1, nearly 100 percent of channel banks are unstable. Bank heights range from 8 to 12 feet throughout the observed section. Bank

heights in the un-observed section are reportedly up to 20 feet. The majority of these banks are 1:1 or steeper and are being undercut during high flows on both banks, and in some cases on outside bends during low flow conditions. Bank materials are sands and silty loam which fail due to undercutting, forming a sloped bank toe. This bank toe is apparently cleaned out during high flows. Vegetation is absent from most banks, though some bank toes have developed annual vegetation. This vegetation, however, does not add to bank stability as it is washed away on an annual basis. Furthermore, long term and heavy grazing practices reduce the potential for regeneration of riparian vegetation.

- In the upper section of C-1, where failing banks may threaten residential structures, a more proactive approach to bank stabilization may be required. This area is a prime candidate for bioengineering methods which can provide both a riparian vegetation corridor and adequate bank protection.

- Genoa Bridge. This bridge appears to be undersized, and given the large in-channel sediment supply upstream, there could be future problems with local aggradation and abutment scour during large floods. All Genoa Lane bridges crossing the Carson and Brockliss are particularly at risk if considering the potential for significant channel shifts above these bridges.

- Cradlebaugh Bridge. Local evidence suggests base level lowering, including the observation of exposed pier footings.

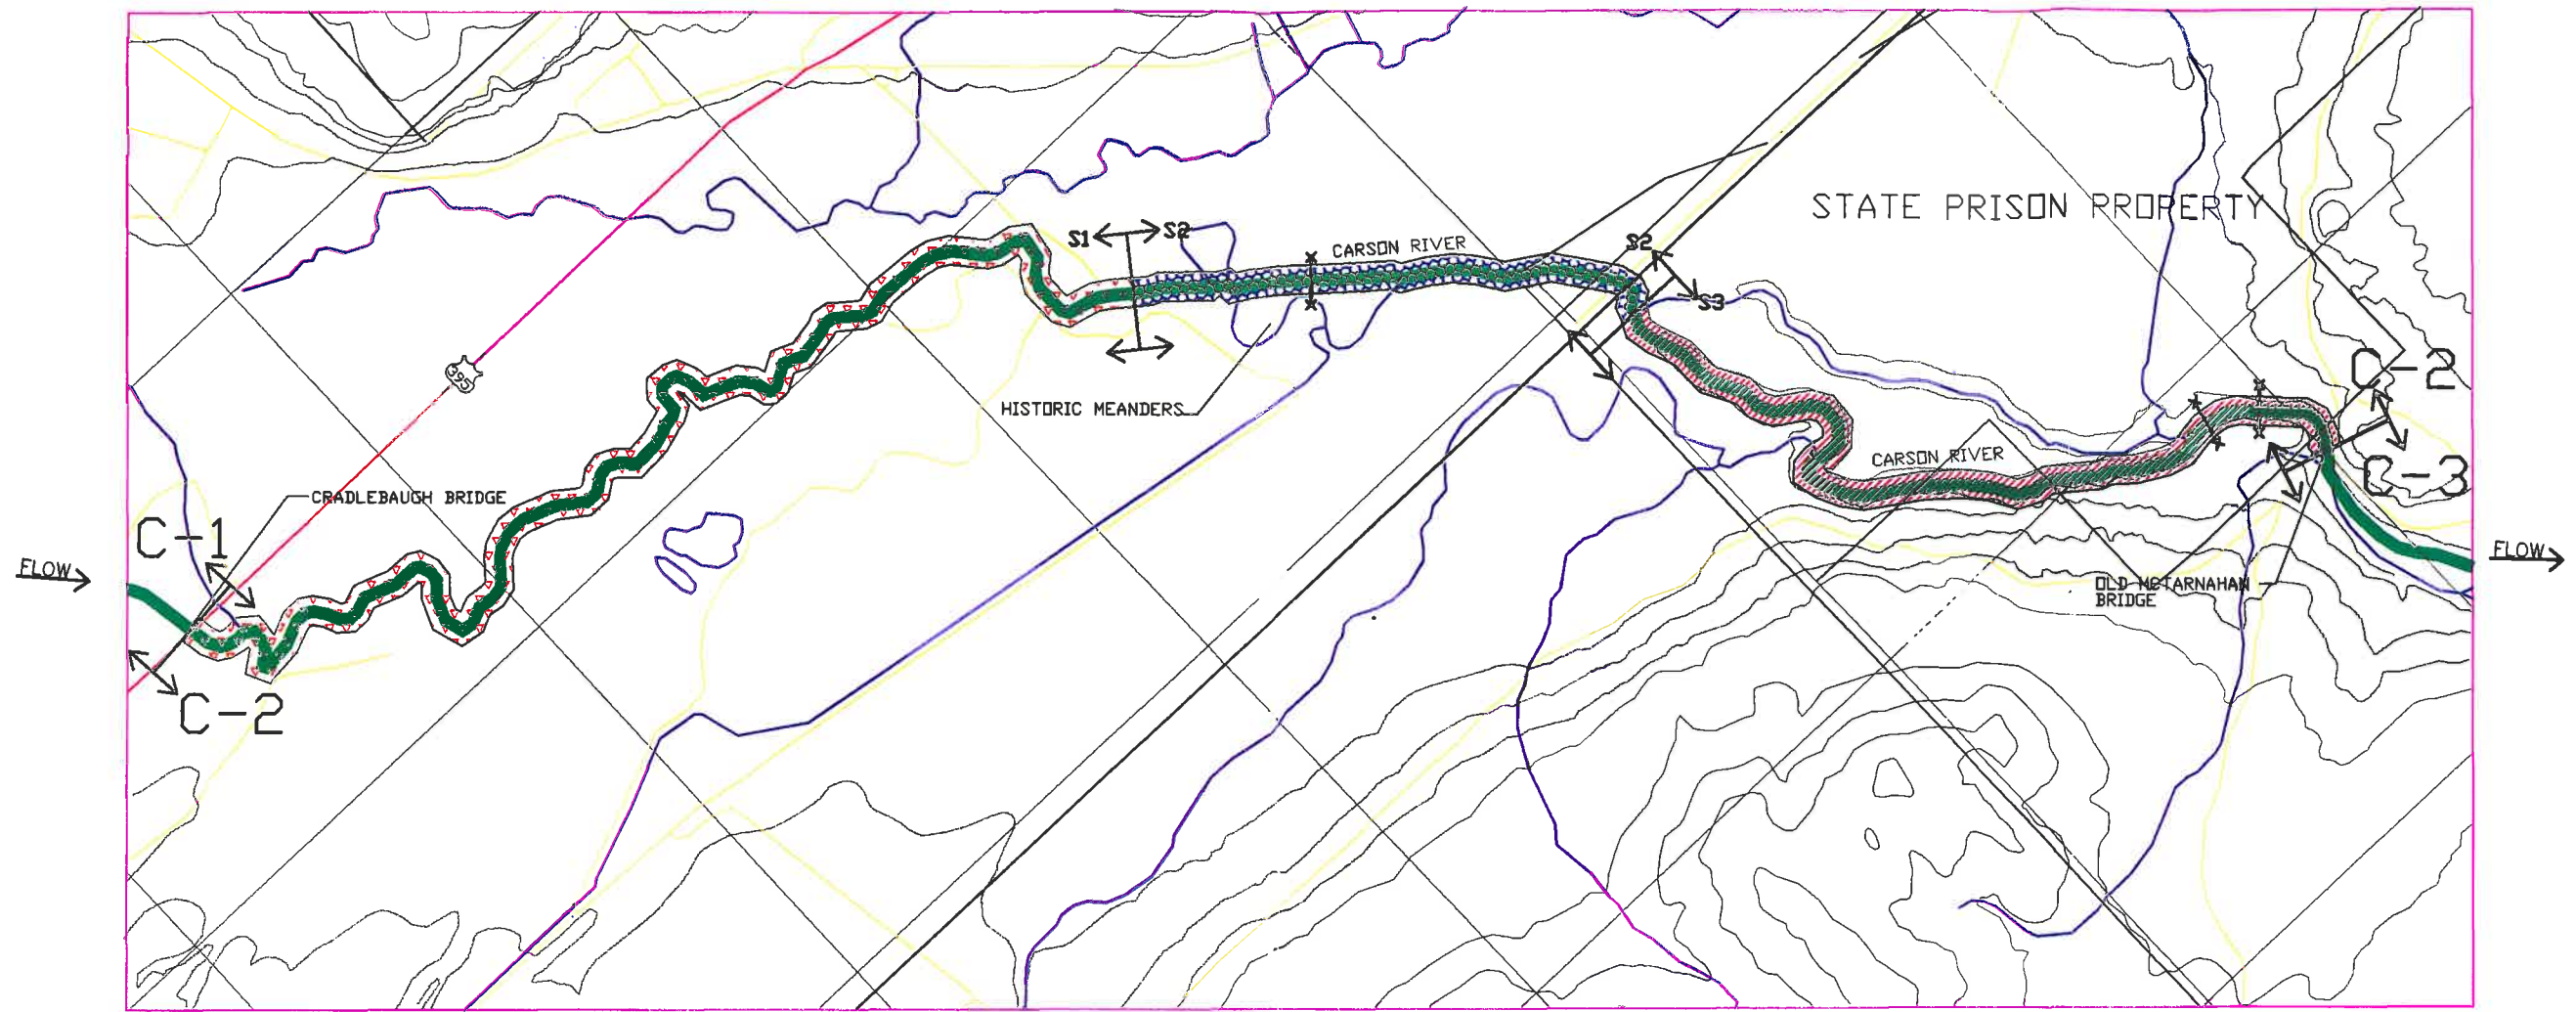
REACH C-2
 APPROX. SCALE: 1" = 2100'

S1: The relative height of the floodplain relative to the channel may be inhibiting riparian vegetation due to reduced moisture. Mature cottonwoods exist on the floodplain, though they are sparse, and old meander bends are thickly vegetated with willows. Many bars show signs of establishing riparian vegetation with sprouts and young willows.

S2: There is a prominent, though narrow, riparian corridor of all age classes of willows. The riparian zone varies from 0 to 100 feet wide. Floodplain condition is good, with 90 percent coverage of grasses and shrubs. Abandoned channels (from channelization) are thickly vegetated with willows and there is some wetland development.

S3: Riparian species are virtually non-existent and floodplain conditions are poor with 30-60 percent bare ground, sparse grasses and shrubs. Grazing impacts are significant. Some willows exist in a parallel slough, though these are heavily impacted by browsing.

- S1: No management or recovery actions are recommended beyond encouraging development of a riparian corridor, which includes protection of pioneering riparian vegetation on channel bars. This reach is incised. However, it appears to be recovering and adjusting without significant proactive management.
- S2: No management or recovery actions are recommended. Due to the current status of grazing exclusion and essentially no land use, this reach of channel is stable. Recommendations are limited to allowing planform to adopt former channels or increase sinuosity over time.
- S3: Management recommendations for this reach are limited to establishment of a grazing exclusion to allow development of a riparian corridor. This may require revegetation, as volunteer plants and seed sources may be limited.

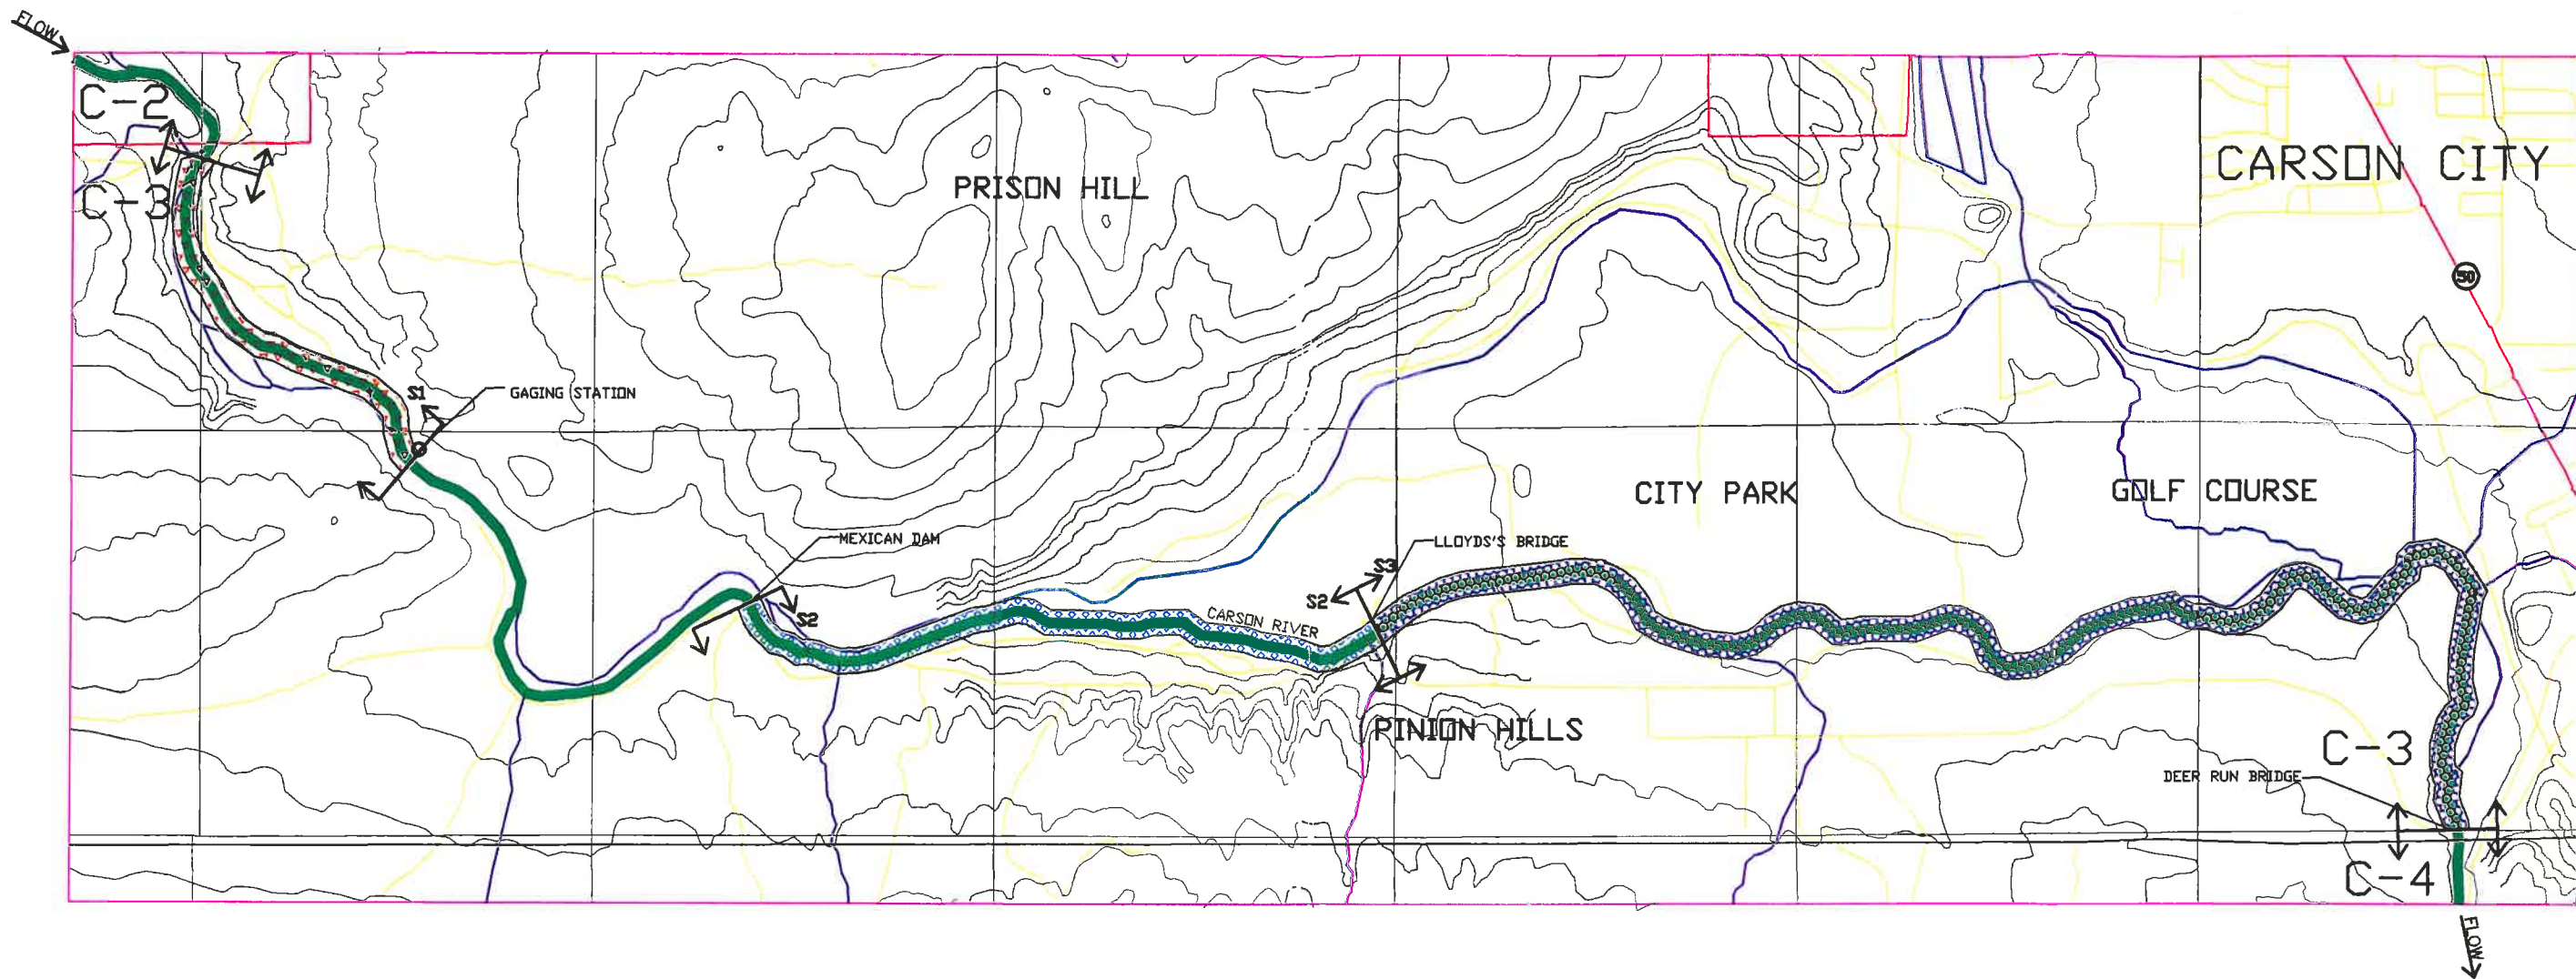
REACH C-3
 APPROX. SCALE: 1" = 2300'

Reach C-3 was judged to be generally stable. S1 was is moderately unstable due to the presence of a high degree of potential bank instability, though the sub-reach appears to have undergone the most extreme geometry changes in the past, and is now either in as good of condition as is likely given upstream instability or is still recovering from past incision. Note that in the Harvey-Watson incision class, it rates a IV.5, suggesting that it is in an advanced class of recovery. S2 is very stable, with the exception of one high vertical bank area which may be considered a natural feature. S3 is stable with some indication of incision, though the extent of incision to date is not greatly affecting overall stability.

In S1, the average bank is 7 feet high and between 3:1 and 2:1. 40% are 1:1 to vertical, composed of both cohesive and uncohesive homogenous fines. Most bank erosion is occurring at outside bends, with point bar development and willow communities on inside bends. Bank failure is from undercutting and gravitational failure. An estimated 60% of banks are well vegetated. In contrast, except for 150 foot long, 20 foot high vertical bank, S2 banks are 90% stable and vegetated. Erosion, where present, is from undercutting of outside bends. Average bank heights are 5 feet and generally between 1:1 to 3:1, and composed of cohesive fines (vegetation cohesion) and fine gravels to sand. S3 banks are 70% stable and vegetated, average 5 feet high and 80% are 2:1 or flatter. Bank composition is sandy silt with vegetative cohesion. Unlike S1 and S2, approximately 30% of the banks have been altered by rip rap, vegetation clearing, grazing and ORV use.

For all sub-reaches, management for increased and or existing riparian and floodplain vegetation is recommended. In S2, it is recommended that public access be better planned to eliminate unnecessary impacts in the floodplain forest and elimination of ORV use in the channel and floodplain. In S3, it is also recommended that ORV use in the channel and floodplain be eliminated and an added emphasis on BMP's which promote further riparian expansion. C-3 does not appear to be in need of any direct action for channel stabilization, as the channel condition is relatively good and non-impacted relative to up- and downstream reaches. This reach may bear further study to assess the reasons for its apparent stability in the midst of up- and downstream reach instability.

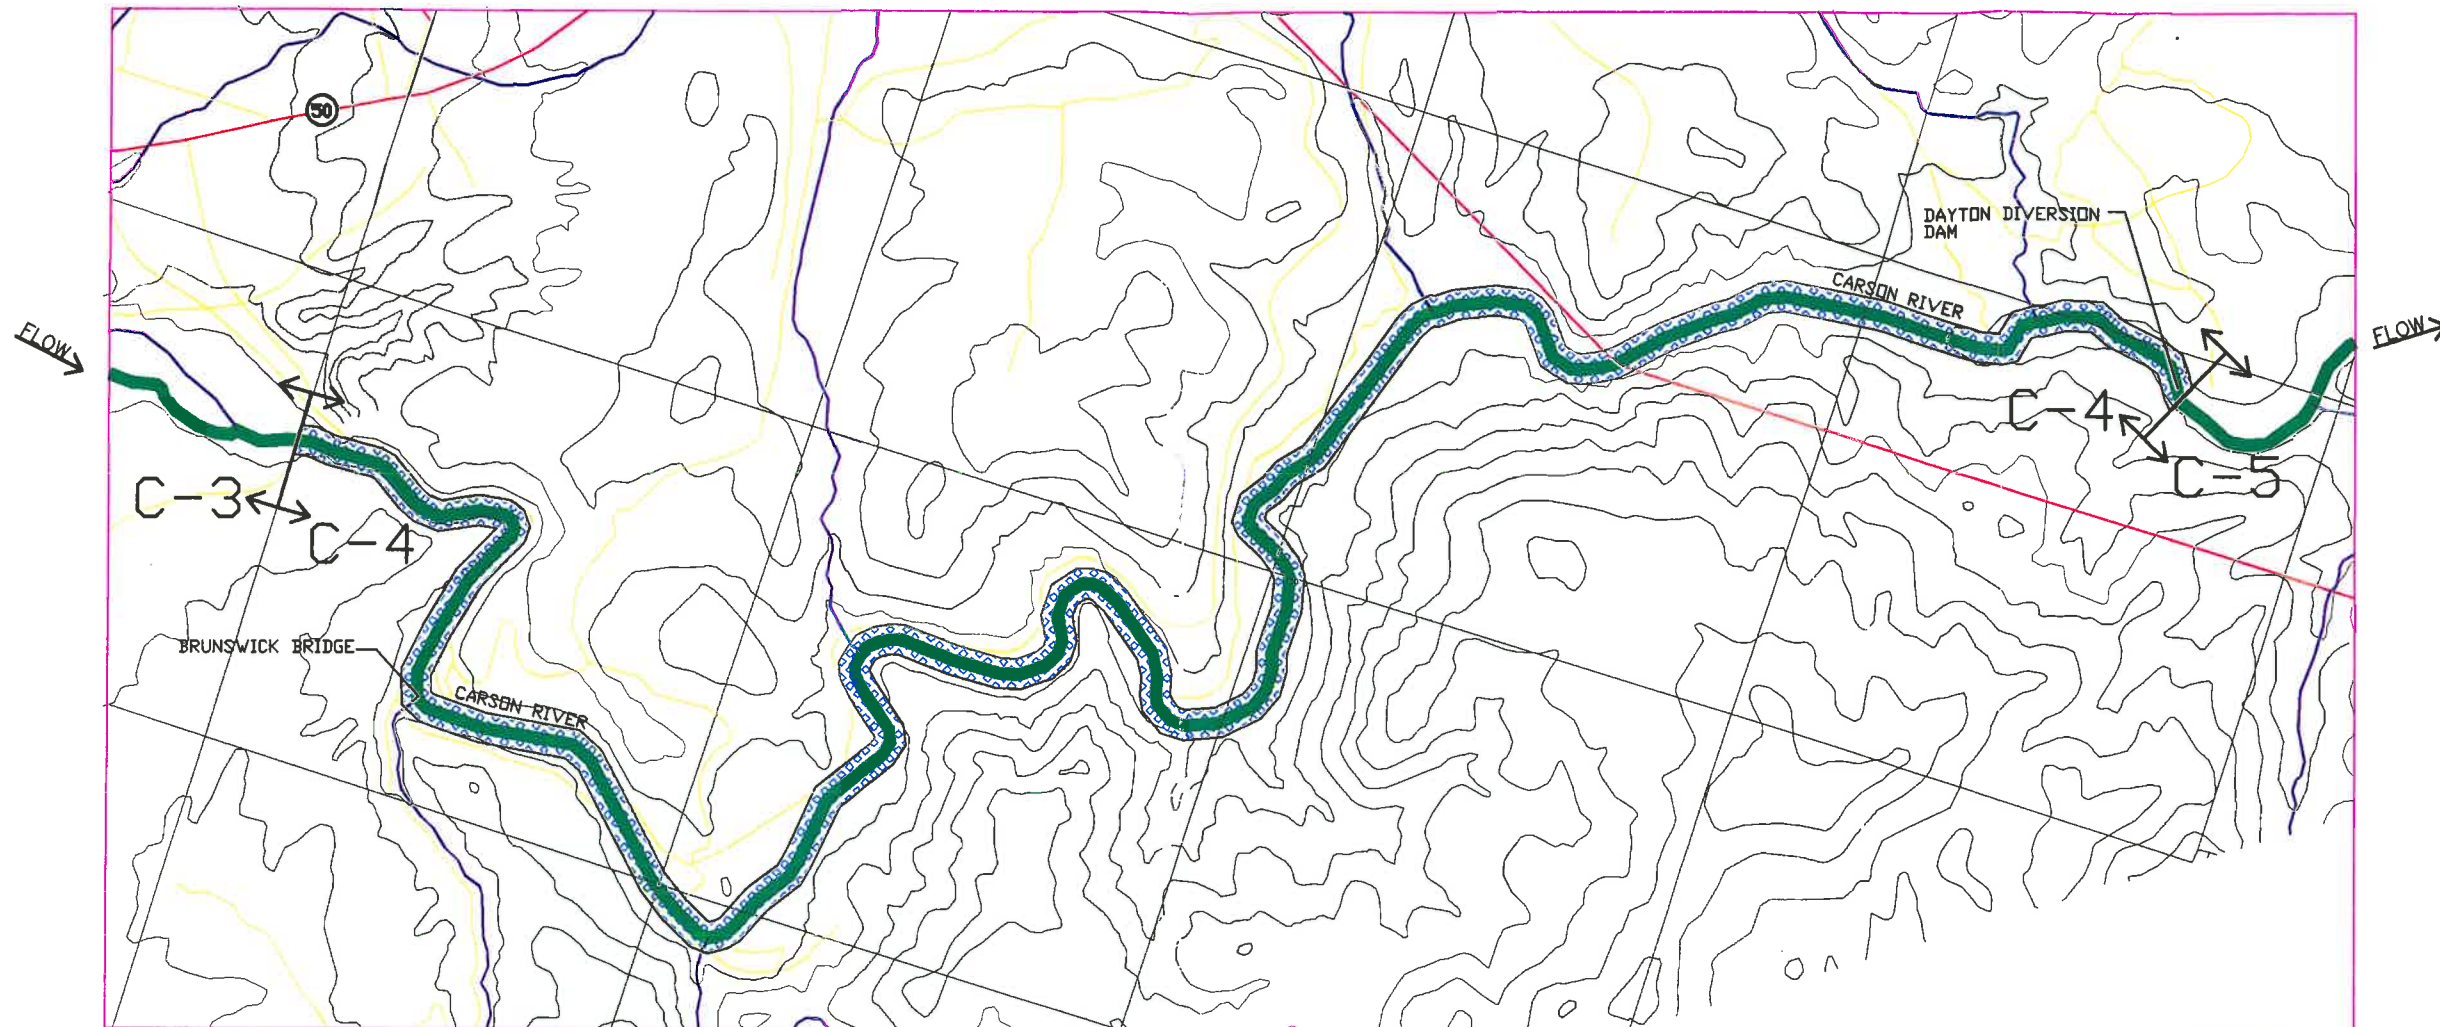
REACH C-4
 APPROX. SCALE: 1" = 2100'

Because of the perceived high stability and low priority of this reach, ground observation of Reach C-4, Brunswick Canyon, was observed from the road along the canyon rim and high up slope. The reach can be generally described as a highly confined, bedrock controlled channel with large substrate. Because of its confinement and minimal land use effects (due to access), little human impacts have affected this section. Furthermore, frequent bedrock controls, natural bed armoring, and rocky banks lend a natural stability that is not easily altered.

In its current configuration, the diversion is not capable of withstanding damage and loss during flood events. The impact on downstream sediment supply during dam failures is worthy of consideration, since the potential for stored sediment behind the dam becoming suddenly and massively available is present. However, it should be worth noting that the segment of stream immediately downstream of the dam is in very good condition, with riffle pool sequences and a reasonably identifiable bankfull channel line. The vegetative condition of the site is excellent - perhaps with the largest riparian zone width and highest diversity of any upstream reach.

Better control of recreational activities in the canyon may be warranted, though overall, the existing impacts are not severe. It is recommended that the canyon be managed as a recreational corridor given its natural scenic beauty and historical connections with the Comstock mining period.

- **Diversion Structures:** We recommend that loose rock diversion structures be replaced with more permanent diversion structures or pumping galleries, in conjunction with the consolidation of diversion points to eliminate unnecessary structures. Conceptually, if the existing permanent structures could be re-engineered to allow for greater bedload transport during moderate and frequent high flow events, overall sediment transport continuity on the river may be improved. Replacement with pumping systems would allow for natural river function without the negative effects of diversion structures. The benefits of improved sediment transport may be difficult to quantify, though allowing the river

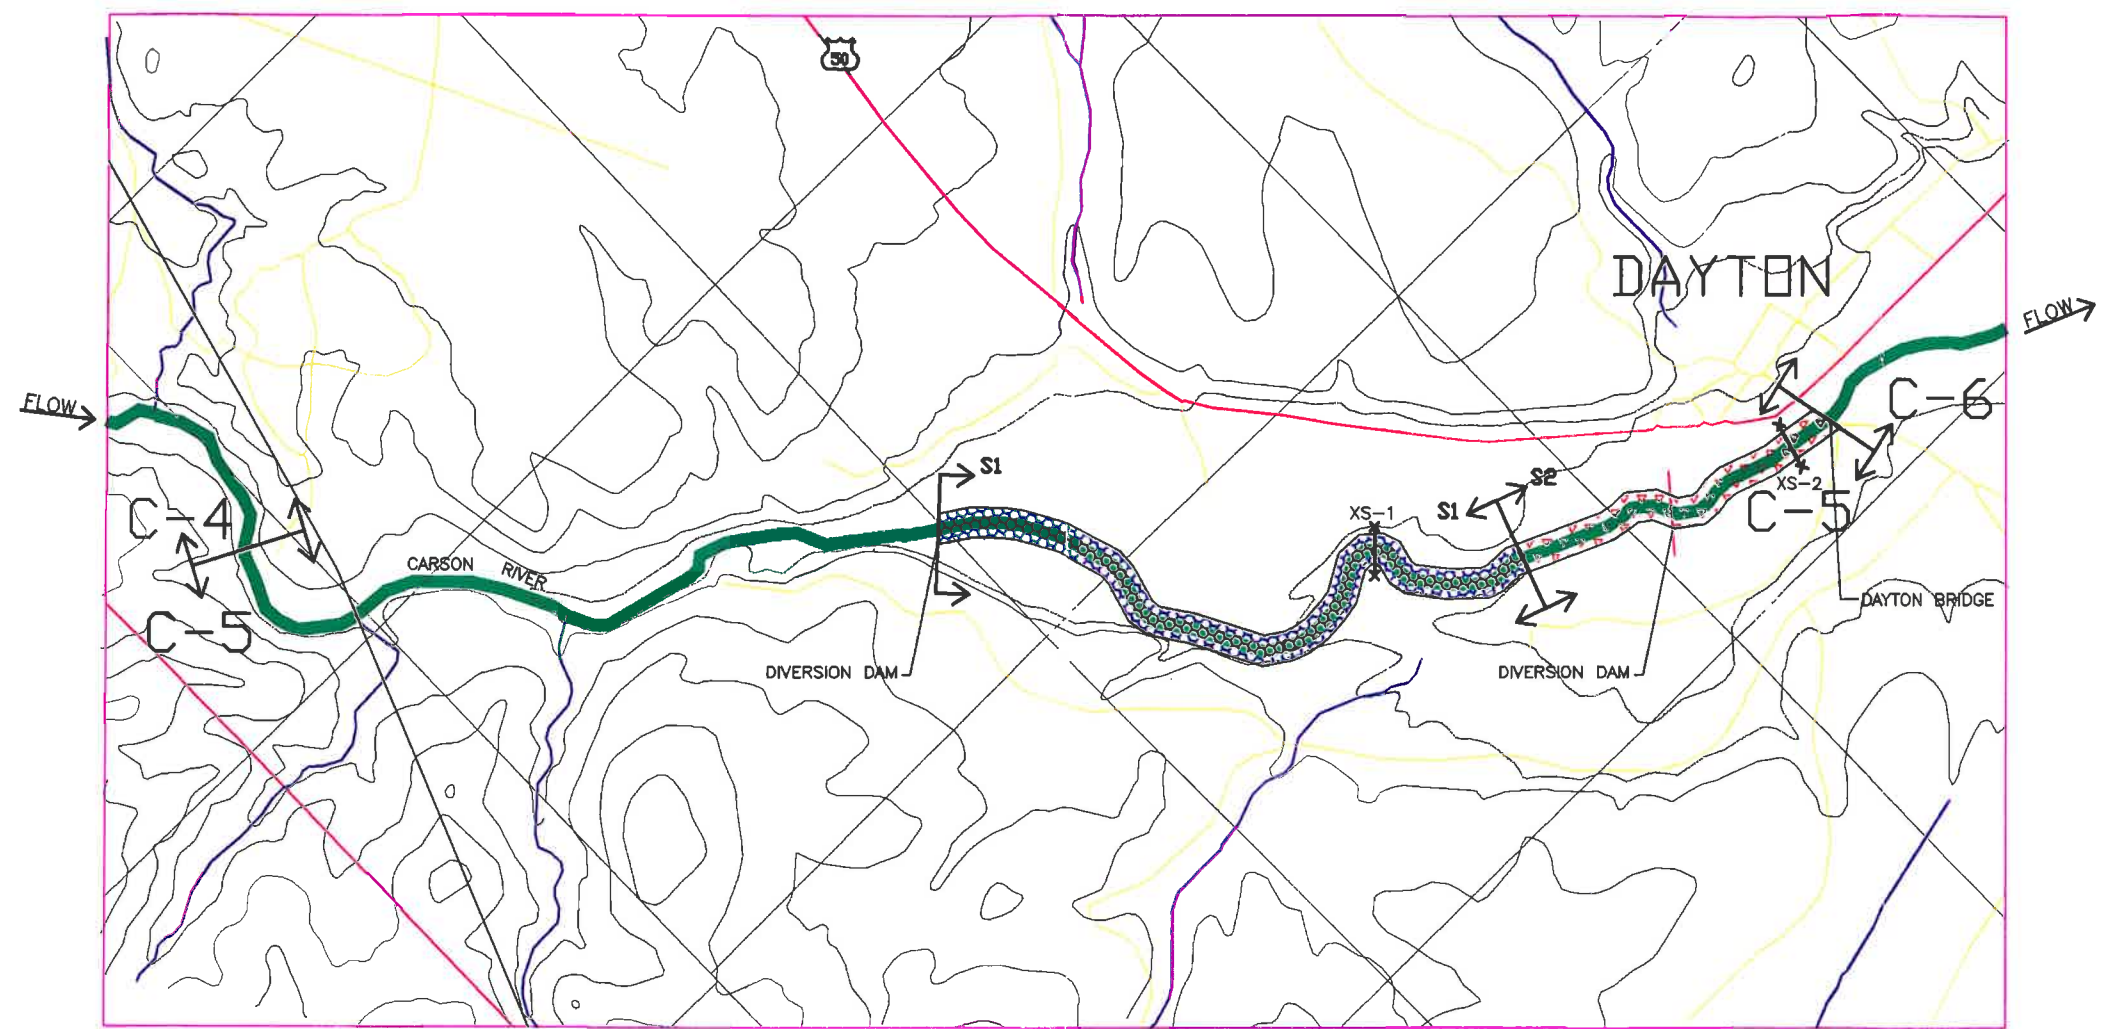
REACH C-5
 APPROX. SCALE: 1" = 2100'

The Ricci diversion, at the top of S1, is undoubtedly having some influence on downstream dynamics. Like the Dayton Town diversion, it is of the gravel push-up variety, and prone to failure during moderate floods. Failure during floods and the resulting sediment pulse through C-5 may be responsible for some of the instability noted in S2. In addition to this diversion, another diversion near the Sbragia ranch is present. Another gravel push-up type, in its current configuration it may pose some tangible flooding and erosion problems for the home owner on the immediate left bank. During our inventory, the crest of the diversion was near the elevation of the left bank. In a worst case scenario, flood water surfaces will be elevated to the point of overbank flooding. An alternative scenario is that the diversion will fail during a flood, reducing flood risks, though its failure may impact the already eroded left banks adjacent to the home and downstream stability due to sediment pulsing. It is strongly recommended that this

S1 banks are mostly stable, though several outside bends have rip rap on the bank toes. Bank heights range from 2 to 10 feet, with 10 feet being the levee top, where levees exist. Failure of banks is from undercutting; 90% of banks are 2:1 or flatter and well vegetated. Bank composition is un-cohesive heterogeneous cobble to small gravels. In contrast, more active meandering has destabilized bank toes in several areas of S2; bank heights range from 4 to 10 feet and average 7 feet. About 50% of the banks are 2:1 to vertical and composed of uncohesive small gravels and fines; most of these banks are unvegetated. Some bank protection efforts observed are in poor shape and consist of concrete rubble and rip rap.

S1: Riparian cattle grazing should be discouraged until the riparian community has reached full potential. Consideration should be given to removing any right bank levees as very little development is present in the historic floodplain. Such a plan would perhaps accelerate the recovery of this reach to a yet more stable environment. Where bank toes on the developed left bank levees are being eroded, it is recommended that well engineered rip rap be installed at the levee toes to prevent further undercutting. Such a program should coincide with extensive vegetative planting through installed rip rap and on the upper slopes.

S2: Like S1, riparian cattle grazing in this reach should be discouraged; it is in worse vegetative shape than S2. Managing S2 for riparian recovery should be a priority. Levee failure is ongoing where they have not been maintained in a professional manner and/or recent rip rapping is poorly accomplished. It is recommended that well engineered and installed rip rap levee toes be installed in combination with heavy re-planting. The Holly diversion dam

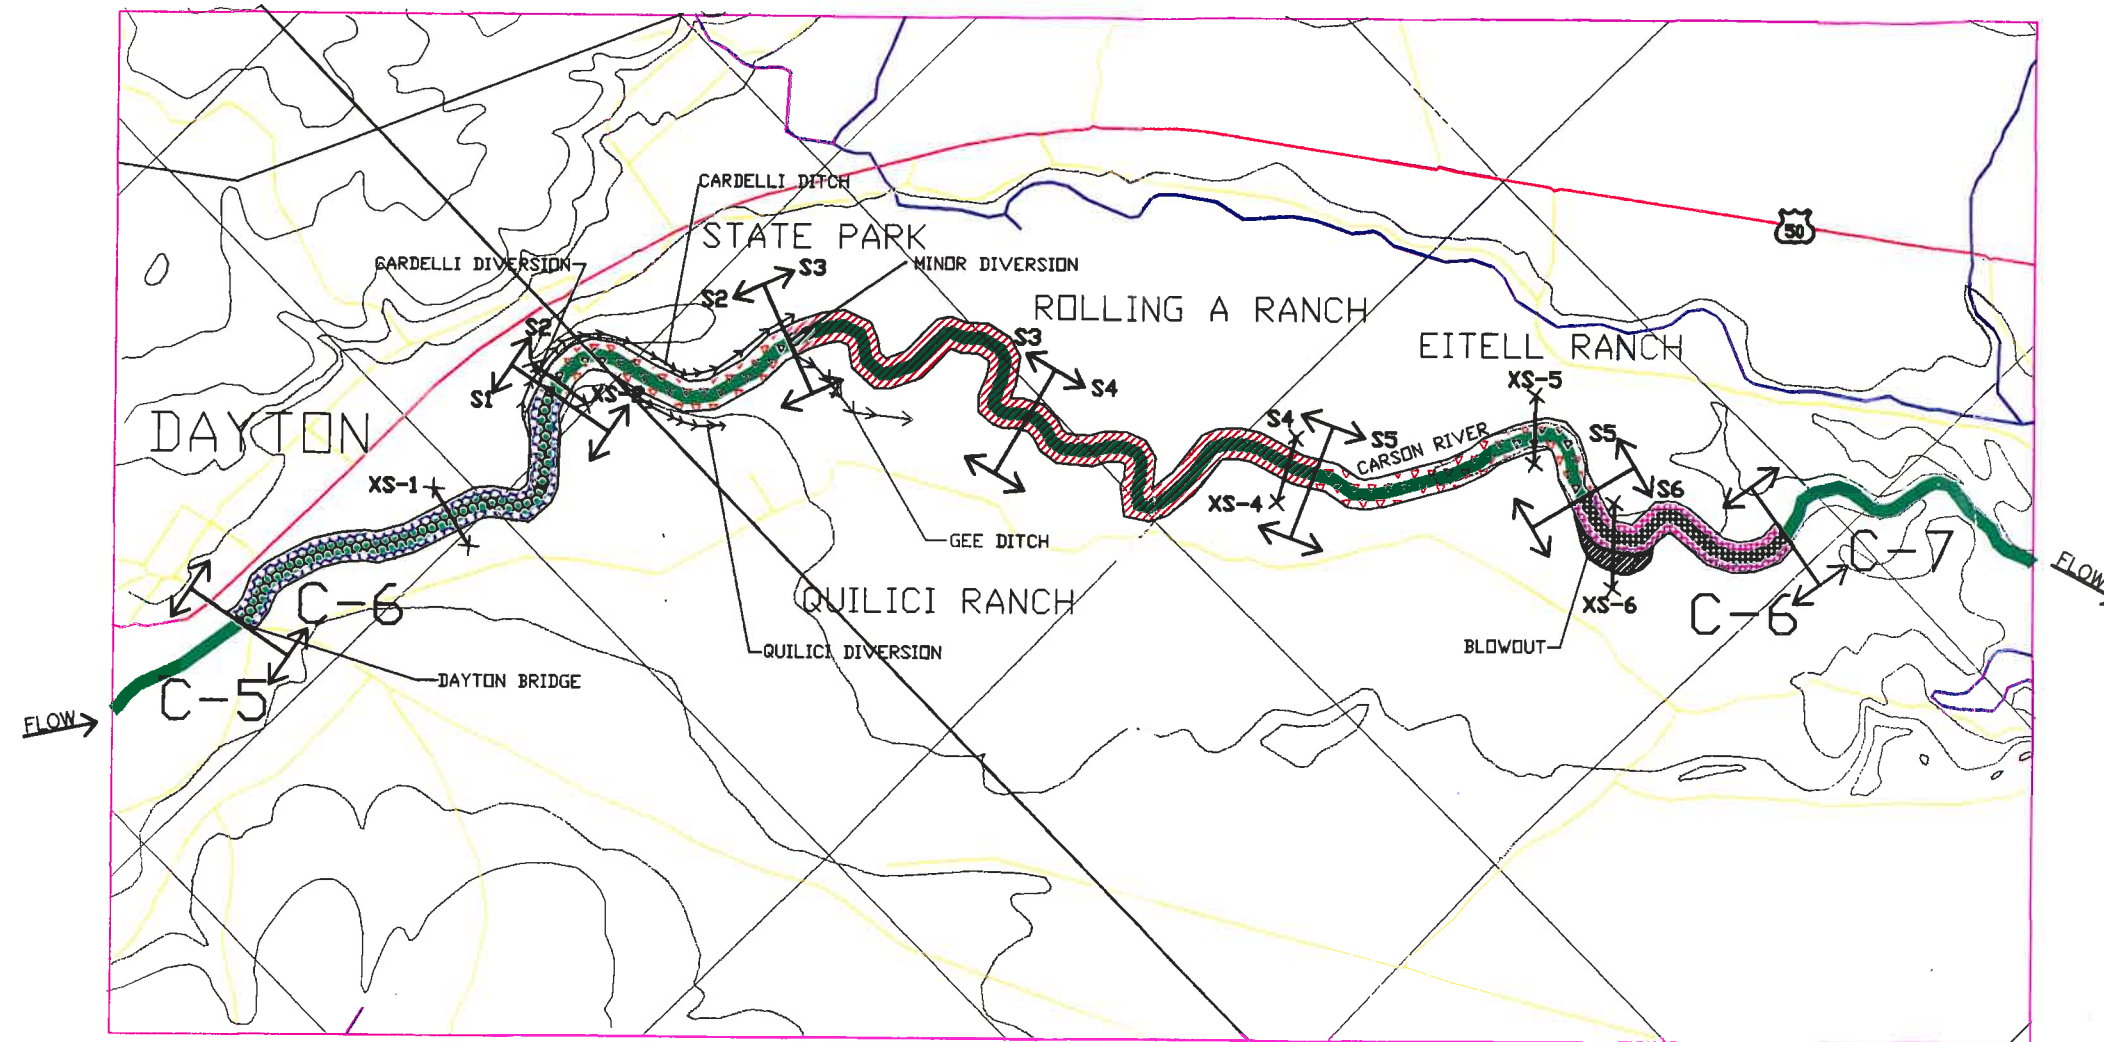
REACH C-6
 APPOX. SCALE: 1" = 2100'

- S6: S6 is very unstable and is rapidly increasing its active channel width, up to 60 feet in two years at one point, as identified a landowner. Channel widening is likely caused by significant channel aggradation in conjunction with erosion prone banks.

- Bank instability is moderate in S5 and mostly associated with outside bends. Banks average 3 feet in height and are generally 3:1 or flatter.
- Both undercutting and gravitational failures affect S6 banks, with 90% in a failing condition. Outside banks are vertical and composed of very easily eroded sands and small gravel, while inside banks are less steep.

S1: From the Dayton Bridge to the Cardelli diversion, the channel is generally stable. The trailer park on the left bank above the diversion may be threatened should the river's flow erode the already inadequate bank protection adjacent to the structures. It is recommended that the banks adjacent to the trailer park be subjected to further investigation and assessed for existing stability. Also, it may be appropriate to move the Cardelli diversion downstream such that capture by the river is less likely. On the right bank, a diversion ditch may be vulnerable to capture should the banks fail. Currently, the rate of bank retreat here is only minor.

To protect the Cardelli ditch and State Park facilities, the left bank needs substantial protection. There are several methods available to protect the bank including: a) rip rap banks, b) install bendway weirs and, c) construct a low terrace with a hardened face adjacent to the failing banks; plant terrace; lay-back or fill vertical banks to angles amenable for revegetation. In conjunction with these options, it is conceivable that the main channel alignment can be moved off the vulnerable left bank. Additionally, total or partial removal of the right bank levee should be considered so that larger flood flows have the opportunity to spread out more (note that the Quilici ditch on the right bank moves away from the river soon after the diversion, and therefore, there would still be a buffer between the river and the ditch). We recommend that a strategy be pursued which is complimentary to the

S6: This reach is most notable for the "blow-out" on the right bank, where the river is very actively widening. Currently, the landowner is losing ground at a fast rate, and is very vulnerable to more loss with a flood of even moderate magnitude. There may be some stabilization strategies that would be effective for the right bank; these have been discussed previously (see S2 recommendations). The hardened terrace option may prove to be the most effective as there is evidence on site that a vegetated terrace is viable. Without making light of the land owner's predicament, it should be noted that any substantive effort to inhibit further channel changes on this sight will prove to be very expensive and not without significant risk.

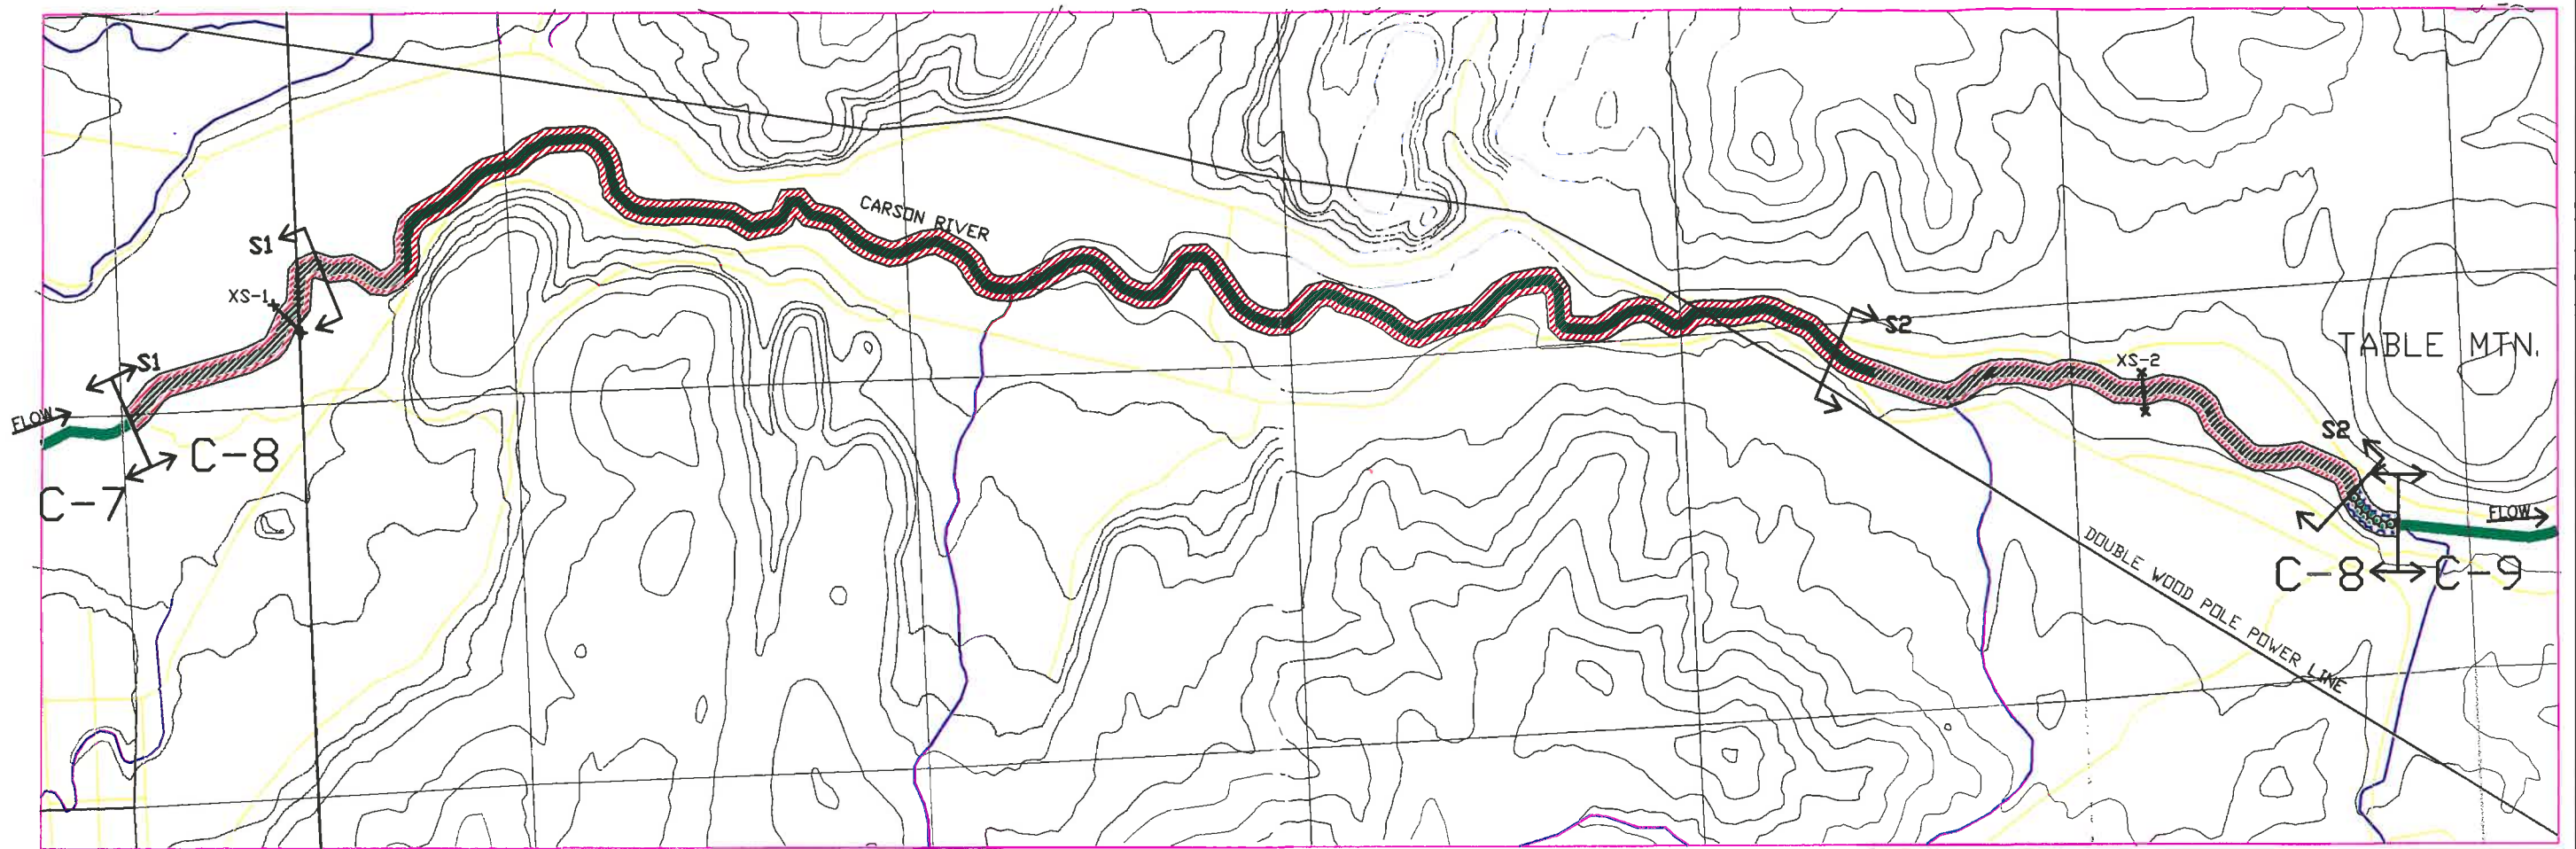
REACH C-8
 APPROX. SCALE: 1" = 2300'

S2: The same observations for S1 hold for S2. Given its slightly higher resistance to bank erosion provided by the riparian fringe vegetation, this sub-reach may change at a slower rate than S1. However, given the upstream instability and large in-channel and mobile sediment supply, it is not difficult to envision a continuation of an unstable pattern through the near future. The absence of sufficient flows to support channel fringe vegetation during the summer months may perpetuate the area's instability. Furthermore, channel bars and/or terraces are only inundated at approximately 10-year flows and so are not receiving annual or even less frequent moisture inputs. Wild cards in this scenario may include the absence or occurrence of large floods in the near future and the integrity of the Houghman and Howard Diversion dam. An absence of floods may promote better channel stability while a large flood may dramatically change the existing conditions.

Based on the relative lack of infrastructure, upstream instability, the degree of instability on sight and the perceived tendency for future channel enlargement, we recommend that structural approaches for stabilization not be explored in either S1 or S2.
