## TECHNICAL MEMORANDUM

Alluvial Fan Evaluation:  
Fans 44, 45, 78, 79, 81, 82, 115 and 116  
Carson City and Douglas Counties, Nevada

**To:** Carson City Subconservancy District (CWSD)

**Date:** 27 March 2020

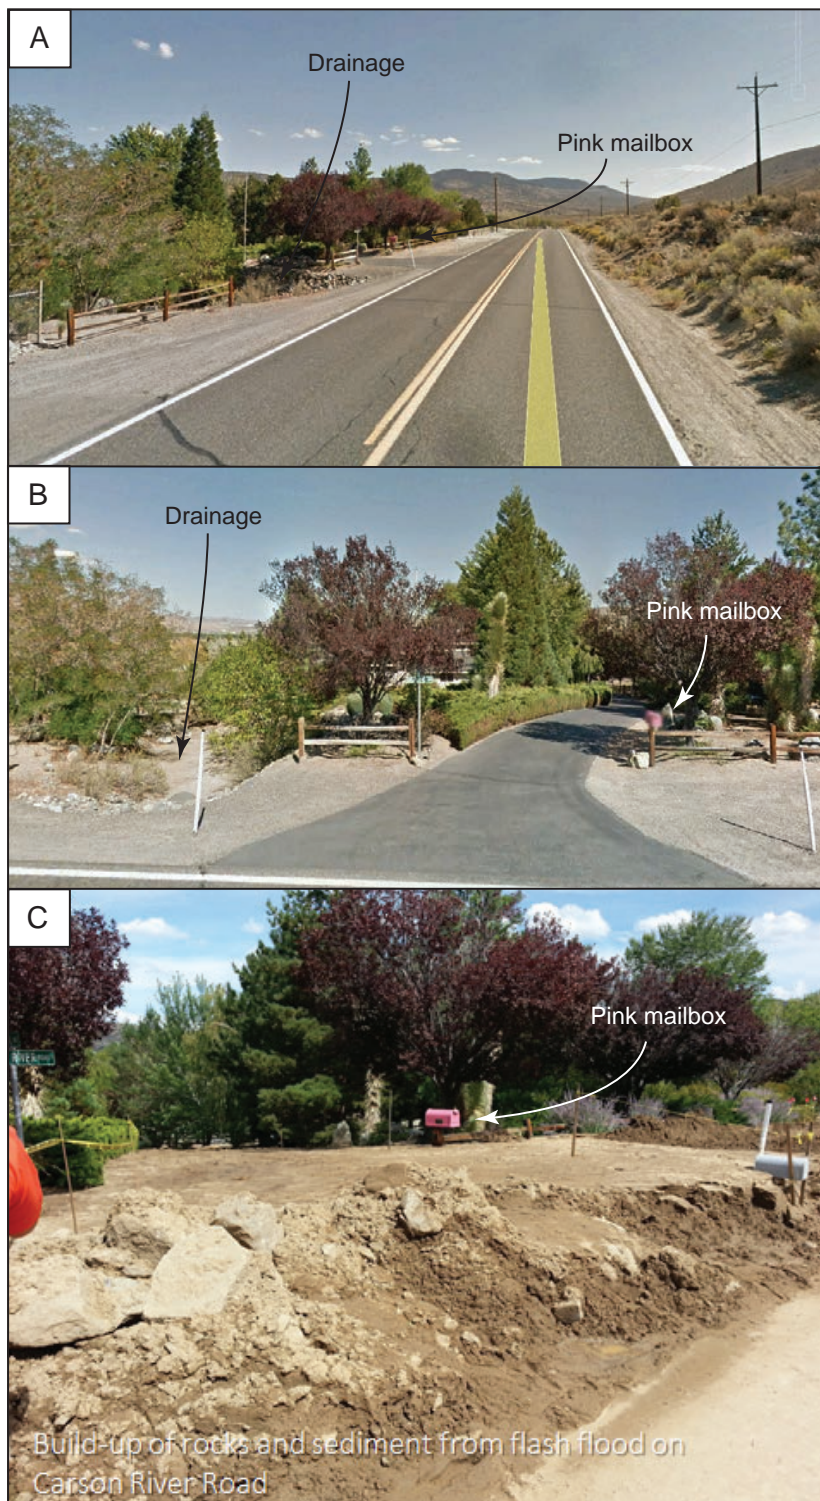
**Figure 6.** Sedimentation over Carson River Road on Fan 116 in 2014. General location shown from screen grabs taken from GoogleEarth Street View shown in A & B. Pink mailbox provides general reference. C) Thick sediment deposits cover road and driveway (Photograph provided by R. Fellows, Carson City County). Deposit primarily consists of sandy mud transported in the form of either hyperconcentrated flow or low density sediment gravity flow (mudflow).

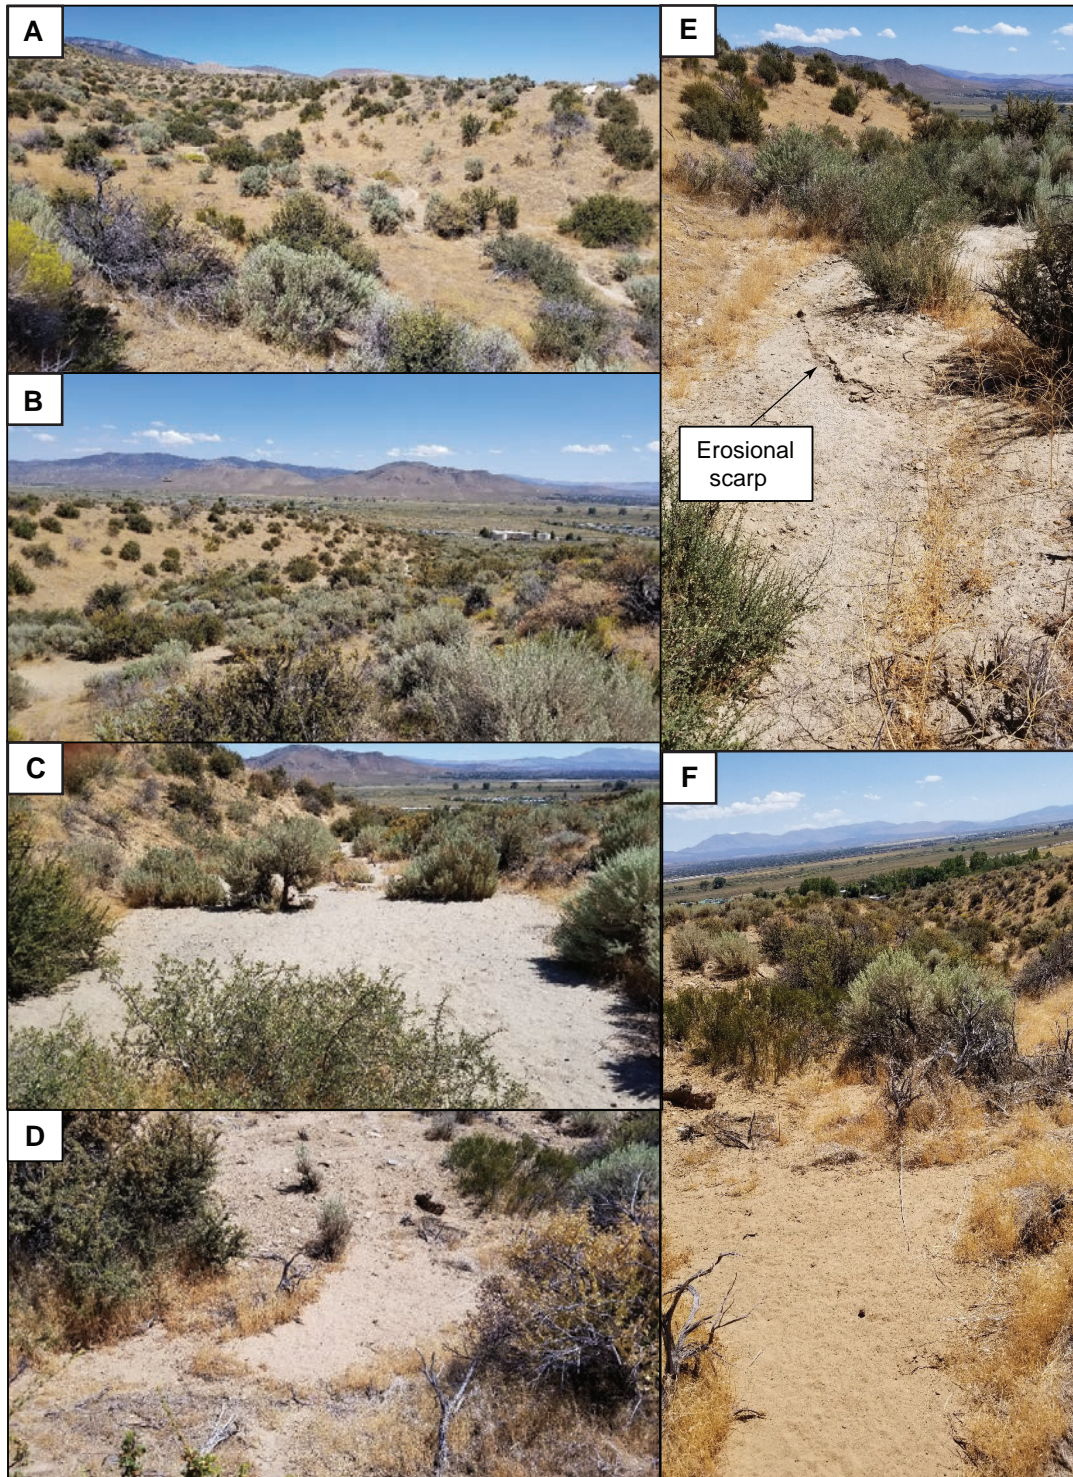
The “undisturbed” surface of the fan is completely covered with low vegetation (**Figures 9a-b & 10**) with no channels apparent in the LiDAR imagery (**Figure 8**); however, during the site walk small patches of sand deposits were observed (**Figure 9c-f**). The surface of the fan is relatively smooth with low relief, except for a large excavation in the center of the fan and a second excavation along the southern boundary. The surface of the fan slopes away from the topographic apex at about 6 - 8°. A well-developed incised channel fed by a narrow gully on the side of Indian Hills was observed south of the main feeder channel to Fan 78 (**Figures 8 & 10**). This channel runs along the western and southern edge of the fan and discharges to a zone in between Fans 78 – 79. Surface material was largely composed of sand below a litter of thin organic debris. The exceptions are sand pockets composed of loose sand with no vegetation that appear to be “recent” alluvial deposits. Weathered, angular cobbles and small boulders are also scattered about the surface (**Figure 11**).

**Figure 9.** Photographs from main feeder channel to Fan 78. Underfit stream bed located in large incised channel. A) Looking upstream from the southern bank and (B) downstream. (C - F) Recent sandy alluvium in center of channel represents modern deposition. E) Shallow channelization can be observed in the deposits. Channelization disappears below the topographic apex indicating that flow diverges as it exits the channel confines.

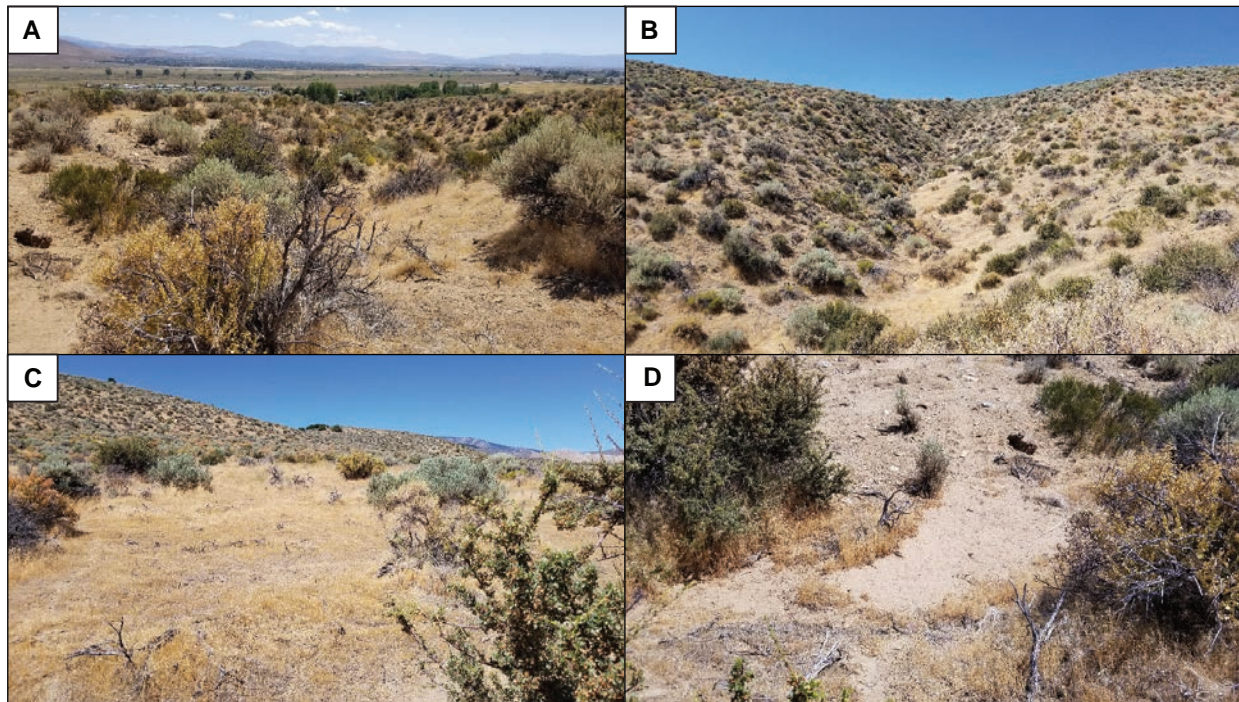
**Figure 10.** View of Fan 78 at Site 1. Incised channel shown in A & B is fed by gully on southwest margin of fan that feeds zone between Fans 78 & 79. Channel is incised into stable fan surface (C) although small pockets of sand are observed filling topographic lows (D). These sand deposits appear to represent deposition from sheet flow.

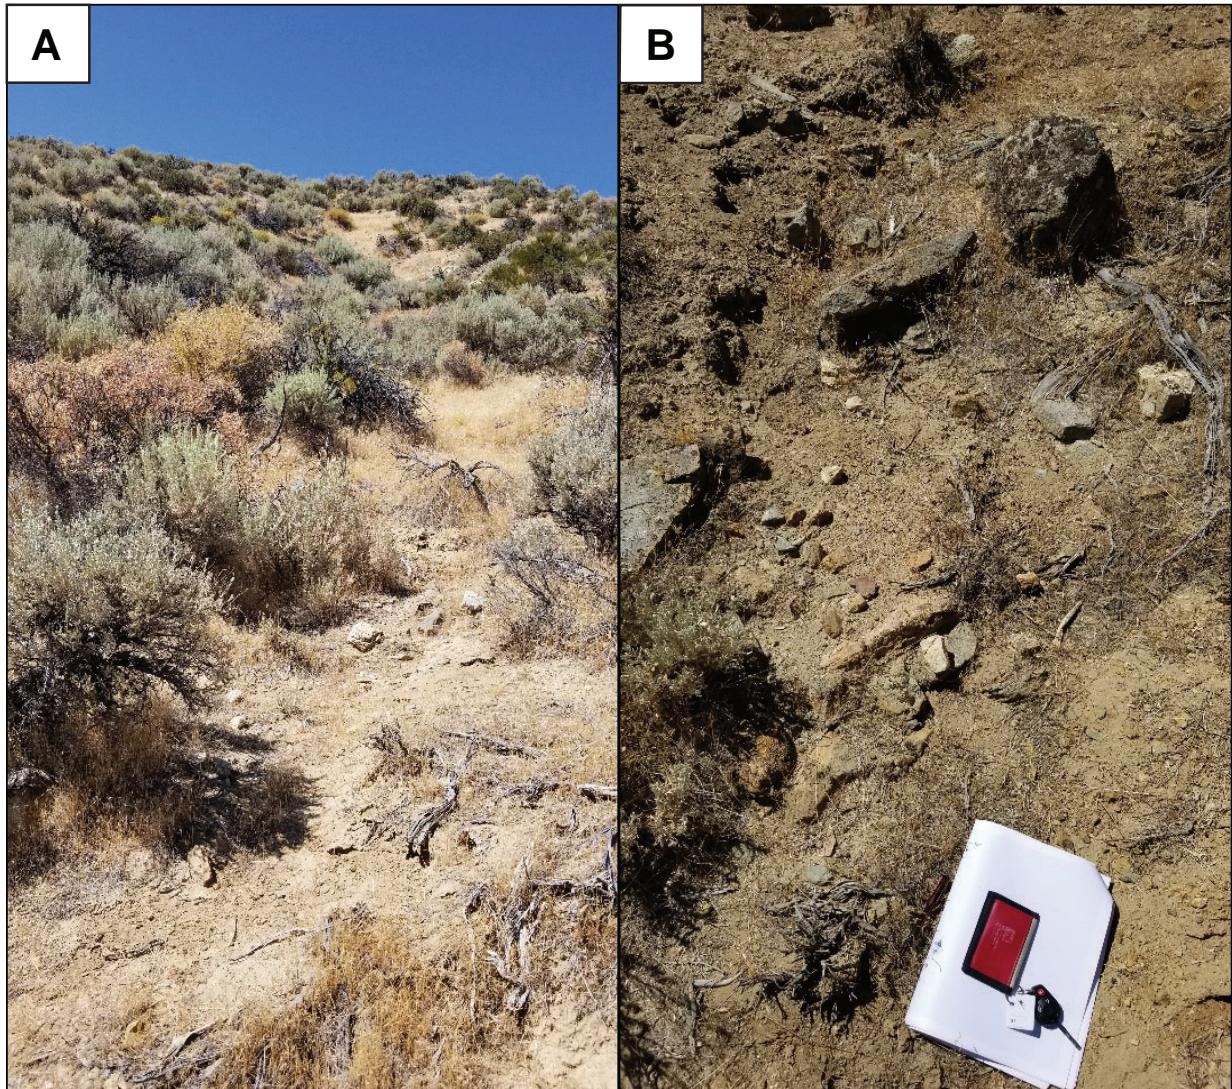
**Figure 11.** Surface materials on Fan. A) Scattered angular to subangular boulders in a sandy matrix and B) close-up view of the angular characteristic of boulders and cobbles.

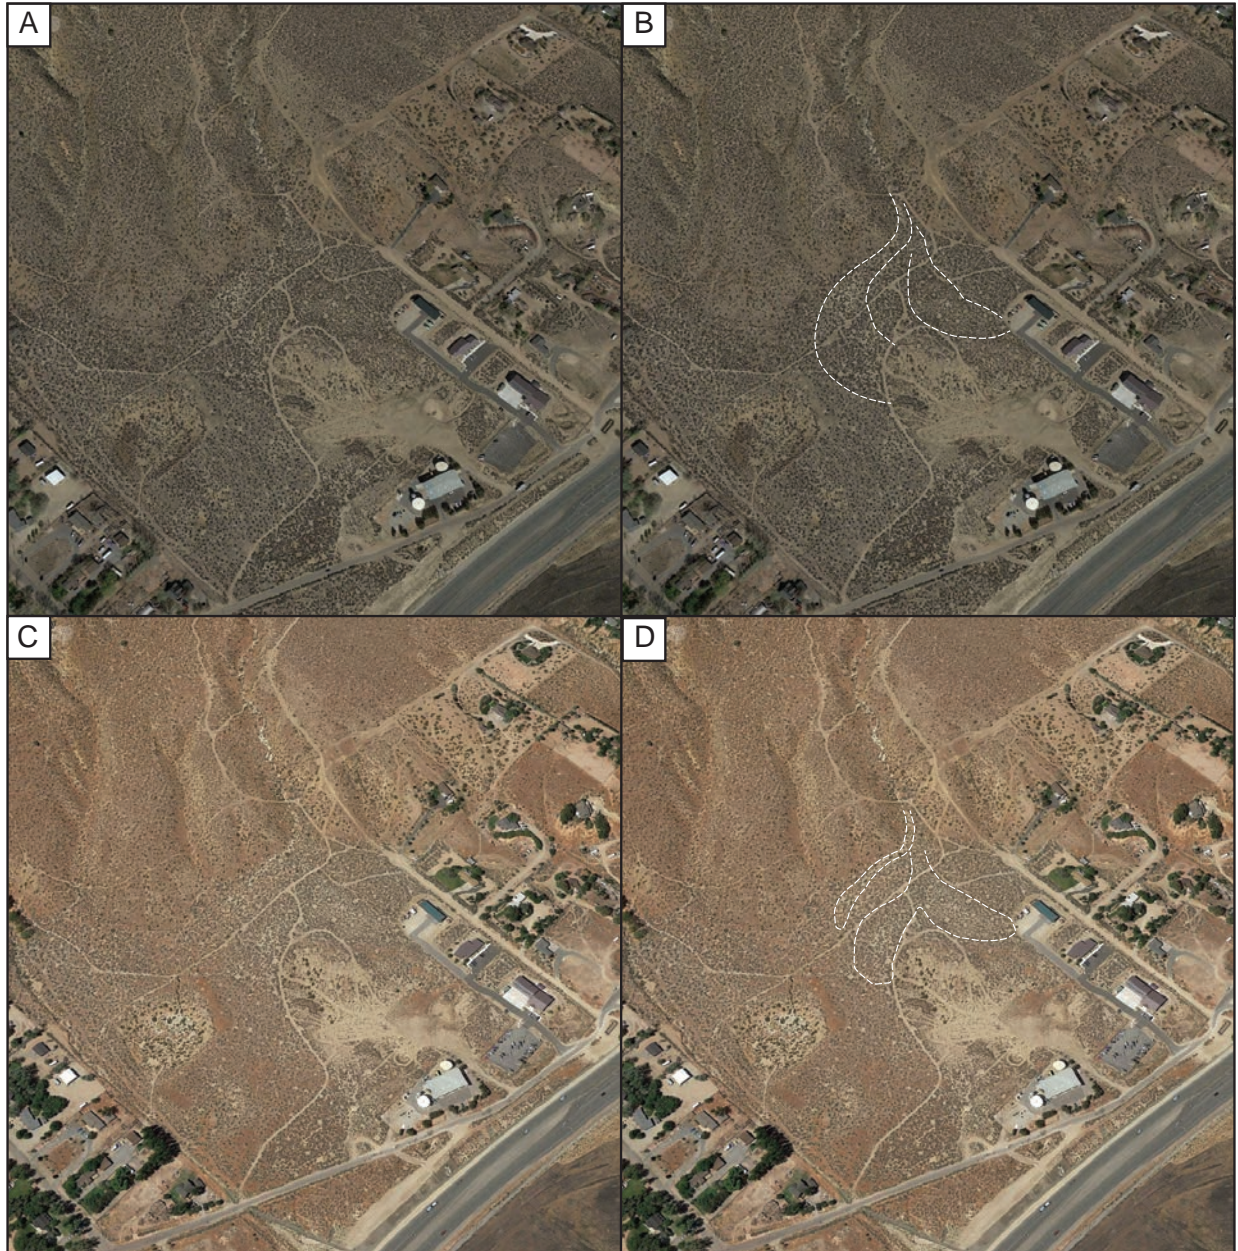
**Figure 12.** Oblique aerial photographs of Fan 78 from GoogleEarth. Photos A) and B) are from April 2015, with B showing interpreted discoloration caused by deposition from surface flows. Photograph C) was taken in August 2017 with D) showing outline of interpreted recent deposition.

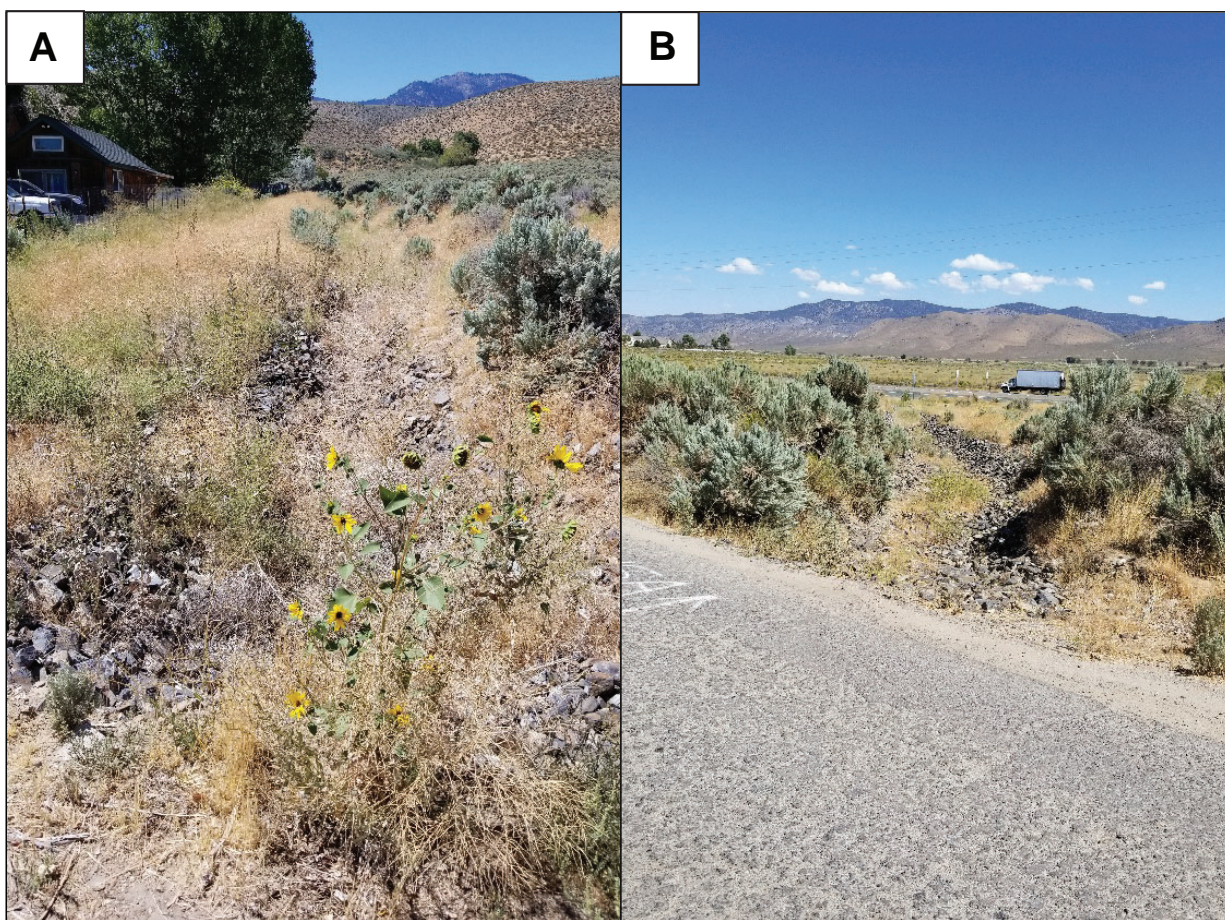
**Figure 15.** Gravel-lined drainage ditch along north side of fan where ditch crossed Hobo Hot Springs Road. (A) Looking to the west and (B) looking to the east.

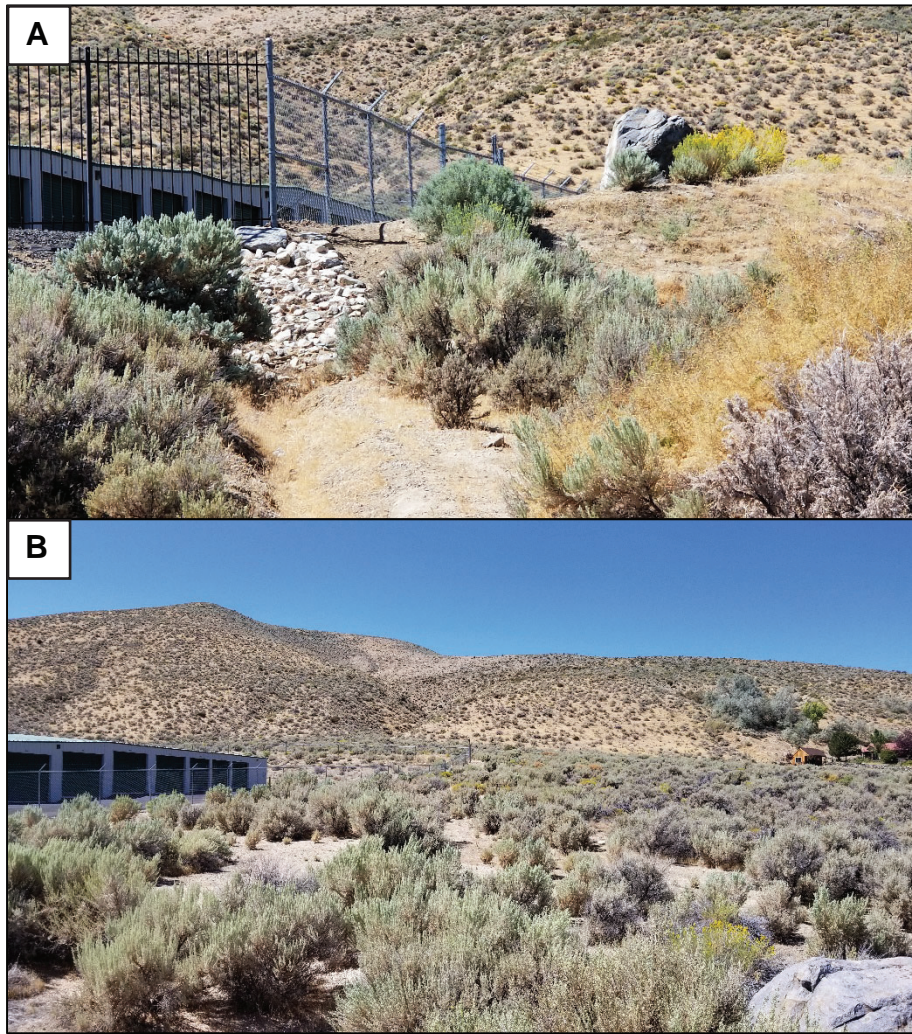
**Figure 18.** Fan 81 along north edge of Hobo Self Storage. (A) Gravel lined drainage feature at northeast edge of pavement. (B) Gently undulating mid fan region and (C) medium to coarse sand with angular granules and pebbles in mid fan region.

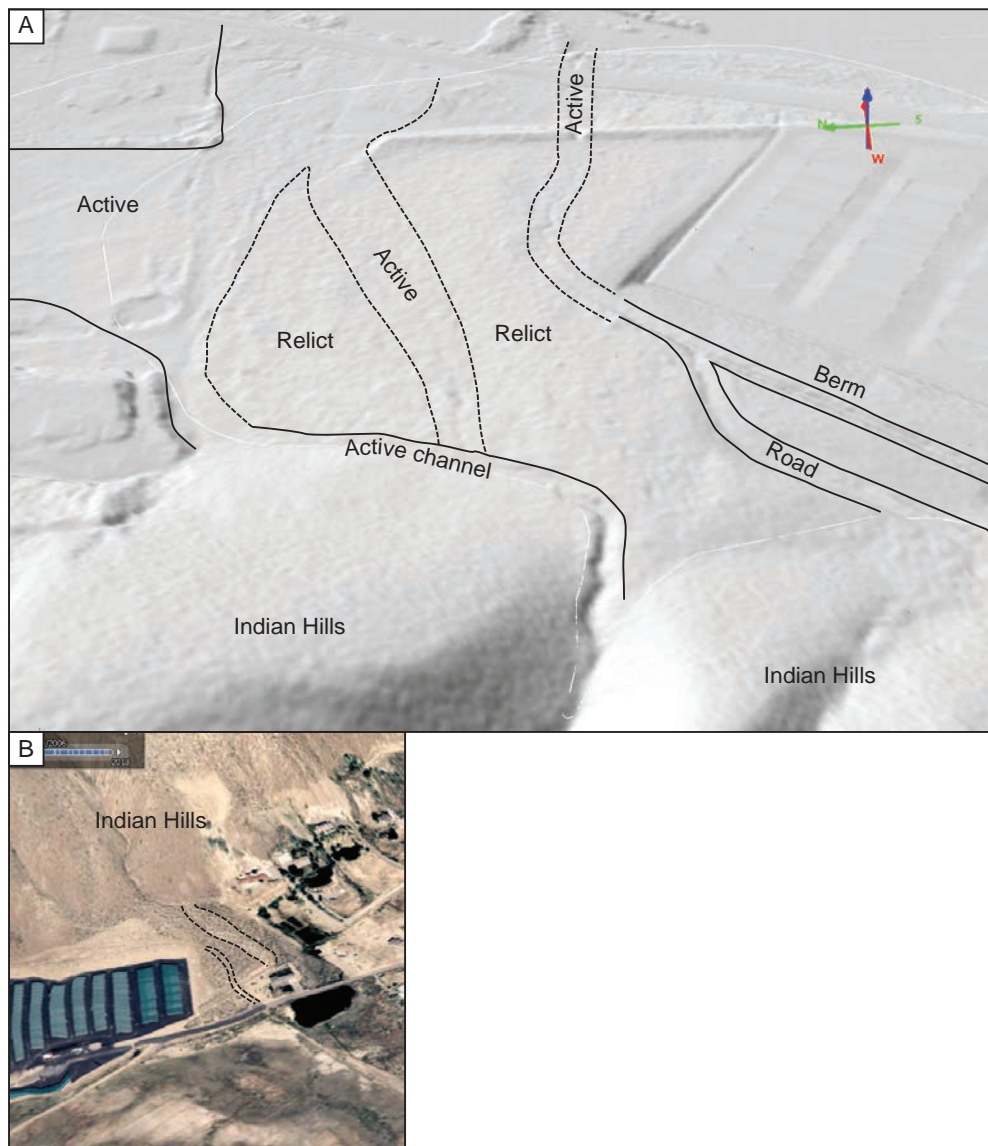
**Figure 19.** Evidence of recent alluvial activity on Fan 81. A) Oblique view looking to the north of a hillshaded relief model. There are two zones (marked active in center of image) where there has been channelization caused by surface flow. The GoogleEarth aerial photograph shown in B) was taken in October 2006. Approximate area of the active zones highlighted in A) are dashed. Fan 82

**Figure 19** shows at least two areas that have experienced recent flow and erosion of the fan surface, as well as general zone of alluviation along the northern boundary where storm water likely ponds in near flat laying areas before draining to the east. A zone of potential concern is along the “Active Channel” where overbank flow has caused minor channel development (**Figure 43c**). During high flow conditions, this could be an incipient area for channel avulsion. The other “Active” zone on the fan is a product of surface drainage being re-directed around the self-storage facility. Downstream of the drainage diversion there is evidence of channelization caused by focused surface runoff. To prevent ponding of water, a levee (or berm) has been intentionally breached to allow eastward drainage.

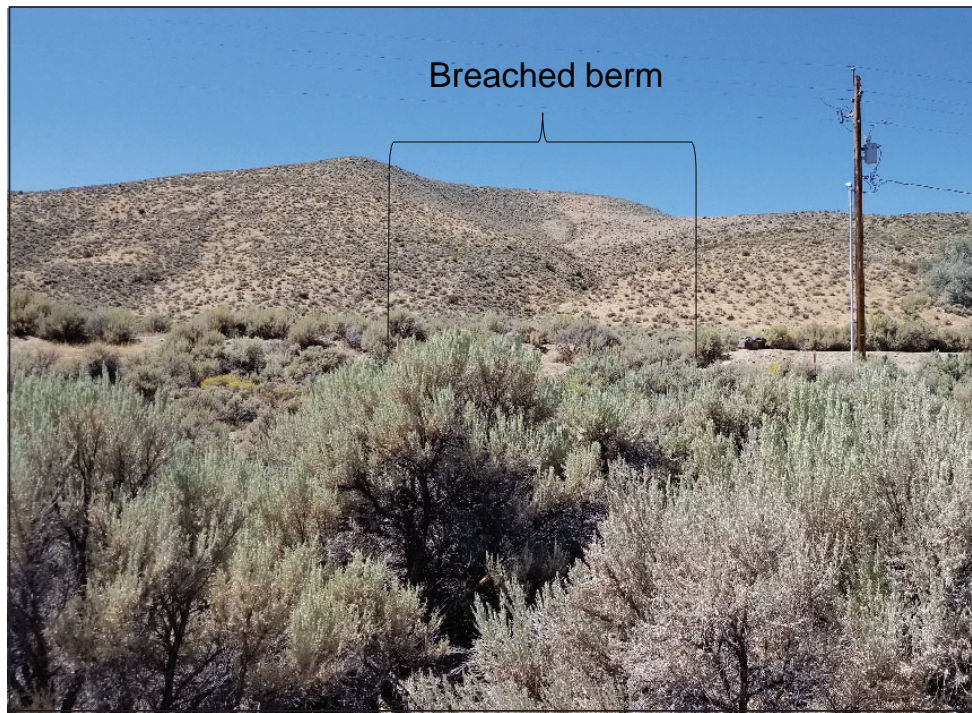
**Figure 20.** Breached berm on north side of Hobo Hot Springs Road to accommodate surface flow off of Fan 81.

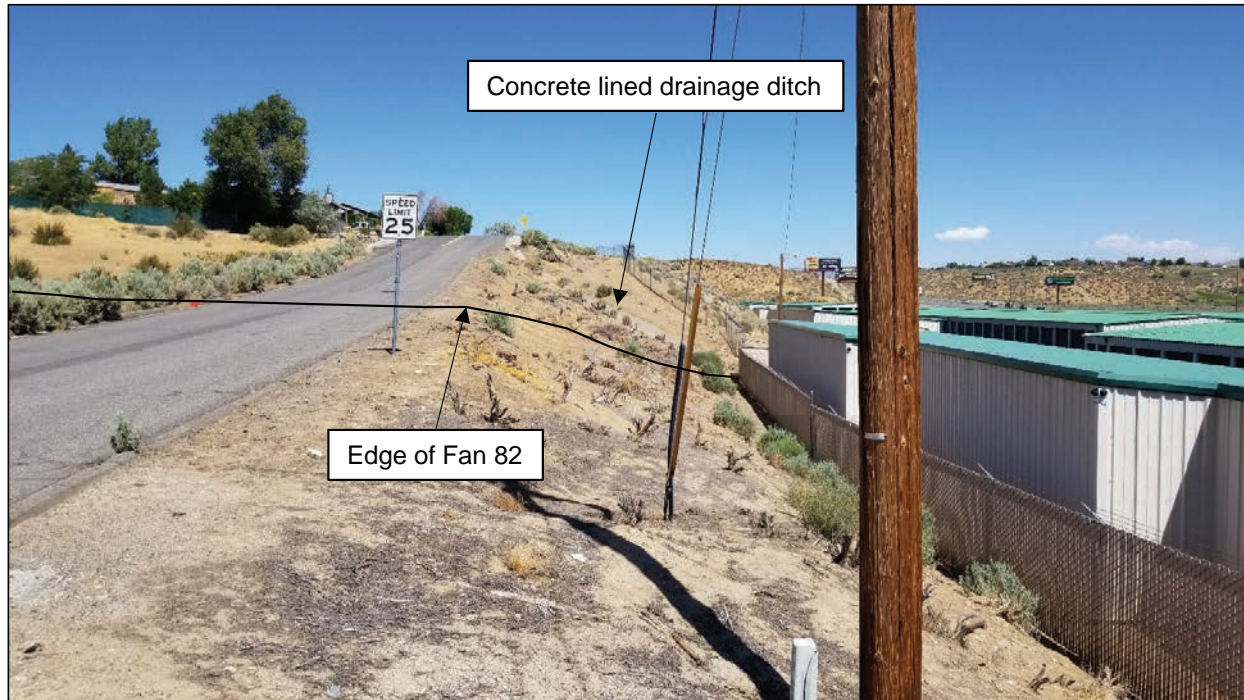
**Figure 22.** View of the northern edge of Fan 82 looking north up Plymouth Road. Drainage apparent on LiDAR data is fed by concrete lined ditch that drains Plymouth Road high area north of fan boundary.

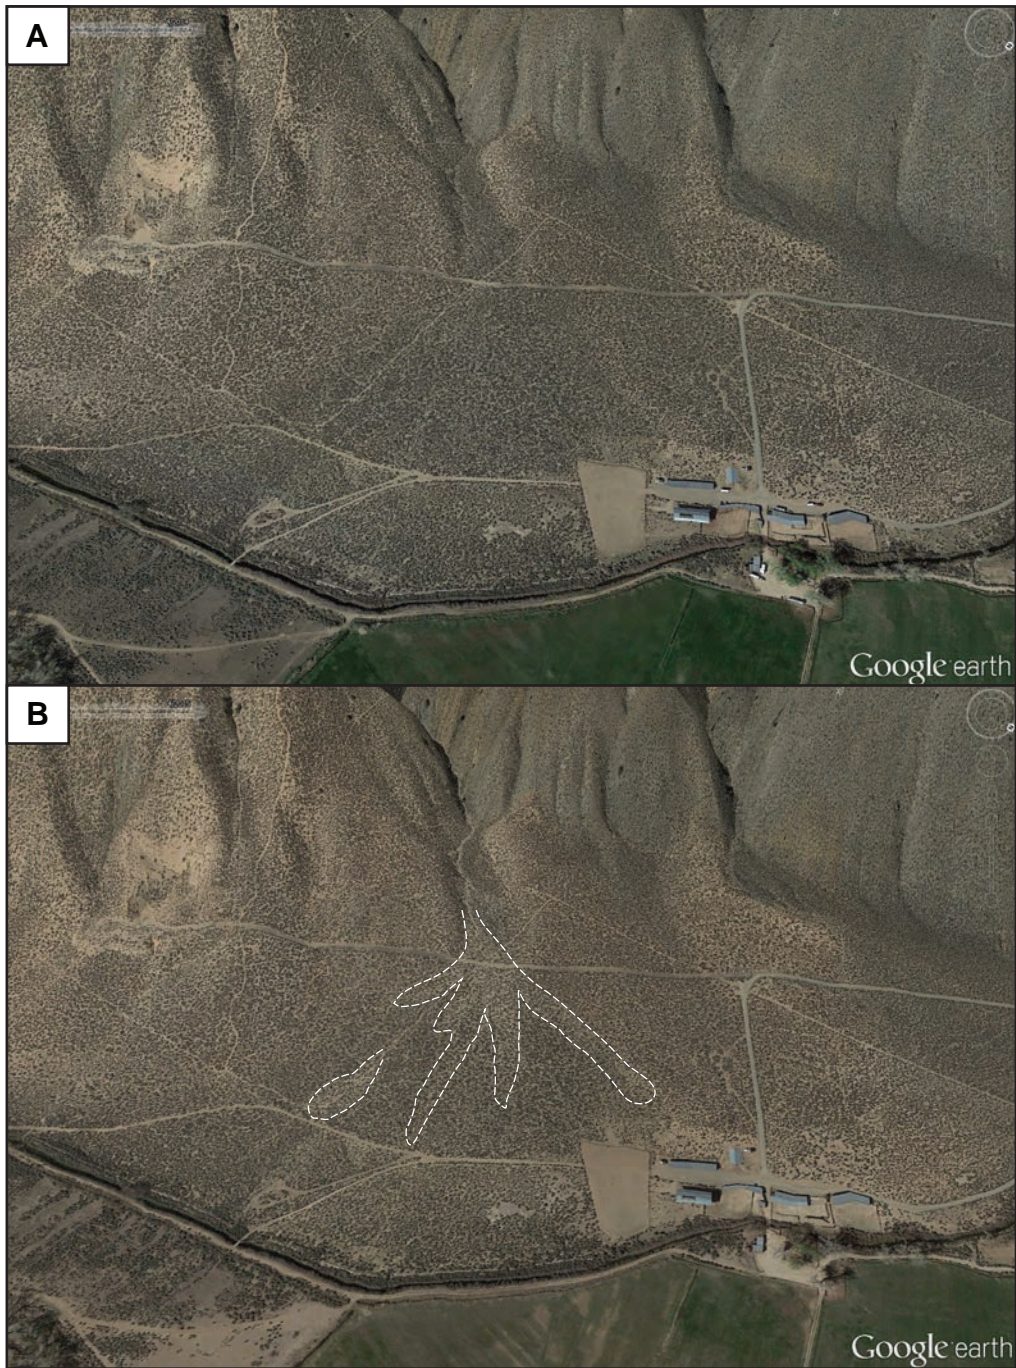
**Figure 26.** Oblique view of aerial photographs showing Fan 115 taken A) April 2014 and B) April 2014. The lighter zones outlined on B do not appear on photograph A suggesting surface flow occurred between the time the two photographs were acquired.

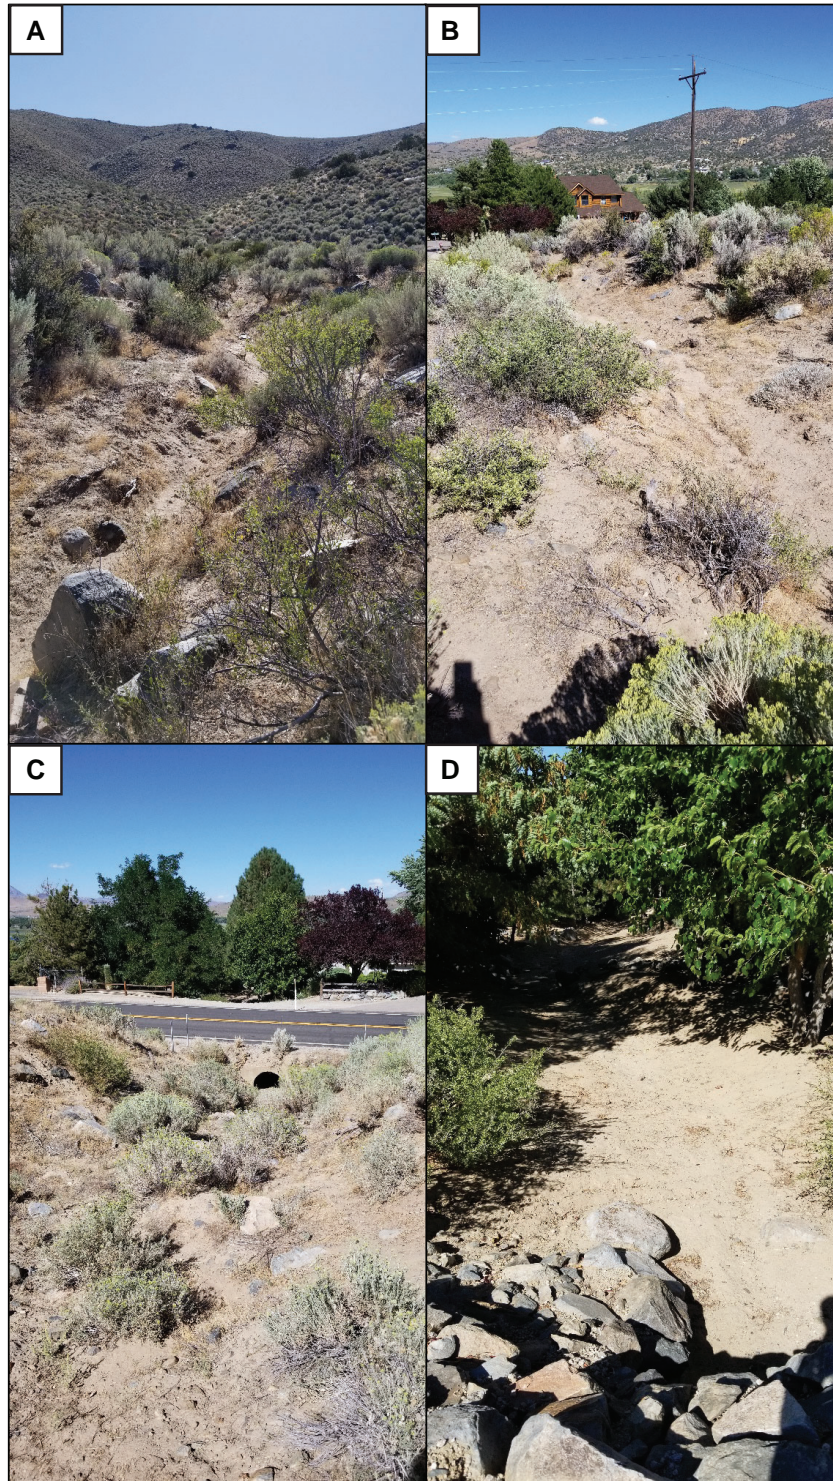
**Figure 31.** Active channel on Fan 116. (A) Looking upgradient towards fan apex at incised channel. (B) Looking downgradient at incised channel. (C) Culvert under Carson River Road used to divert surface flow under road. (D) Well-maintained artificial channel used to divert storm water through housing area.

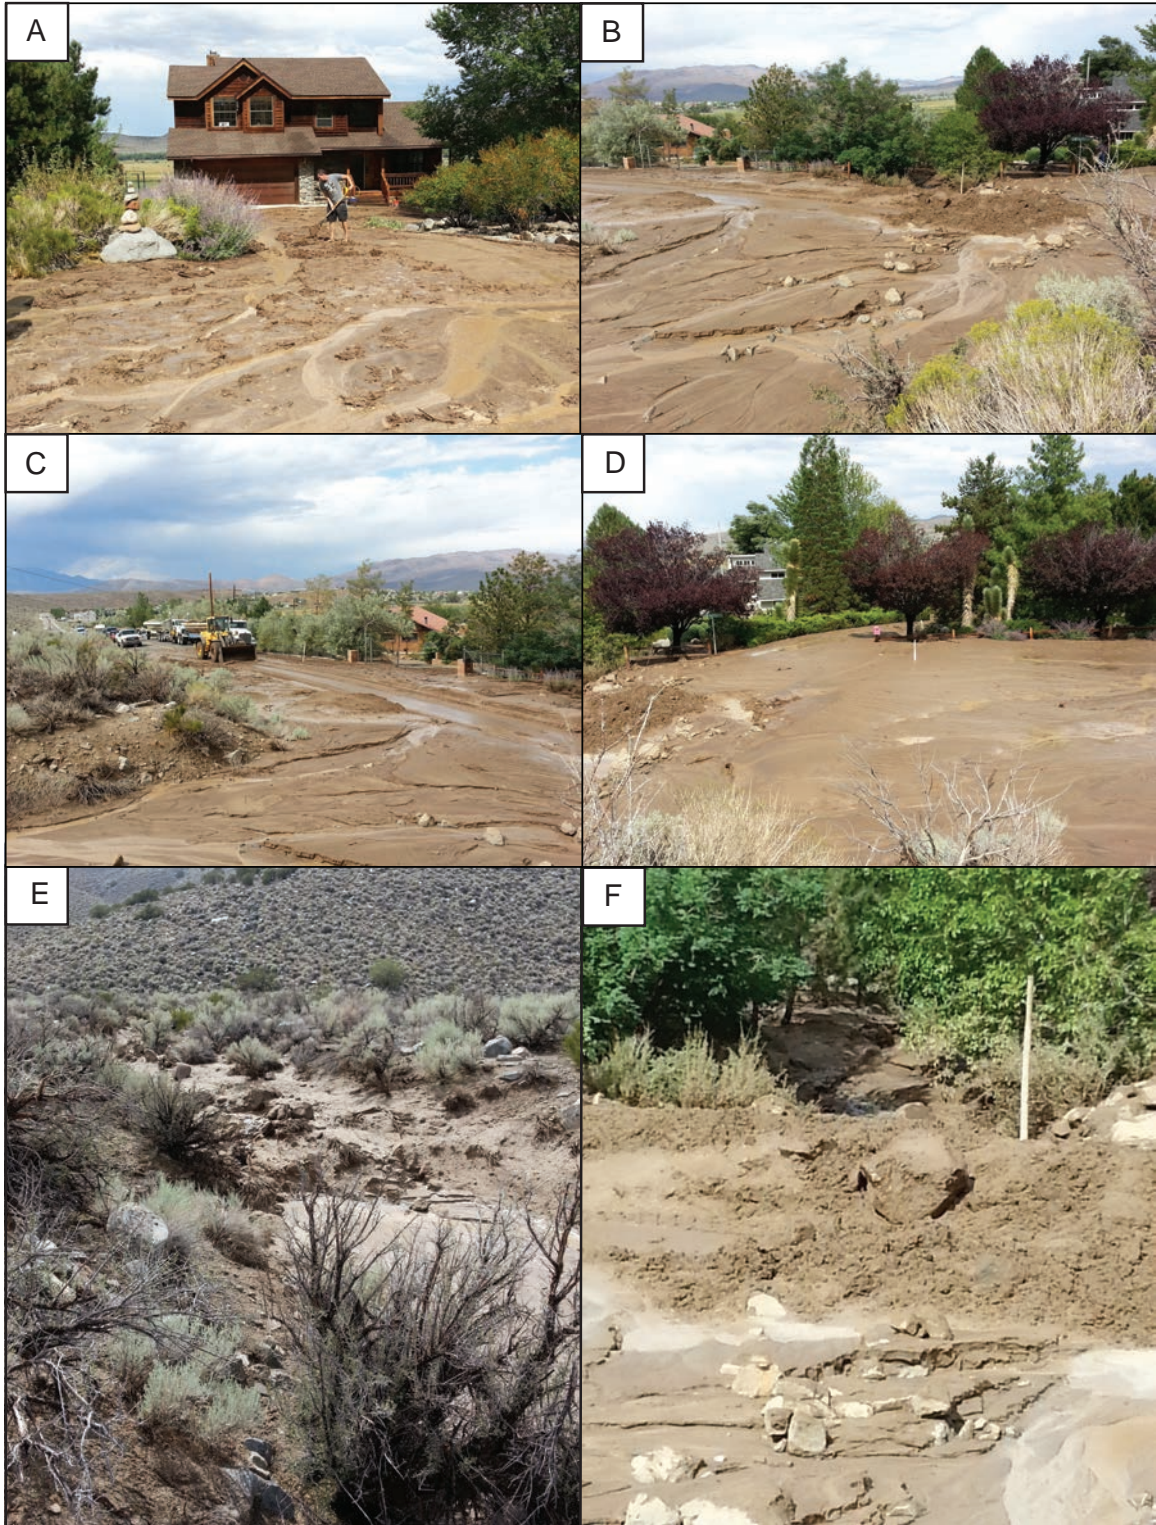
hazard associated with these steep alluvial fans. **Figure 32** shows a series of photographs taken after a flooding event in 2014. According to R. Fellows (personal communication to J. Newton who was conducting the hydrologic modeling in parallel study) the culvert got blocked by debris during the flow and the then overtopped the road. Upwards of 2 ft of gravely sand covered the road and driveway to a nearby home. It is difficult to tell from the photographs if deposition occurred as a result of a hyperconcentrated flow or low-density sediment gravity flow (e.g., mudflow). Close examination of the photographs did observe some laminations in the sediment as well as channelization on the surface, but this could be a late stage dewatering effects. Regardless, the event shows that loose sediment in the fan's catchment is susceptible to mobilization during intense rainfall (and snowmelt) events. Based on the hydrologic modeling it appears that the culvert was undersized and would have been overwhelmed whether the culvert was blocked or not (J. Newton, personal communication). It is therefore unknown if the channel would have passed the event without significant damage.

**Figure 32.** Photographs of sand and gravel deposited on Carson River Road along Fan 116 during the 2014 flash flood. Photos provided by R. Fellows (Carson County). Photographs of the active channel E) looking upstream and F) downstream.

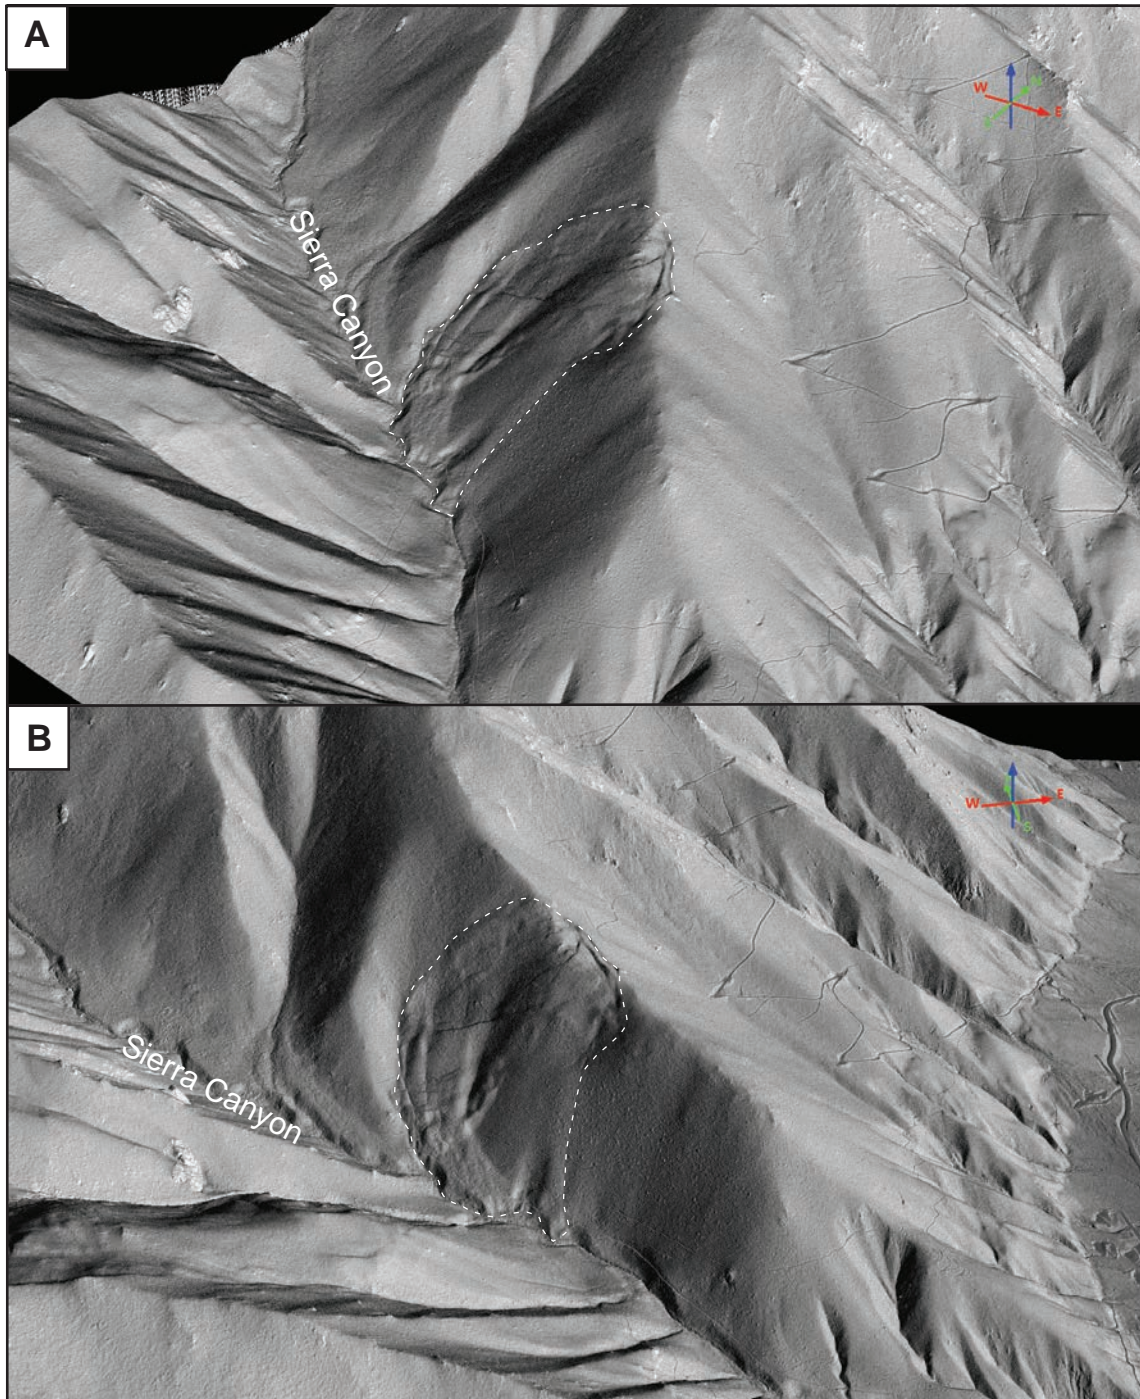
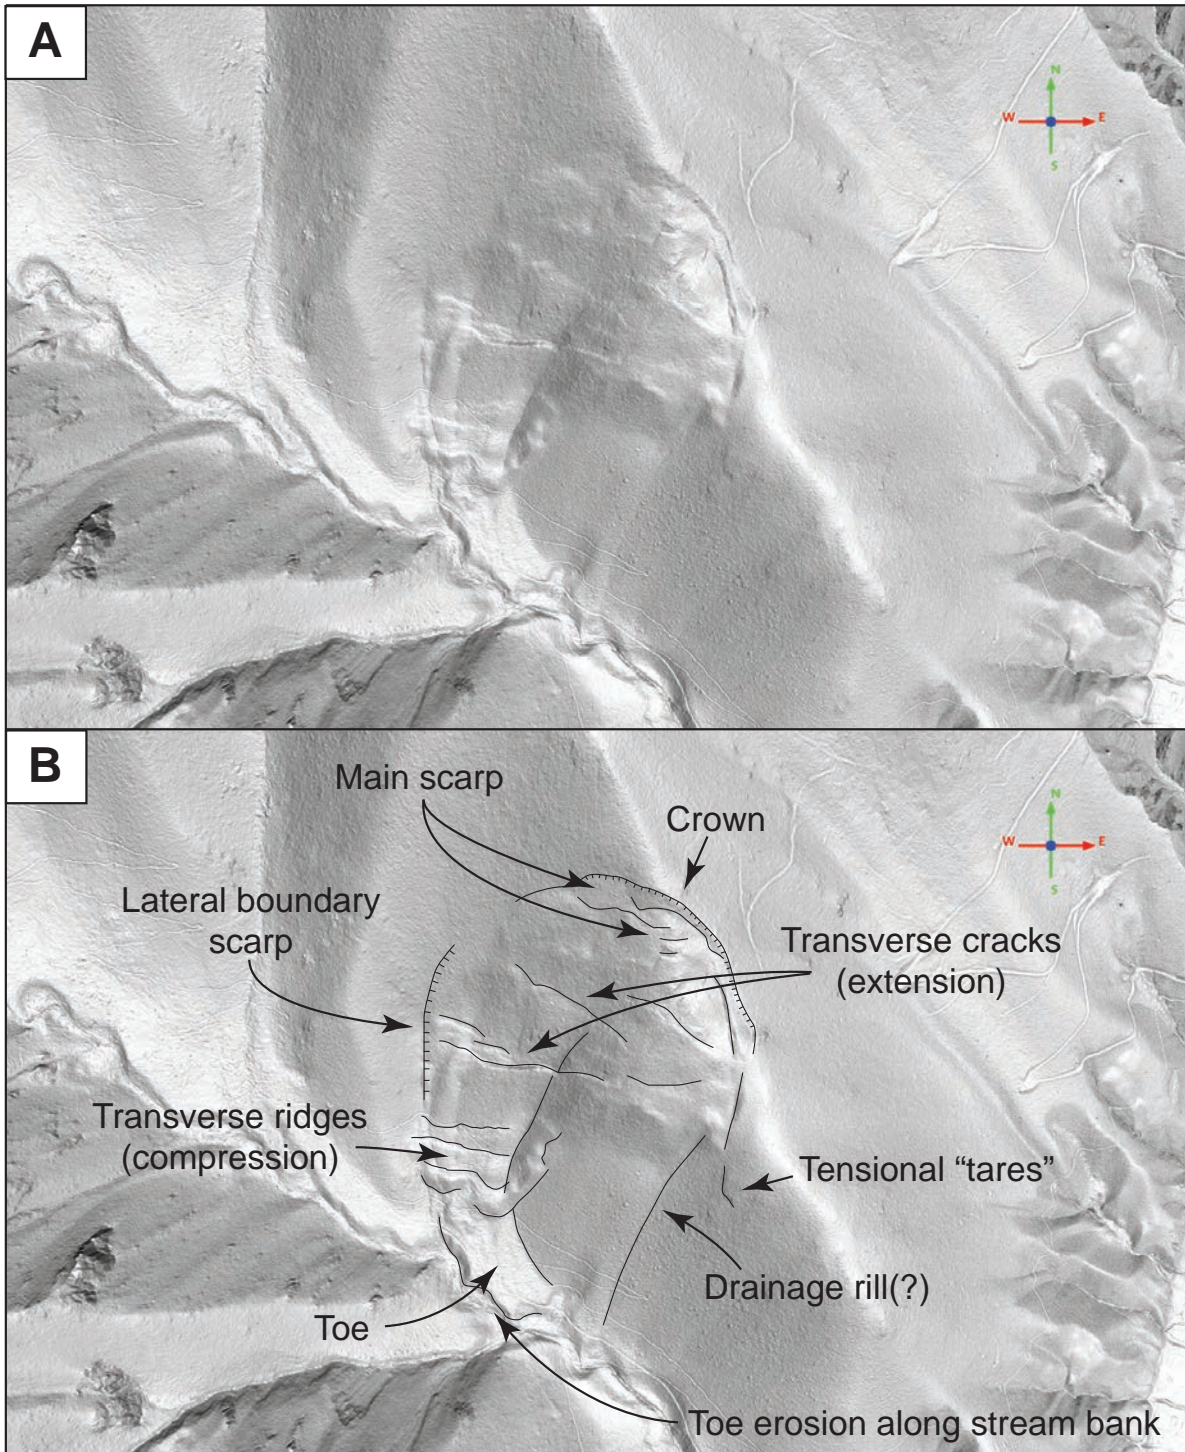
Although not included in the study area, there is a concerning feature on the north side of Sierra Canyon (adjacent canyon to the south of Childs Canyon). **Figures 40 and 41** shows a semi-circular feature that covers the entire south facing slope. This feature is the early phase of a large scale movement that if/when it fails will block off Sierra Canyon. The catchment above the toe has 997 m (3273 ft) of vertical relief and covers 663,387 m<sup>2</sup> (1639.2 acres). Even progressive creep on the slope will gradually impinge on the stream in

Sierra Canyon and depending on the rate of movement could temporarily block the canyon. As flow is impinged upon creek, the sediment load to Fan 46 will increase as the stream undercuts the advancing toe. Catastrophic failure would lead to completely blocking the canyon with the potential for impounding water, subsequent overtopping, erosion and drainage. This could lead to very high sediment loads to Fan 46, with high risk for channel avulsion and associated debris flows. As such, Fan 46 should be classified as a high risk fan.

**Figure 40.** Oblique images of the LiDAR data showing Sierra Canyon. Note the deformed area on the south facing slope of the canyon marking the location of scarps and ridges associated with downslope earth movement (e.g., landslide). The landslide appears to be in early formation, slow soil creep and rotational sliding. The toe is being undercut by stream activity in Sierra Canyon as the tow advances down valley. Looking to the A) northwest and B) north-northeast. Dashed line marks outline of landslide.

**Figure 41.** Oblique image of the south facing slope near lower end of Sierra Canyon, Douglas County, NV. Unannotated image and B) annotated. Sierra Canyon feeds Fan 46. Terminology adapted from USGS Fact Sheet 2004-3072.

weathering. The clasts also often have a tarnished and weathered appearance indicating they have been exposed to long periods of chemical weathering. In many cases, they look like erosional remnants not associated with modern deposition. Boulders and cobbles are also common to at least the mid-fan regions. These clasts were likely transported onto the fan by debris flows during wetter climatic conditions, most likely during the Quaternary when fan aggradation was predominant. There are no stratigraphic exposures in these fans to evaluate historic modes of deposition. Despite these observations, debris flows may potentially be generated in the current climate but their occurrence is likely rare. When they occur, it is likely that debris flows would be restricted to the feeder channels and upper reaches of the fan. An exception would be large slope failures like the one highlighted in Sierra Canyon where a significant portion of the slope is experiencing progressive failure. This feature should be monitored to determine the rate of failure and to evaluate downgradient risk.

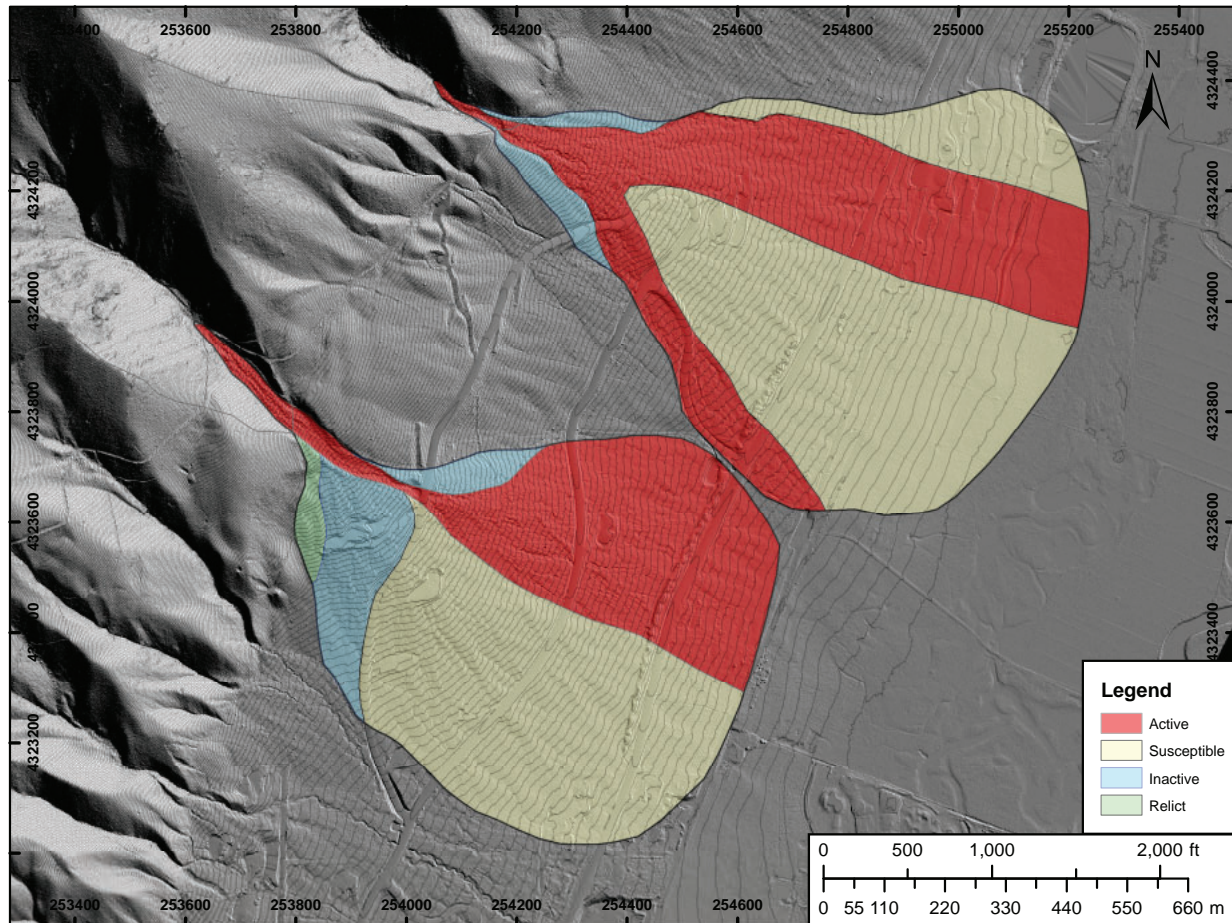
**Figure 42.** Fans 44 and 45 apparent activity/hazards based on LiDAR and aerial photography evaluation. Active areas shown evidence of recent channel activity and sedimentation. Susceptible area are those downgradient of active zones or other areas likely to experience flooding during channel avulsion. Inactive area are those typically located above active flood zones or sheltered behind levees and do not appear to have experienced recent alluvial deposition. Relict zone appear to be older surfaces, probably of Late Quaternary age.
