## TECHNICAL MEMORANDUM

Alluvial Fan Evaluation:  
Fans 44, 45, 78, 79, 81, 82, 115 and 116  
Carson City and Douglas Counties, Nevada

**To:** Carson City Subconservancy District (CWSD)

**Date:** 27 March 2020

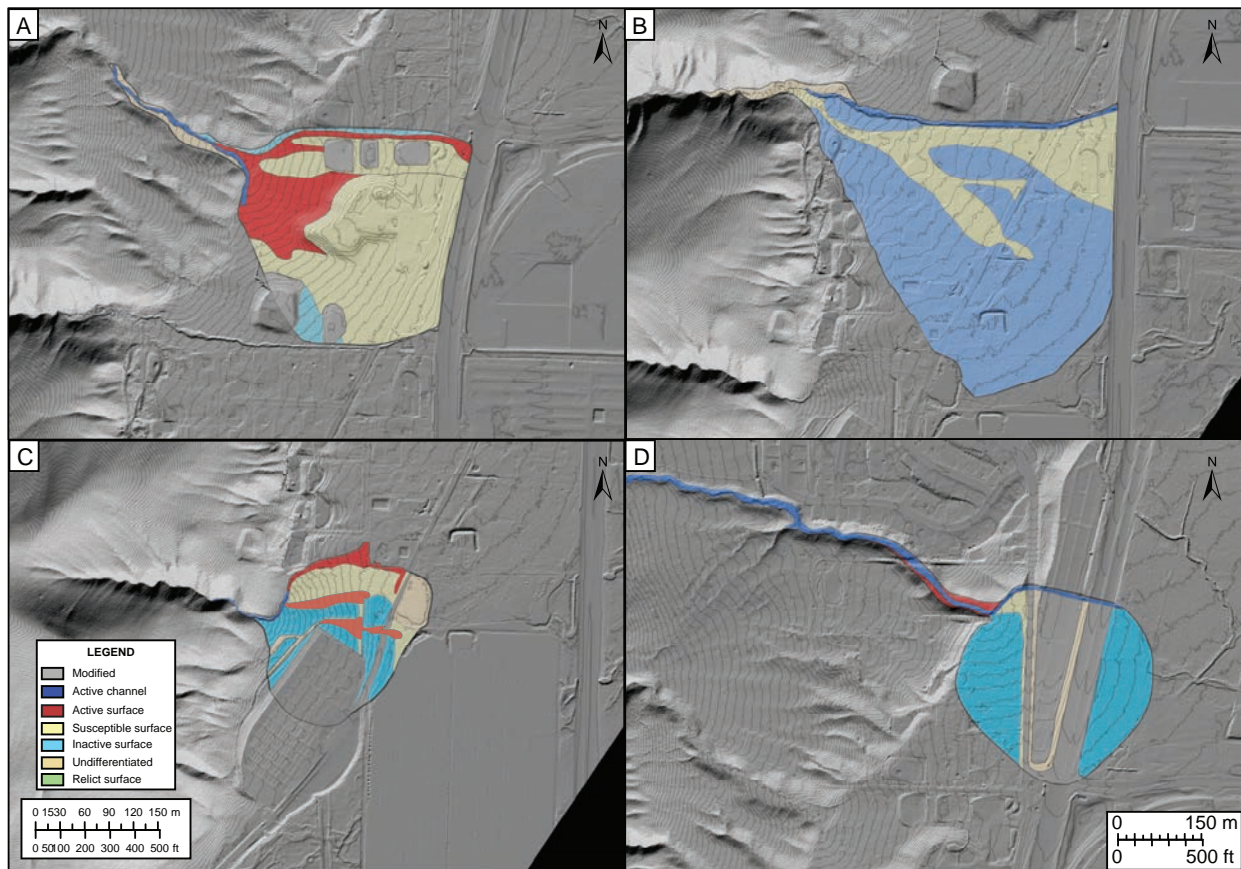
**Figure 43.** Fan hazard mapping. A) Fans 78, B) 79, C) 81 and D) 82. Apparent activity/hazards based on LiDAR and aerial photography evaluation. Active areas shown evidence of recent channel activity and sedimentation. Susceptible areas are those downgradient of active zones or other areas likely to experience flooding during channel avulsion. Inactive areas are those typically located above active flood zones or sheltered behind levees and do not appear to have experienced recent alluvial deposition. Relict zones appear to be older surfaces, probably of Late Quaternary age.

Fan 78 is highly disturbed with several large excavation as well as several building pads for houses (**Figure 43b**). Primary storm drainage follows the active channel along the northern boundary of the fan along a drainage ditch; however, southeast of the topographic apex is a shallow, broad depression. Aerial photographs from 2015 and 2017 (**Figure 12**) show lobate lenses of light coloration that likely represents recent deposition from sheetflow events. Evidence of sheetflow deposits were observed in these areas during the site visit. These areas are mapped as Active in **Figure 43b**. Gullies (likely enhanced by excavation) along the upgradient side of the large excavation are indicative of surface flow capture. As the upper portions of the fan are generally “Active,” avulsion and downgradient flow means much of the fans surface is “Susceptible” to flooding.

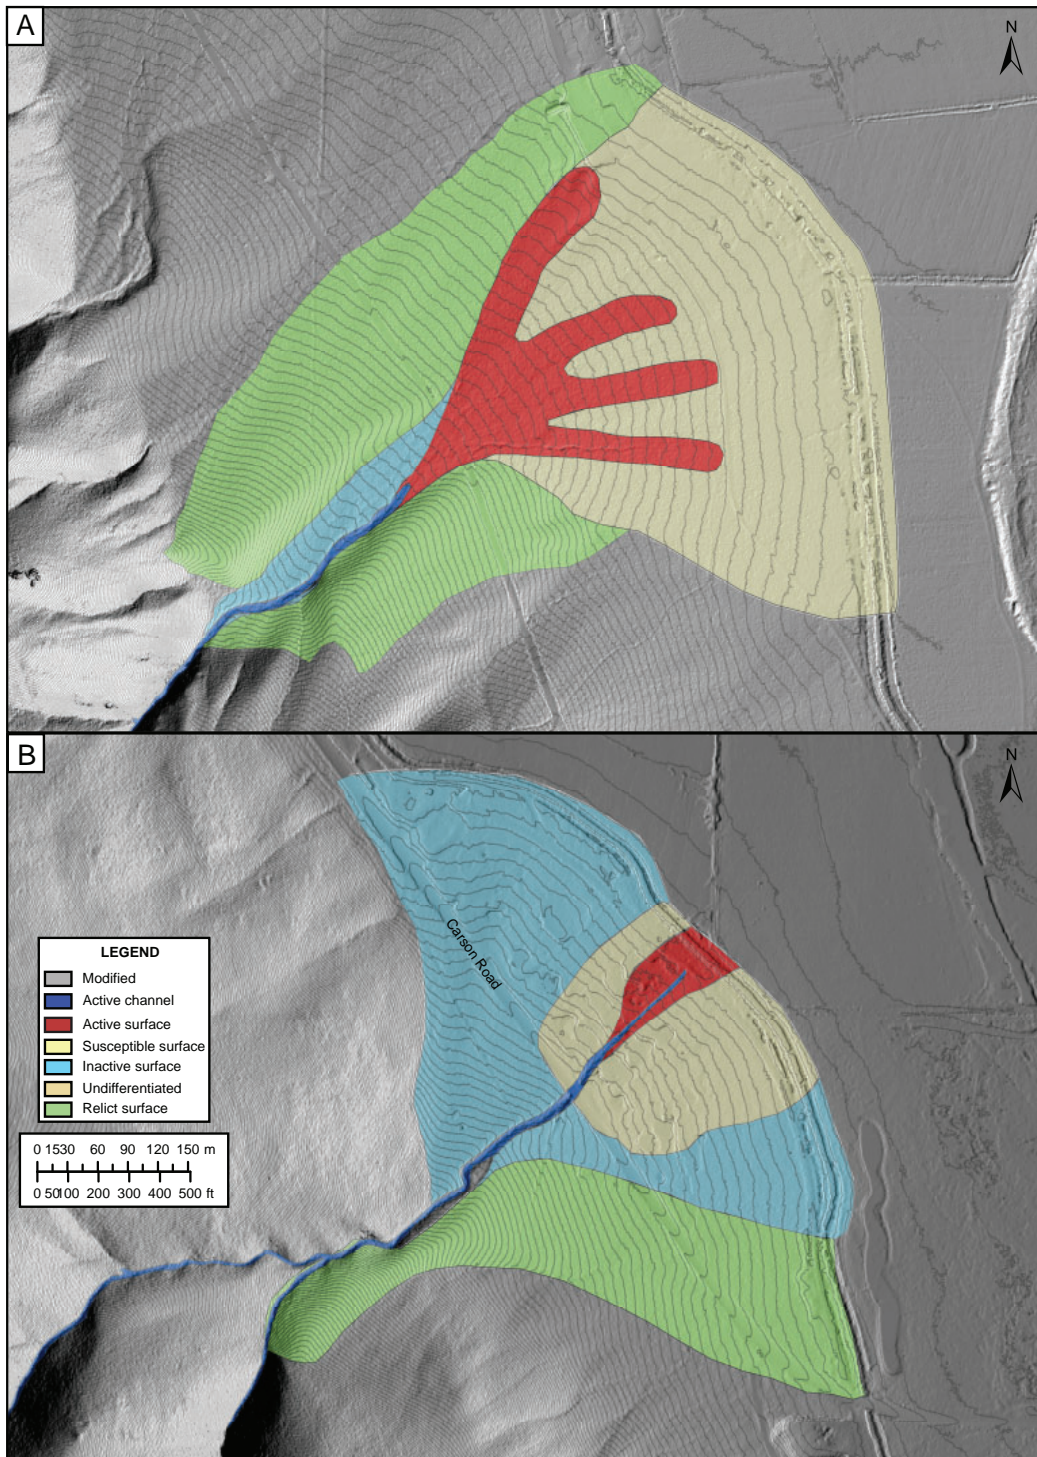
**Figure 44.** Fan hazard mapping. A) Fans 115 and B) 116. Apparent activity/hazards based on LiDAR and aerial photography evaluation. Active areas shown evidence of recent channel activity and sedimentation. Susceptible area are those downgradient of active zones or other areas likely to experience flooding during channel avulsion. Inactive area are those typically located above active flood zones or sheltered behind levees and do not appear to have experienced recent alluvial deposition. Relict zone appear to be older surfaces, probably of Late Quaternary age.

The active classification on Fan 116 is associated with the area east of the hydrographic apex, which forms a thin alluvial zone that extends out to the toe of the fan (**Figure 44b**). The channel feeding the hydrologic apex is deeply incised and stable. The channel above the culvert is stable and that downstream of the culvert is well-maintained by the community. Although this lower area is active, flooding looks to be generally well confined. However, the 2014 flooding demonstrates the potentially destructive hazards associated with the fan.
