Hope Valley Meadow Restoration

PROJECT OVERVIEW

HOPE VALLEY MEADOW RESTORATION PROJECT 50% DESIGN SUBMITTAL

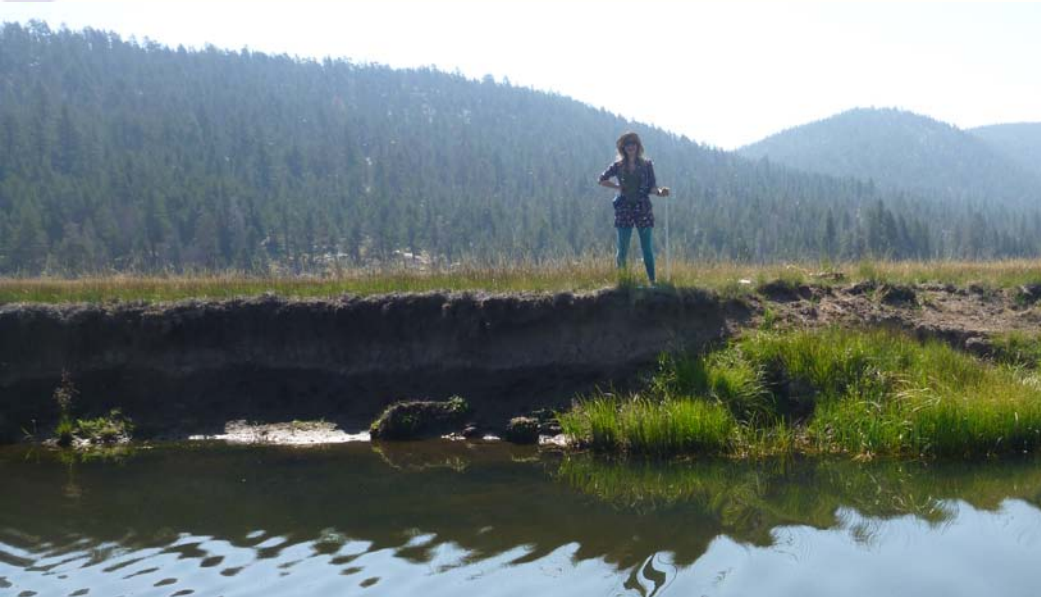
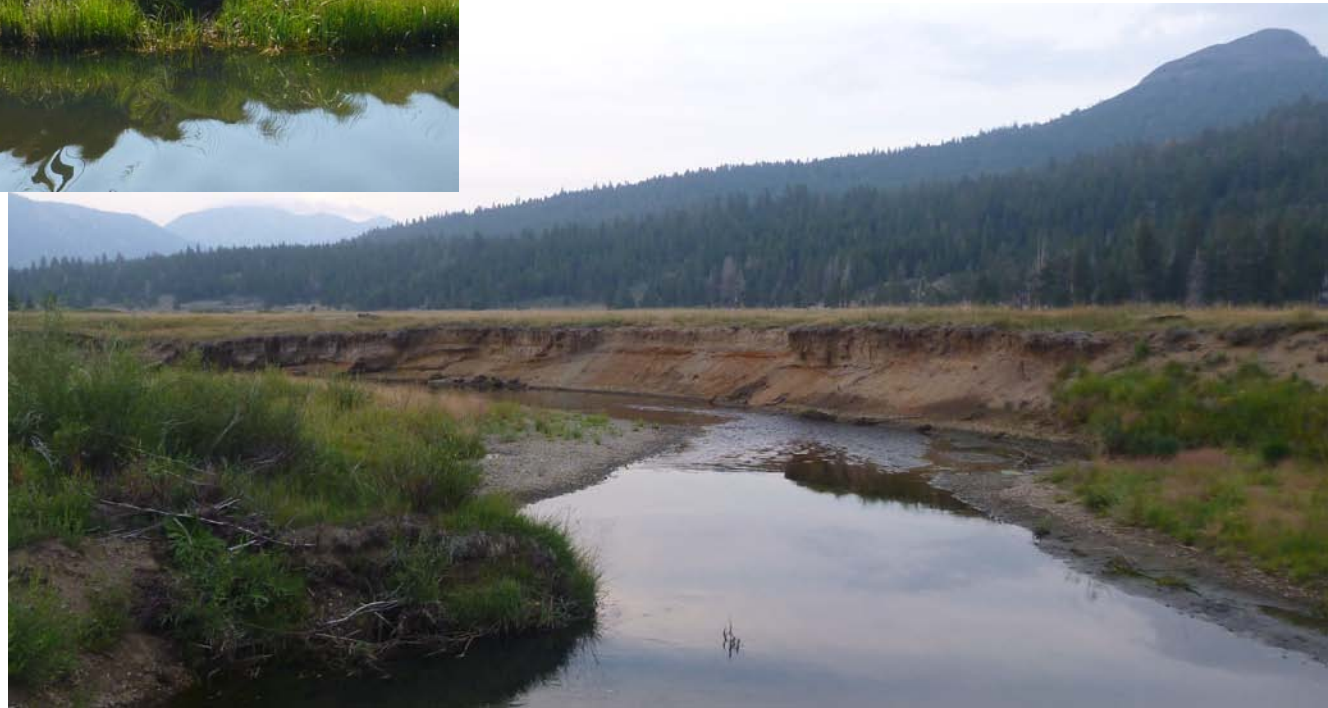
Current Conditions

Incision and
high, unstable banks

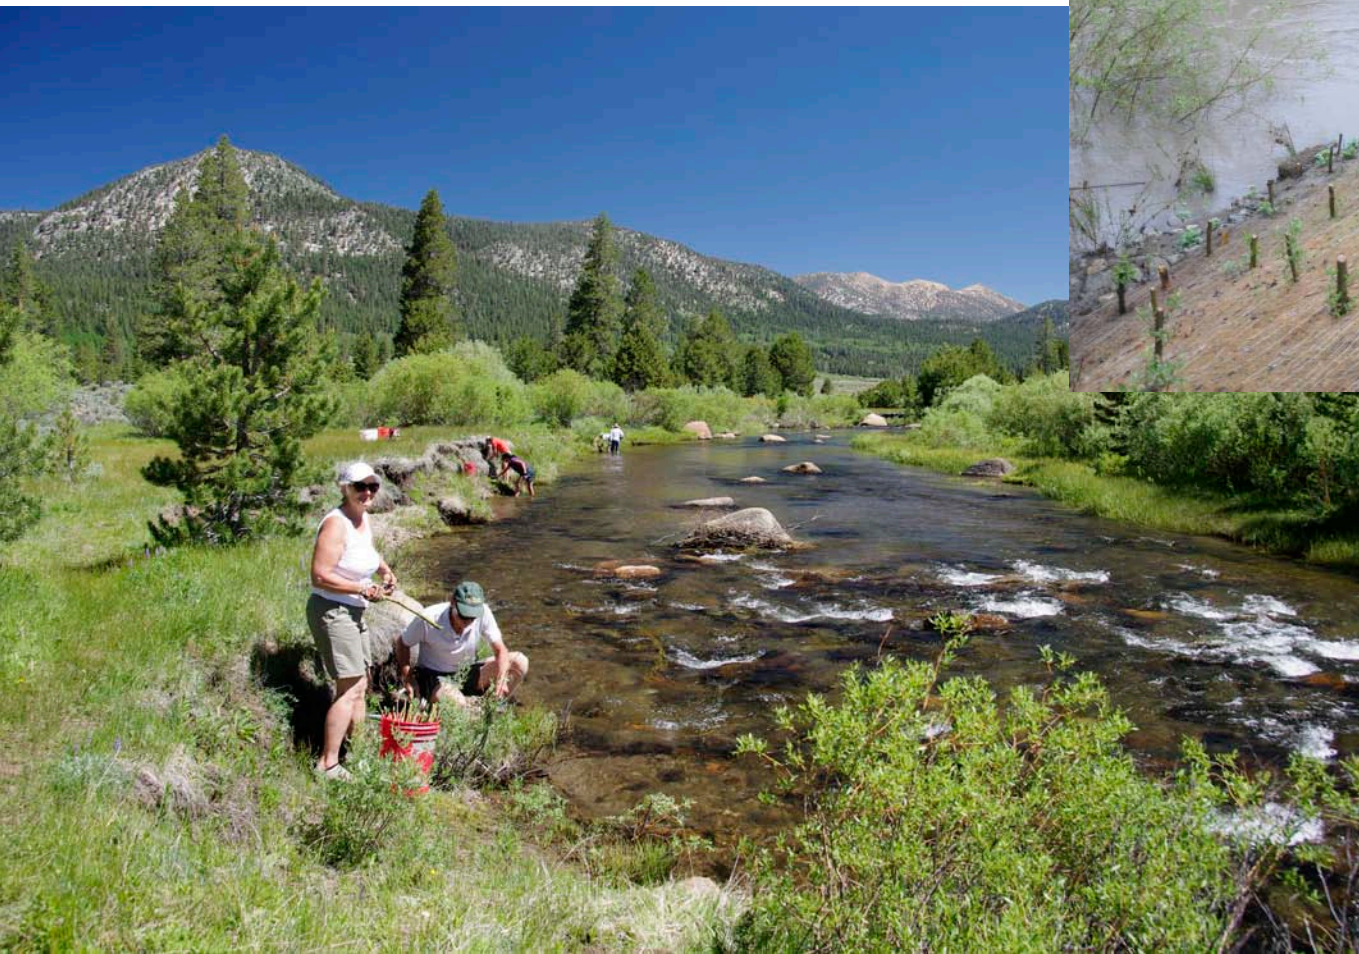
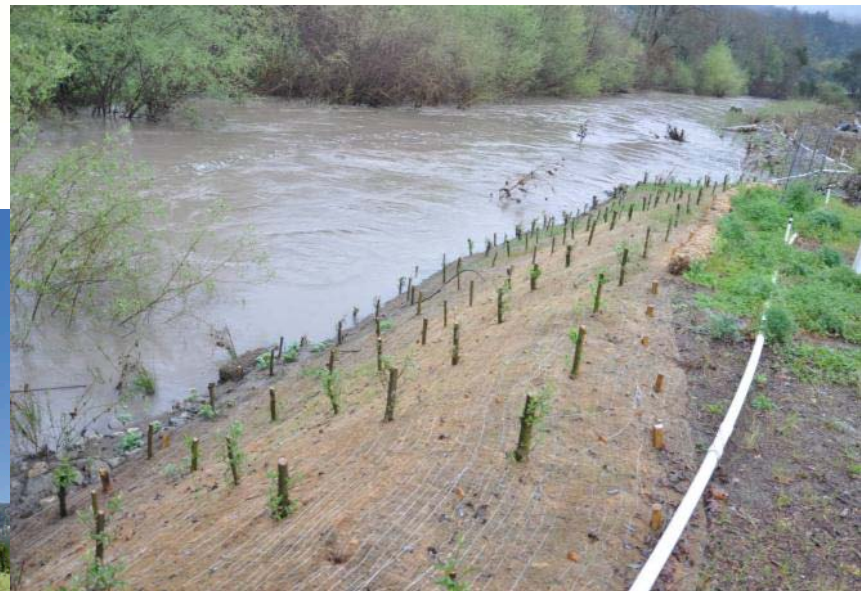
Vegetative Stabilization

- Light-handed approach
- Low cost, low risk

- Used by FOHV below Hwy 88 for 20+ years.

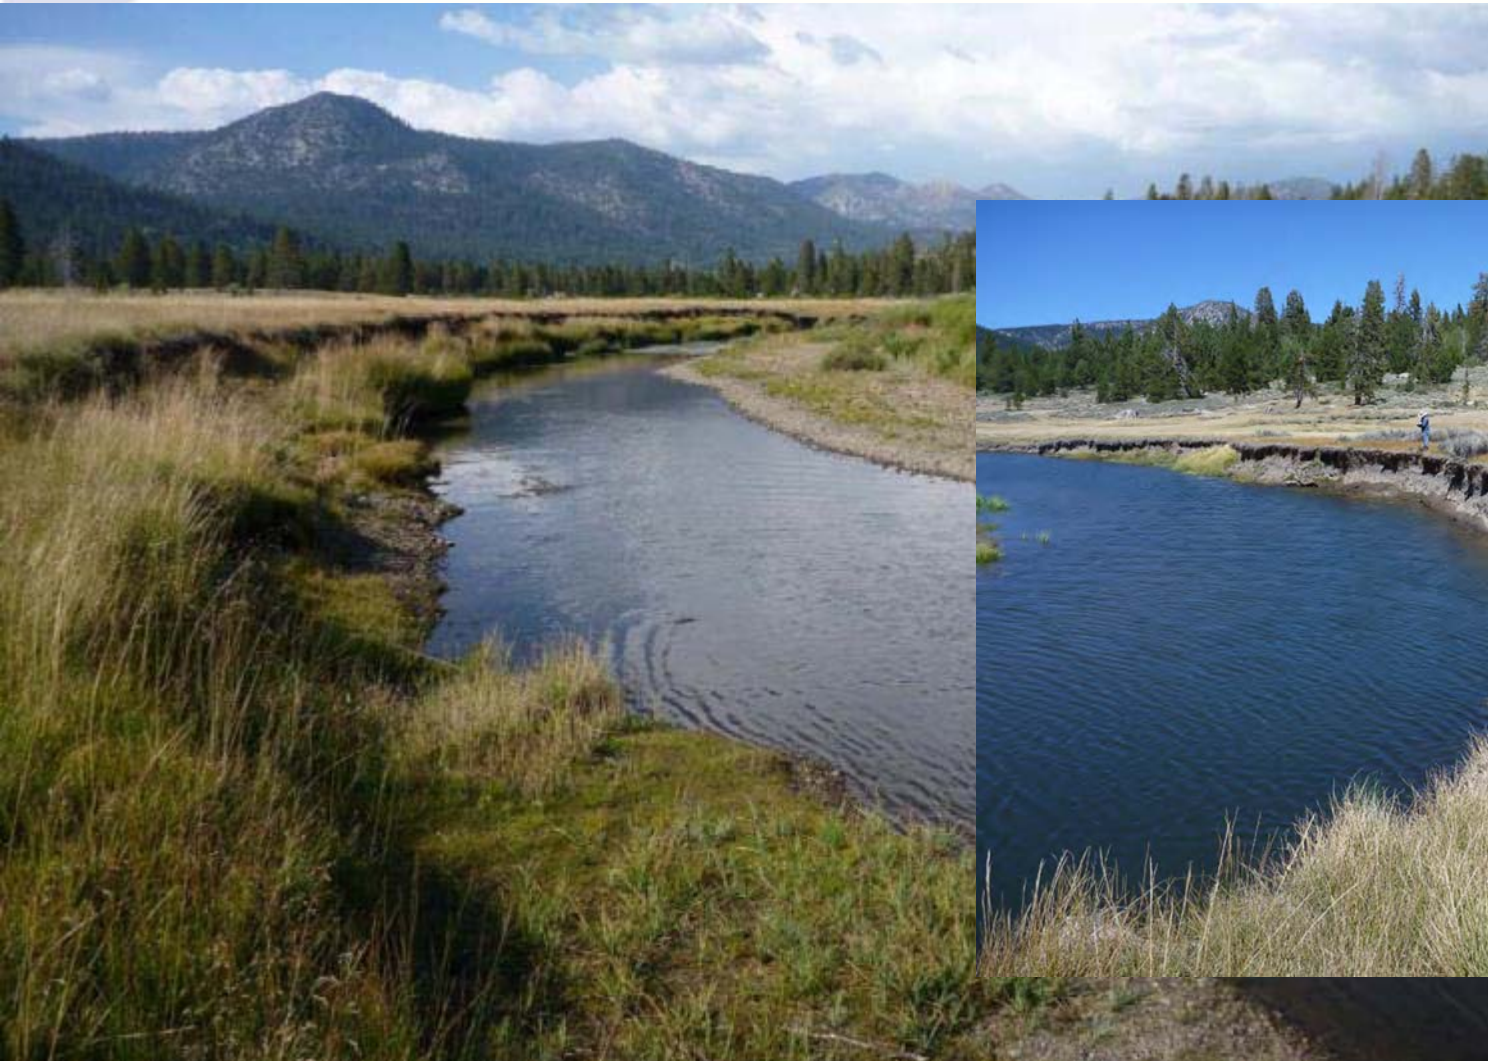
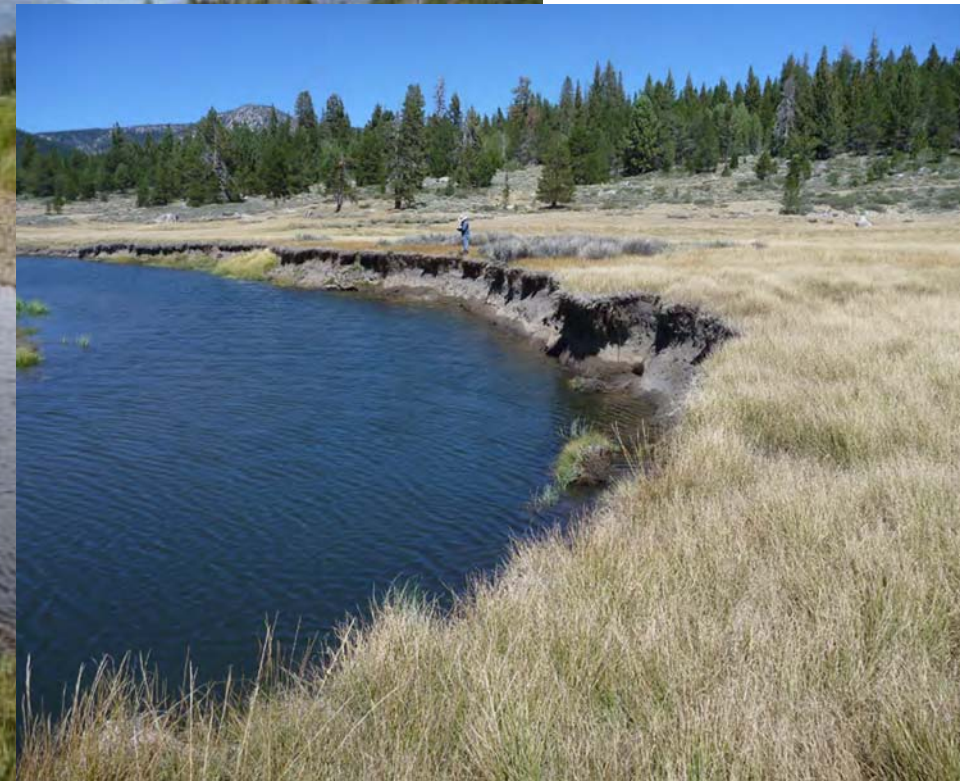
Stabilization of Streambank Toes

Sod block placed at toe of eroding bank

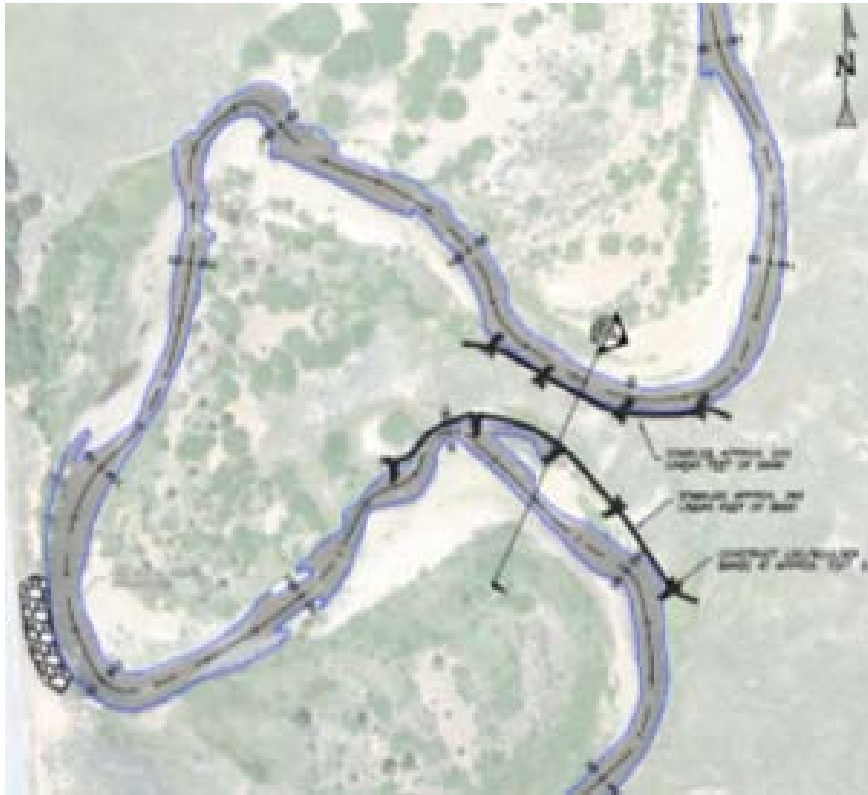
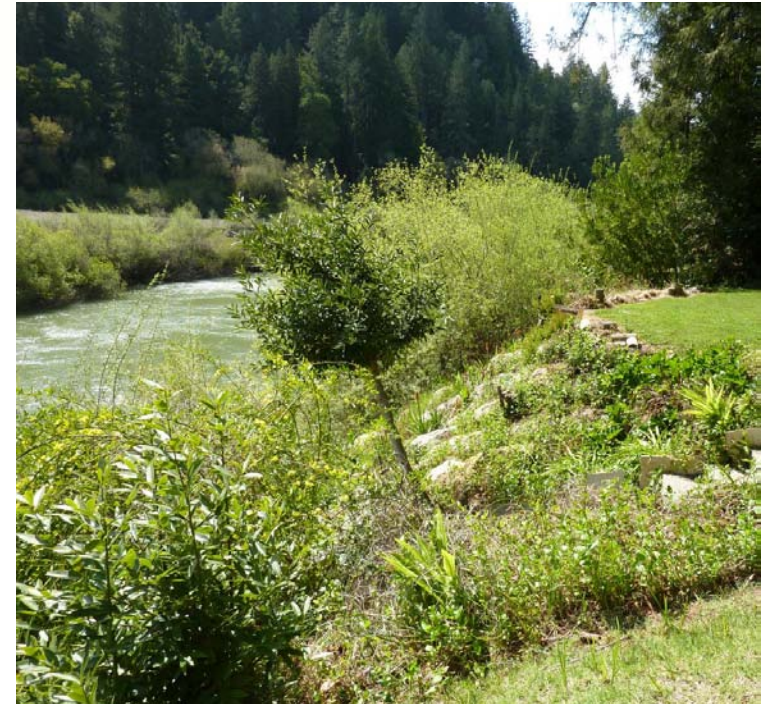
Meander Cutoff Protection

- Channel shortened 1500 ft
- Loss of 3 ft of profile grade

Bank protection to prevent:

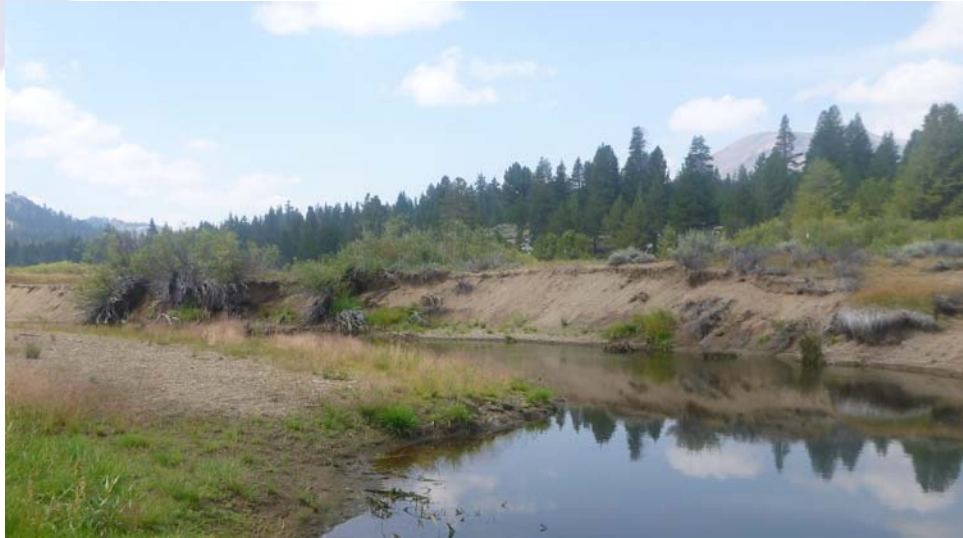
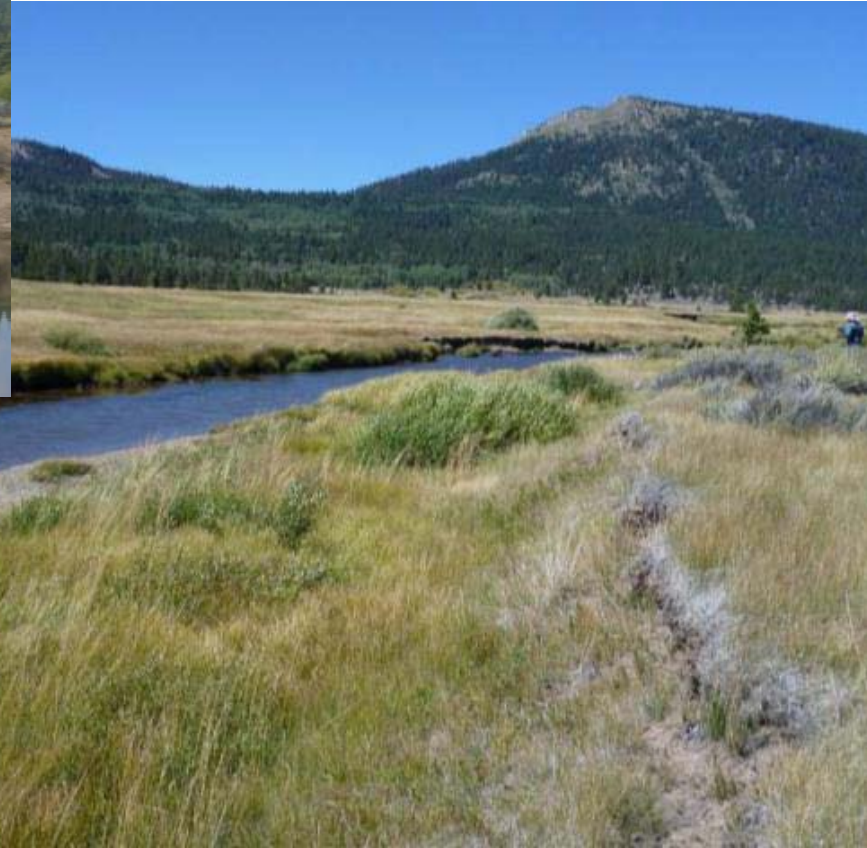
Floodplain Benches

(At Two Demonstration sites)

- Create stable inset floodplain where erosion is currently highly active
- Favorable access site, monitor to inform future restoration work

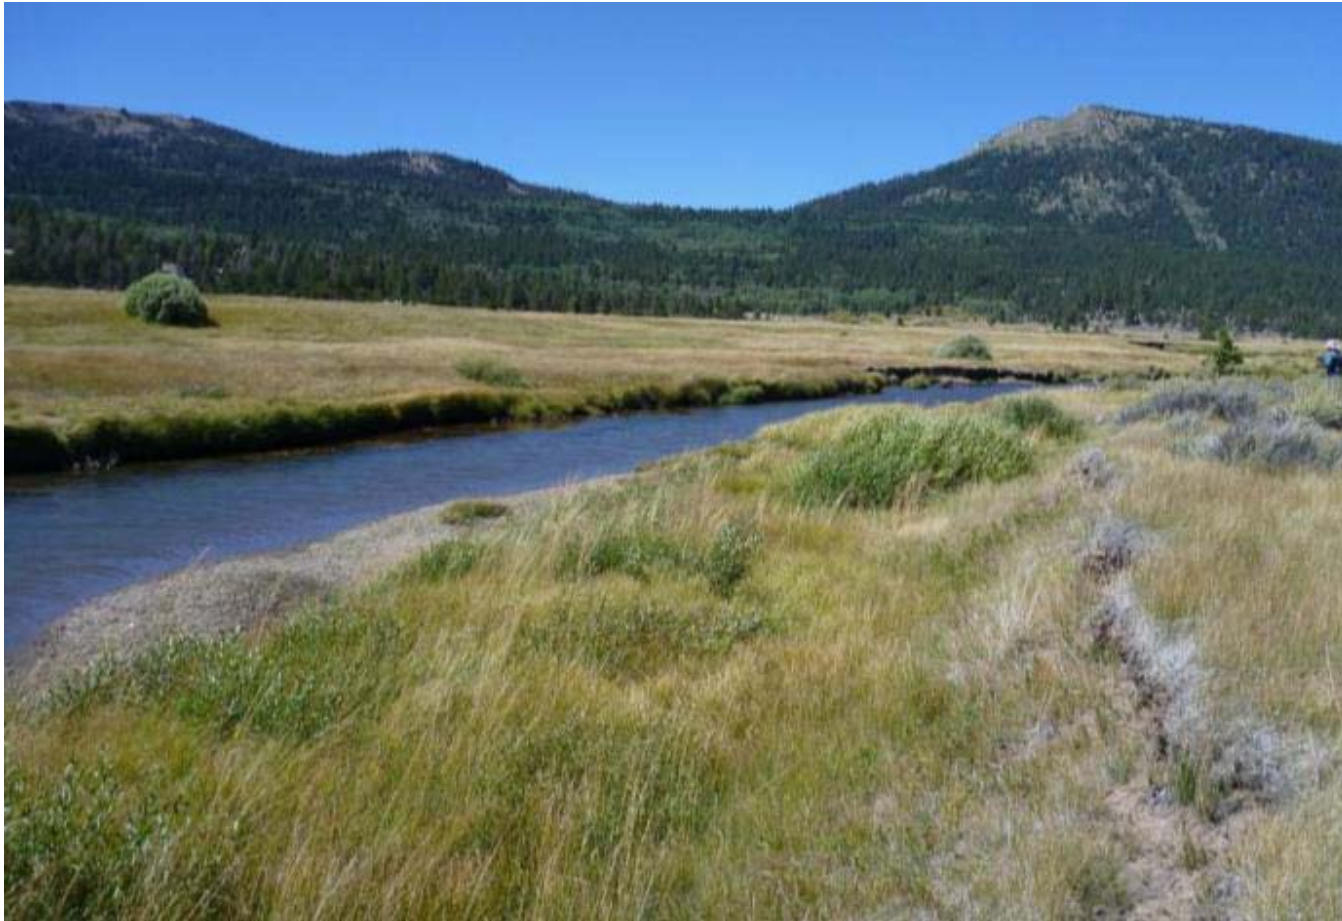
Floodplain Benches

(At Two Demonstration sites)

- Create stable inset floodplain where erosion is currently highly active
- Favorable access site, monitor to inform future restoration work

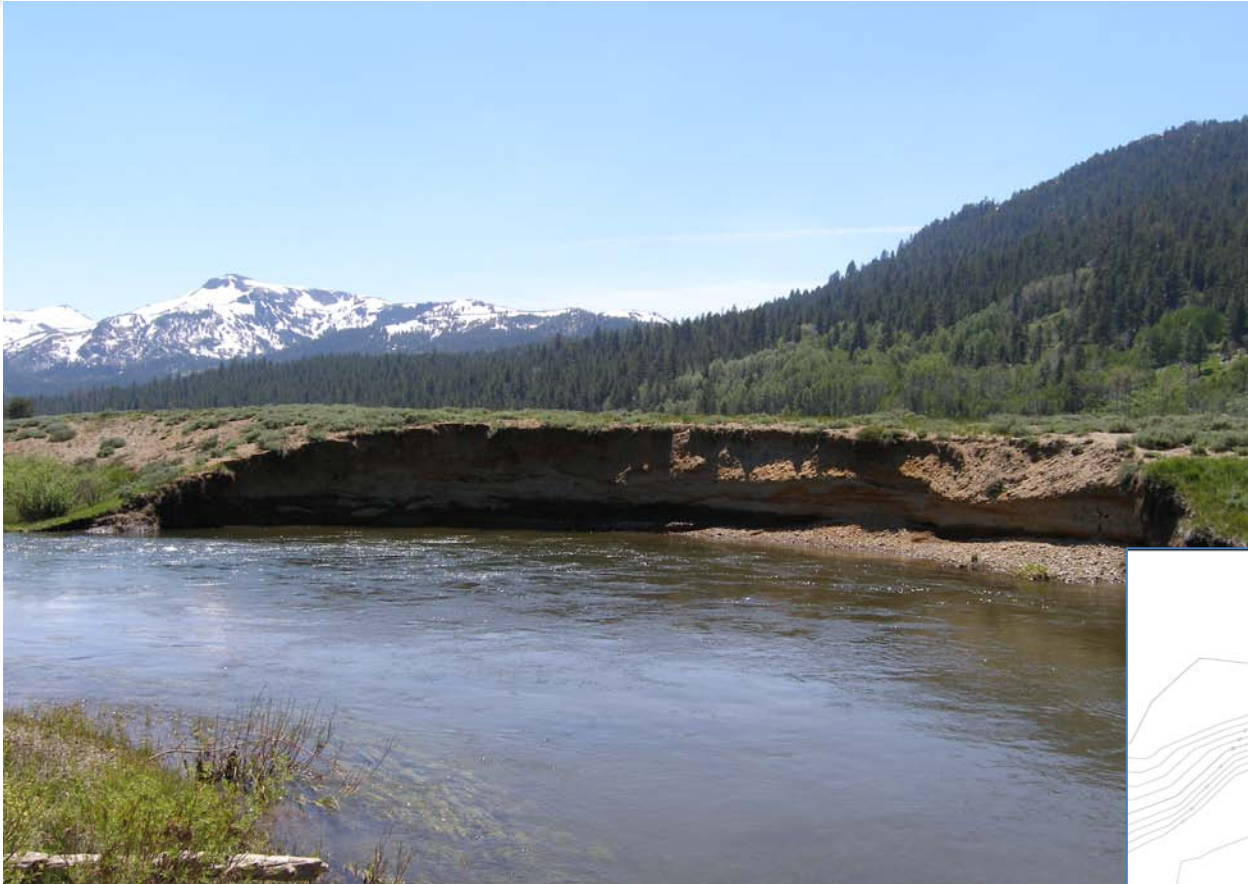
Log Crib Bench Stabilization

(CA DFW property)

Stabilize high, eroding bank using log-crib structure & willow plantings
