# **CRADLEBAUGH BRIDGE STREAMBANK RESTORATION**

CARSON VALLEY  
CONSERVATION DISTRICT

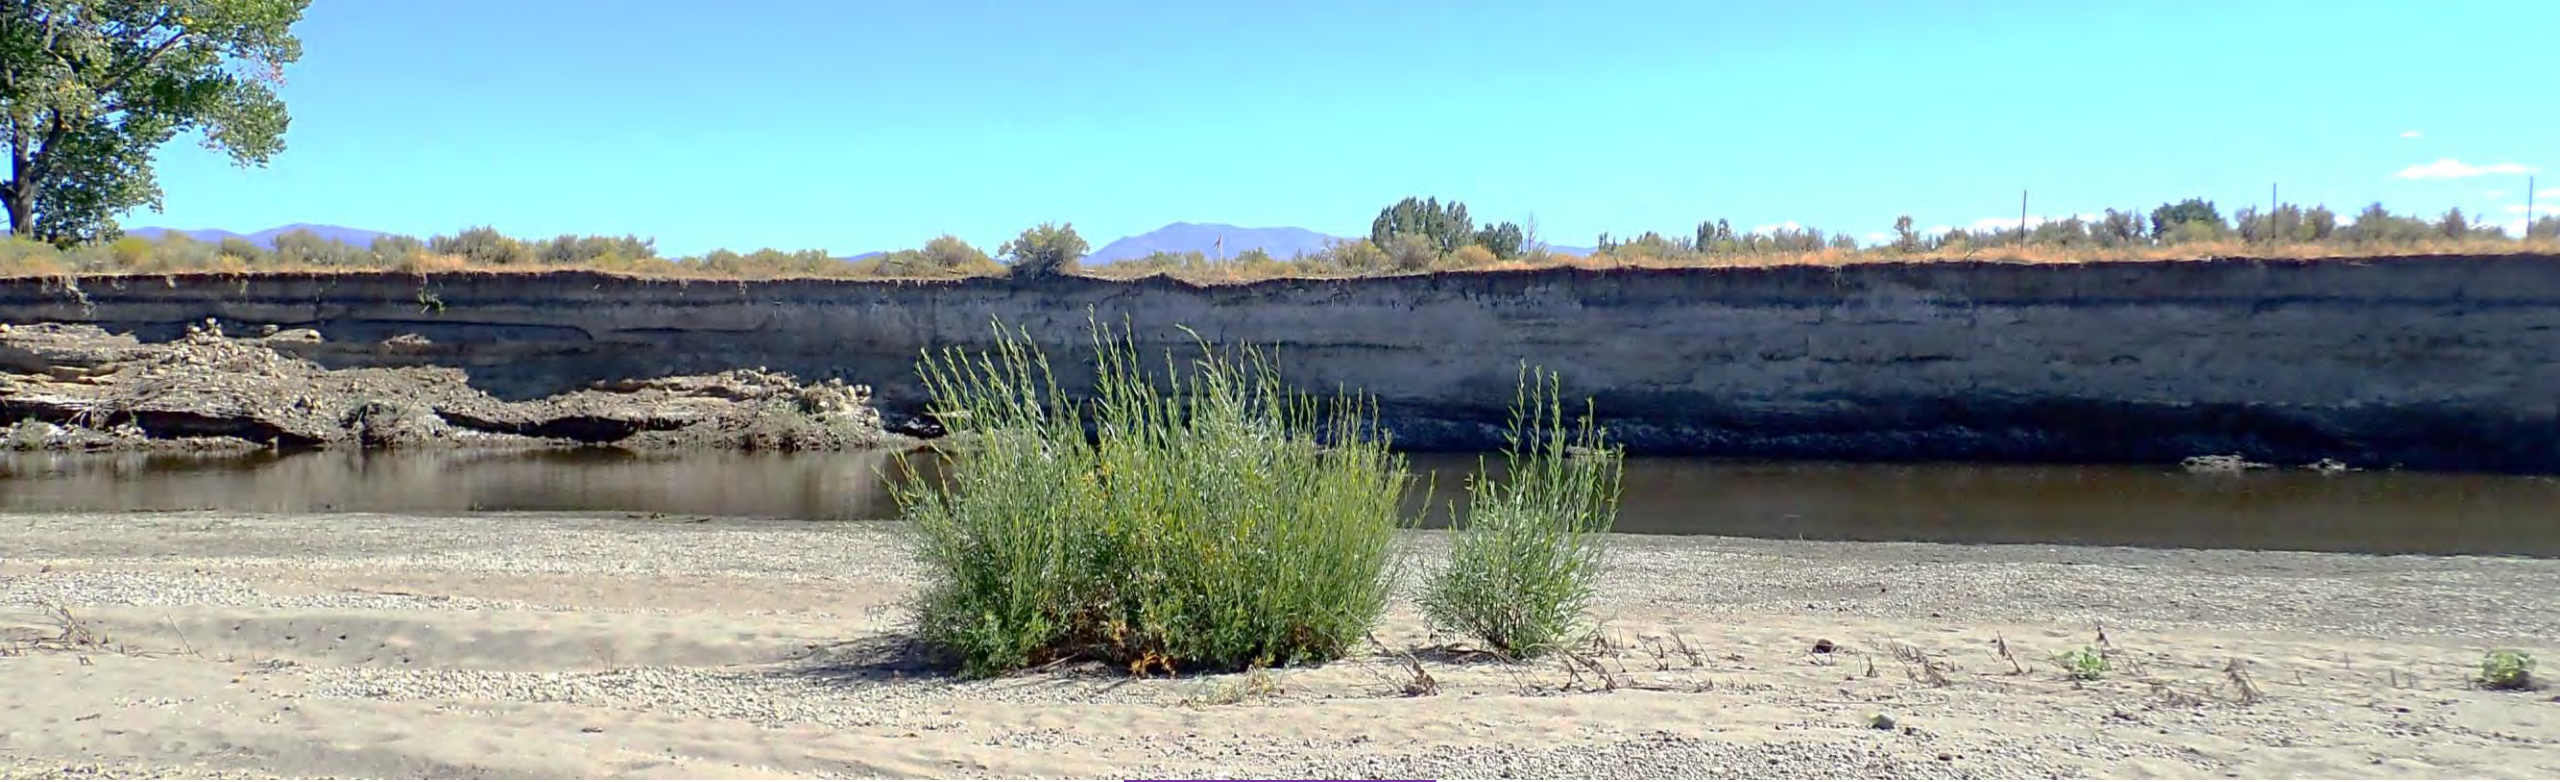
## BEFORE

The stream bank has eroded due to the high water levels of the past years and has left a stretch of 600' with a 10'-15' vertical bank in its wake. This project was designed to minimize erosion, improve water quality, re-establish desirable vegetation, and improve river function within the project reach.

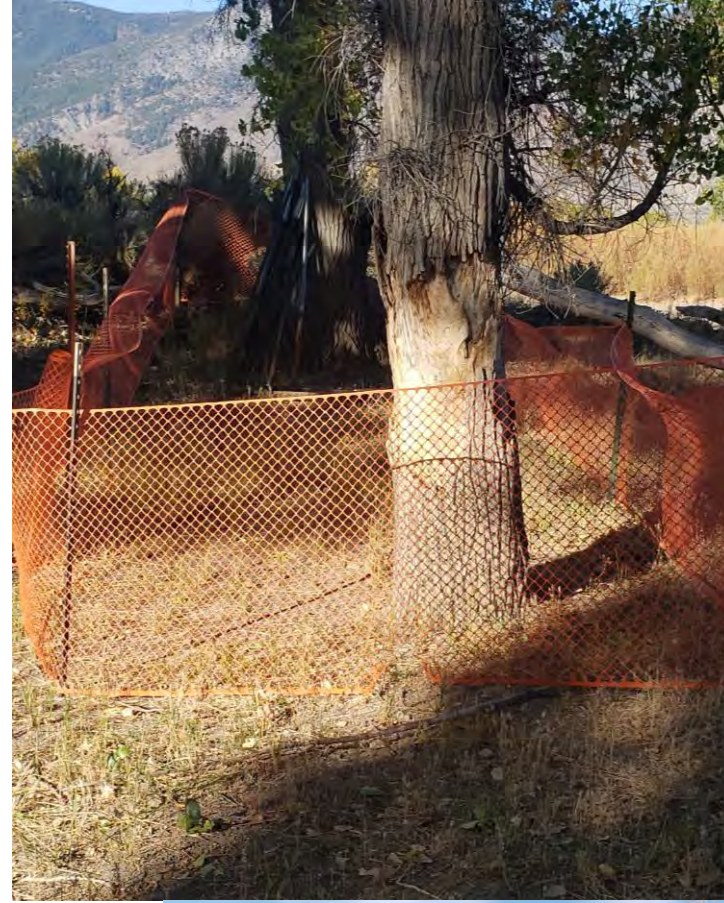
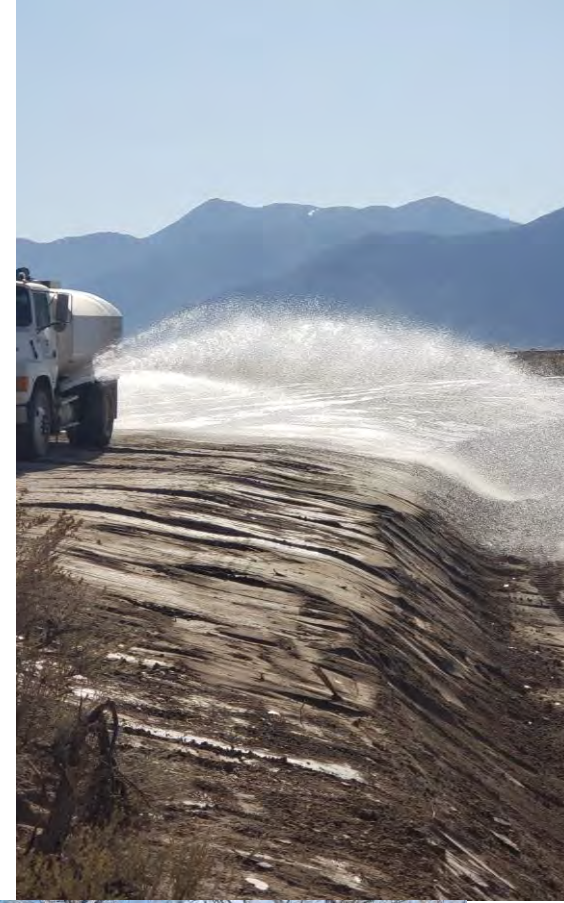
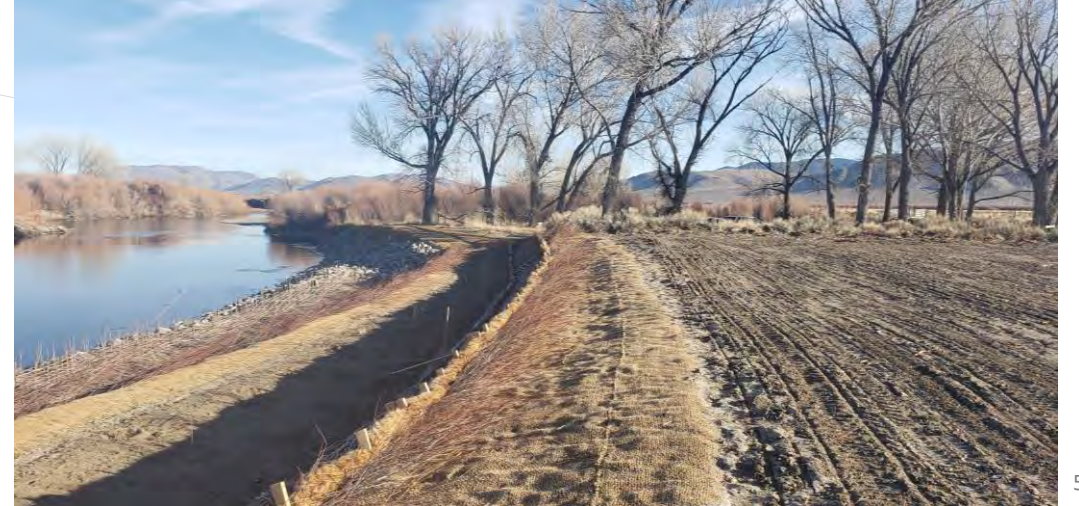
- Dust Control
- Fencing around sensitive resources
- Working in the channel during driest period
- Drill seeding disturbed areas
- Coir Fabric Mats & Logs
- Silt fencing & filtration waddles
- De-watering

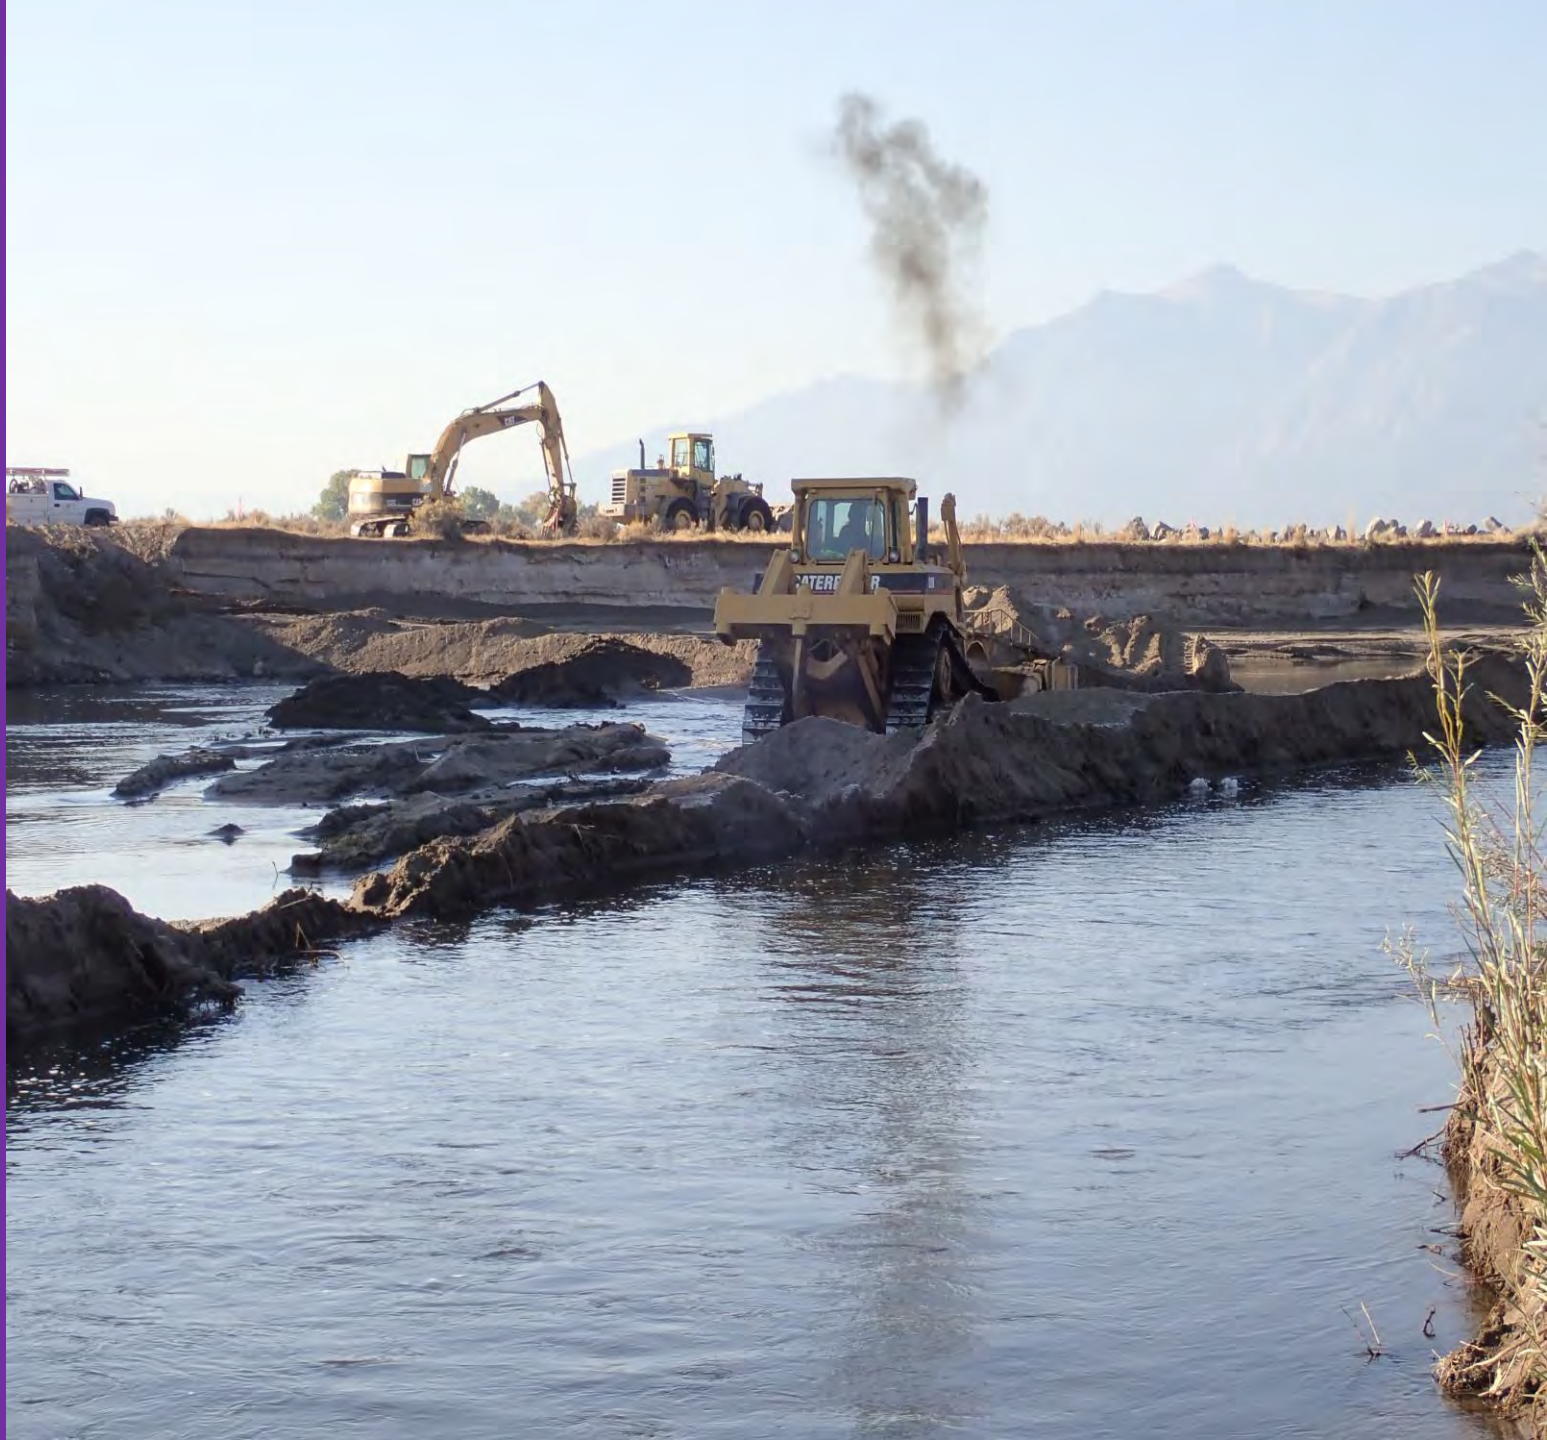
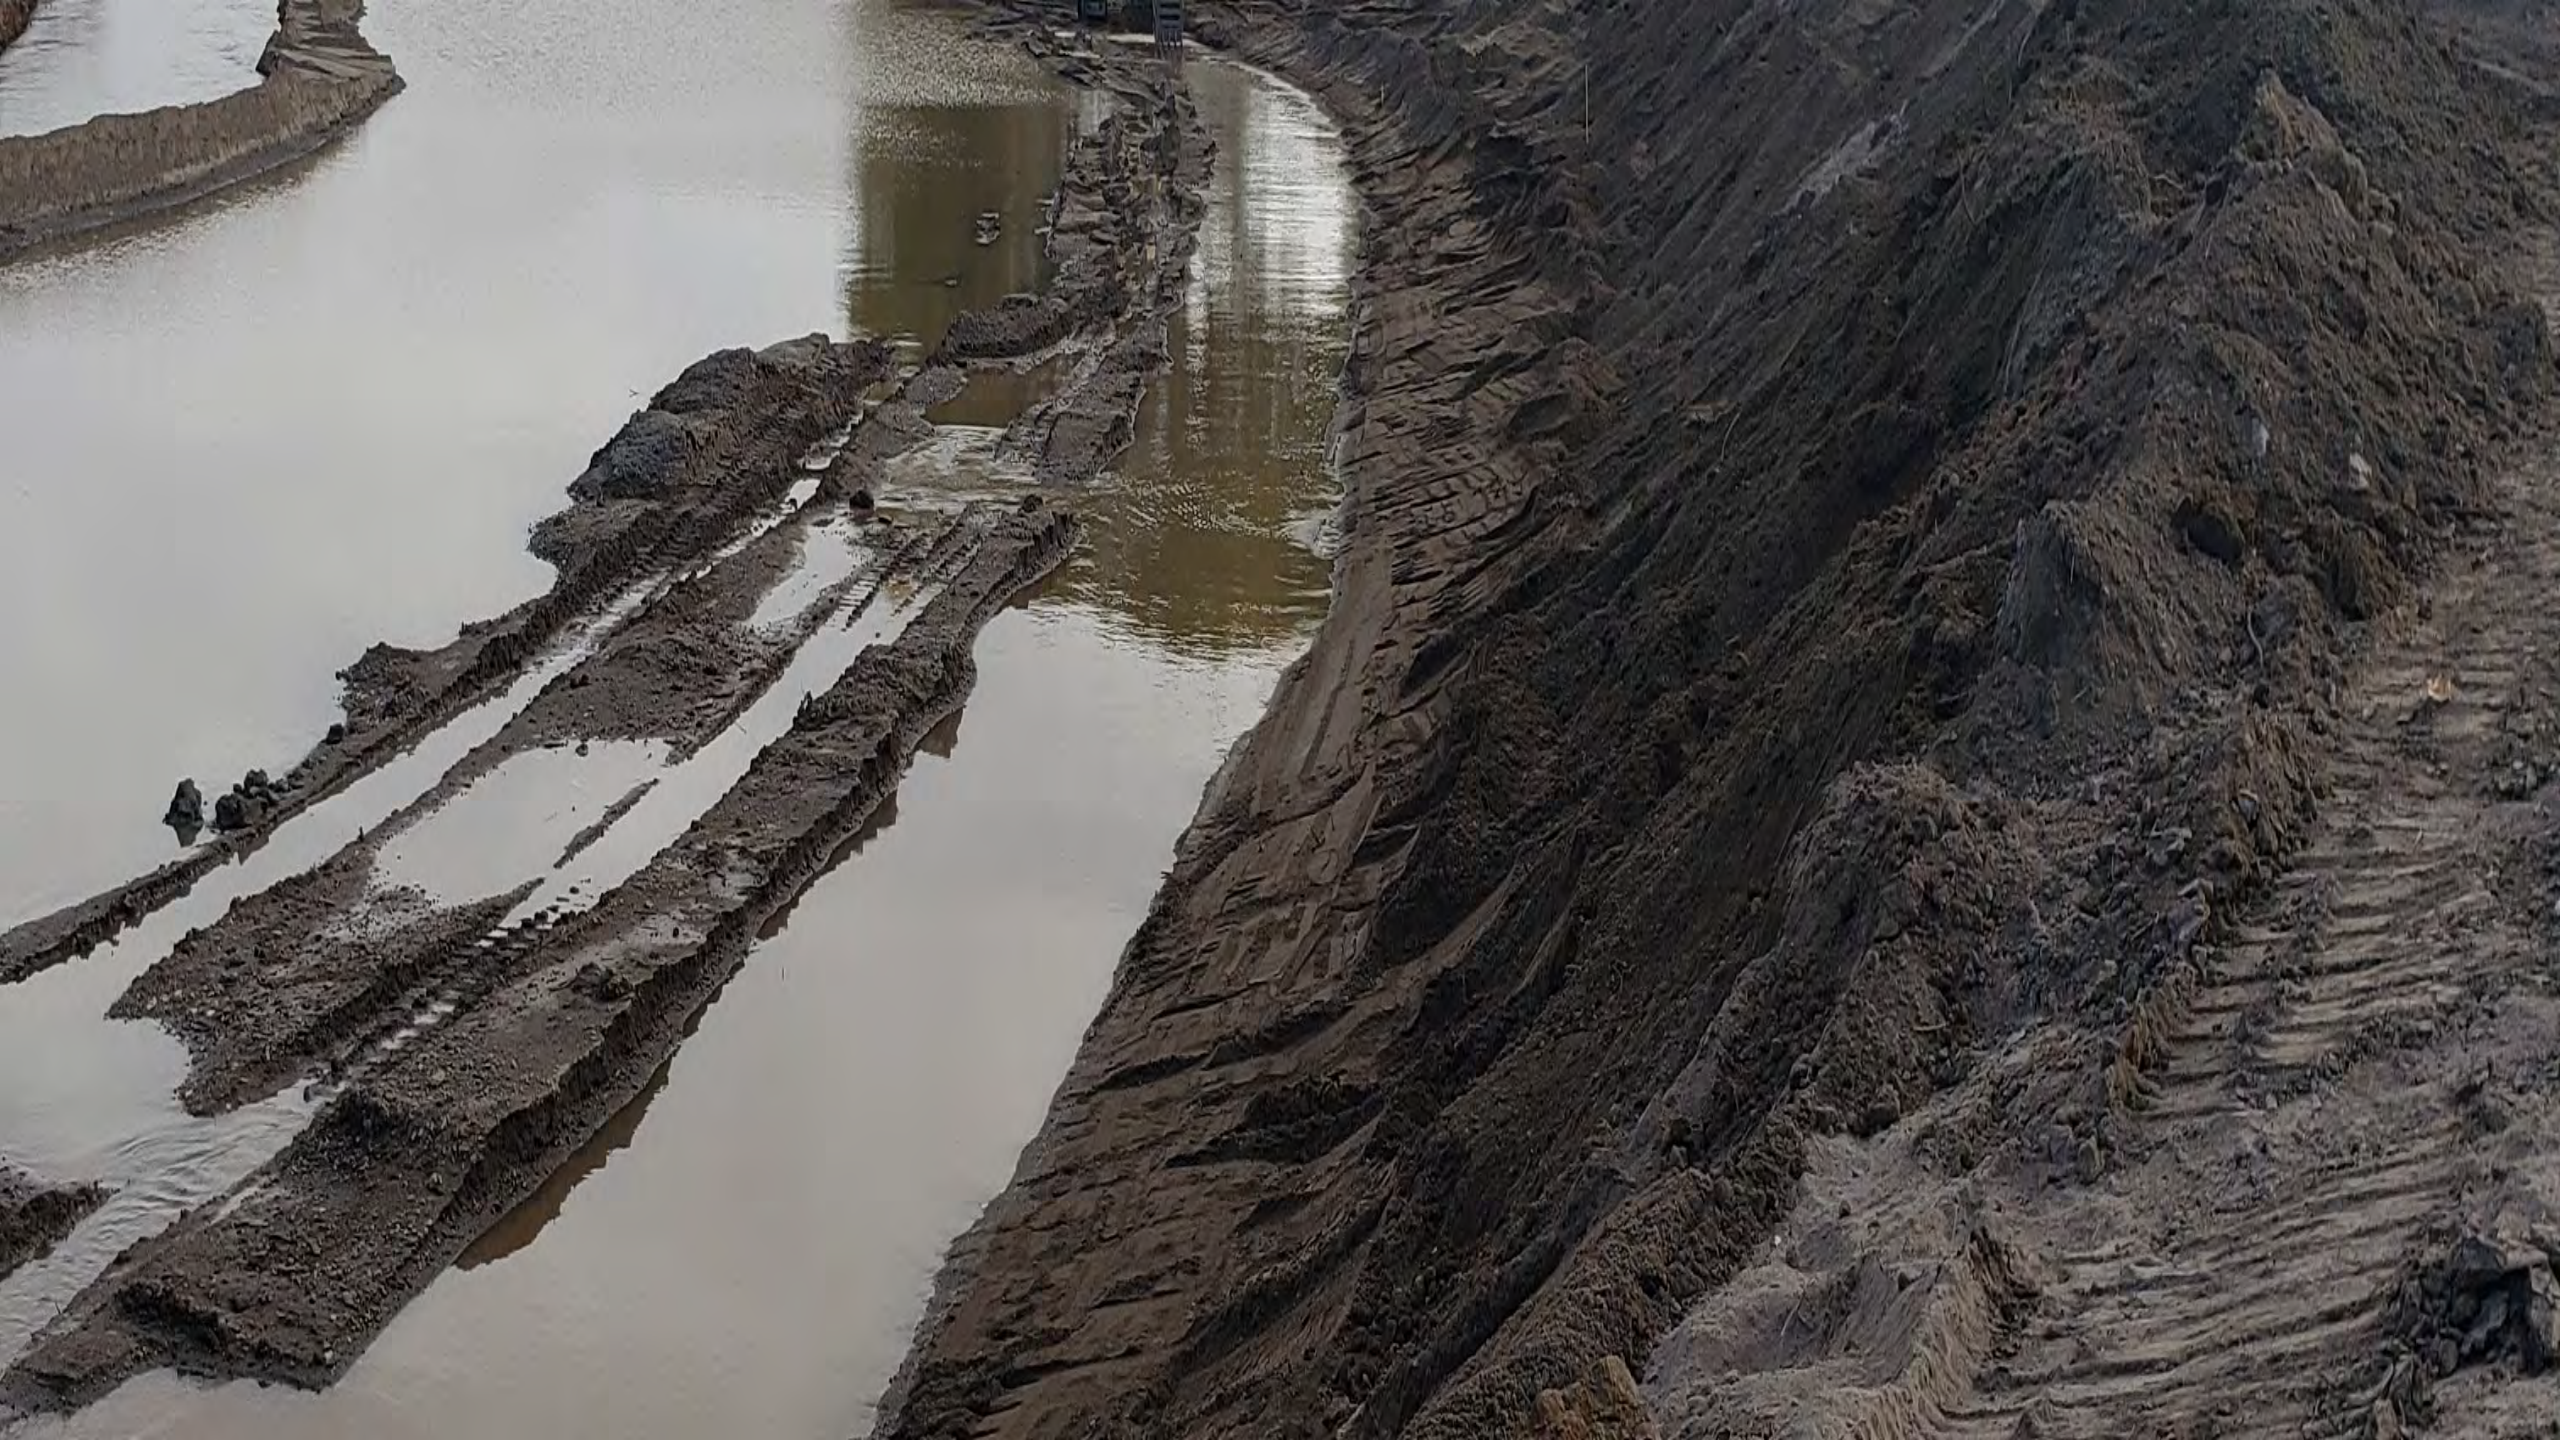
# DURING CONSTRUCTION

This project relies upon the success of structural based treatment, streambank shaping, as well as plant based treatments.

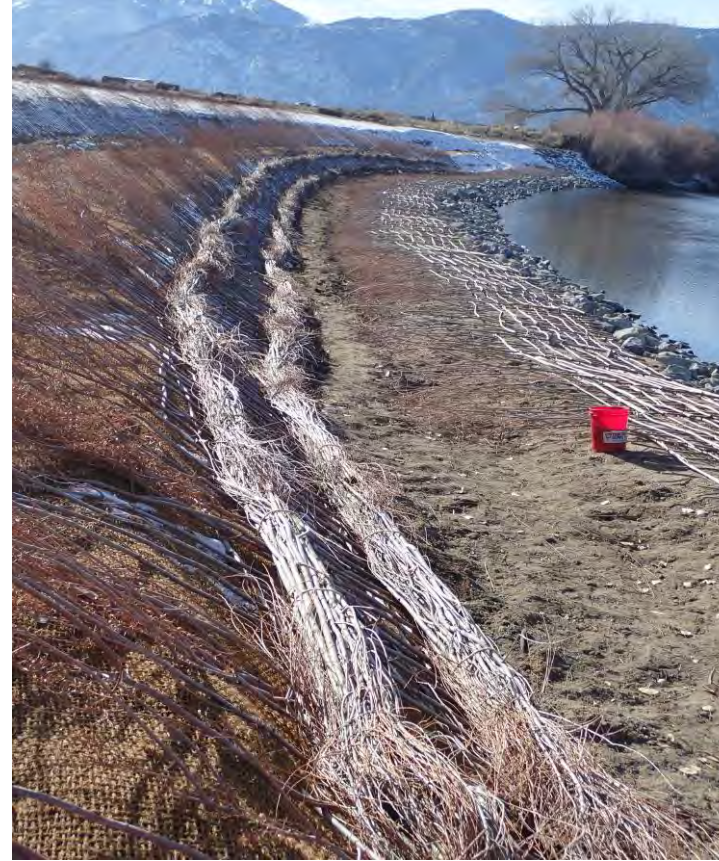
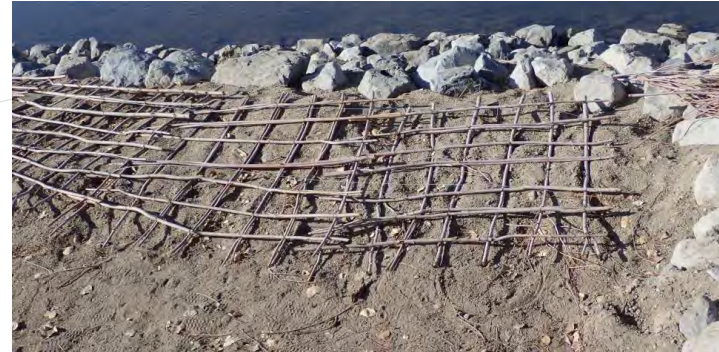
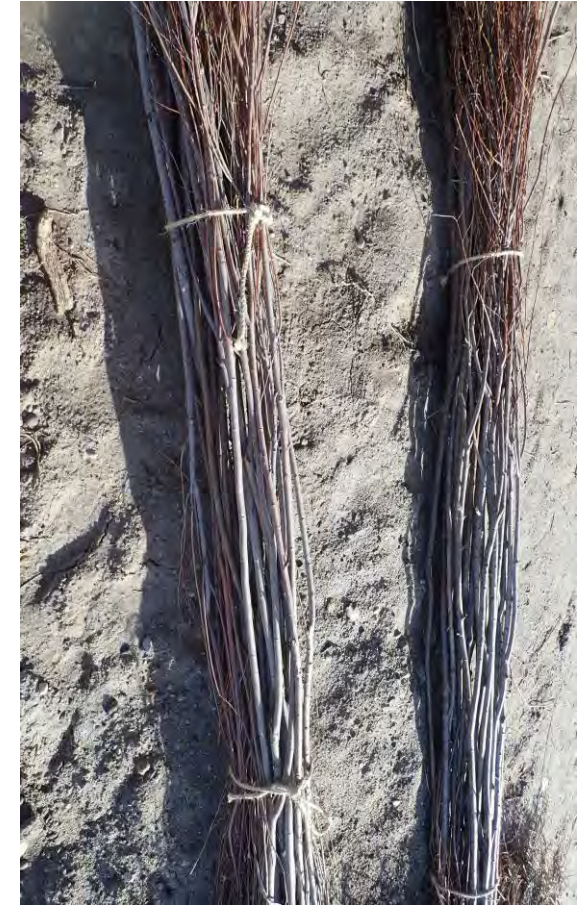
# BIOENGINEERING

- Stone Toe Trench
- Willow Poles
- Willow Fascines
- Willow Bundles
- Streambank Sloping
- Seeding
- Willow Stakes
- Coir Fabric Mats & Logs
- Live Plants

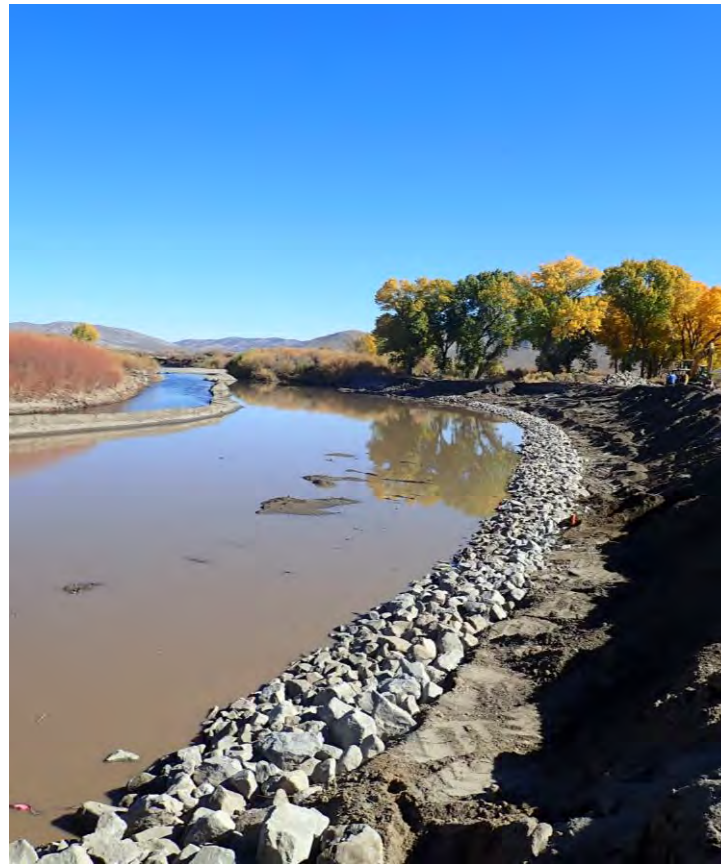
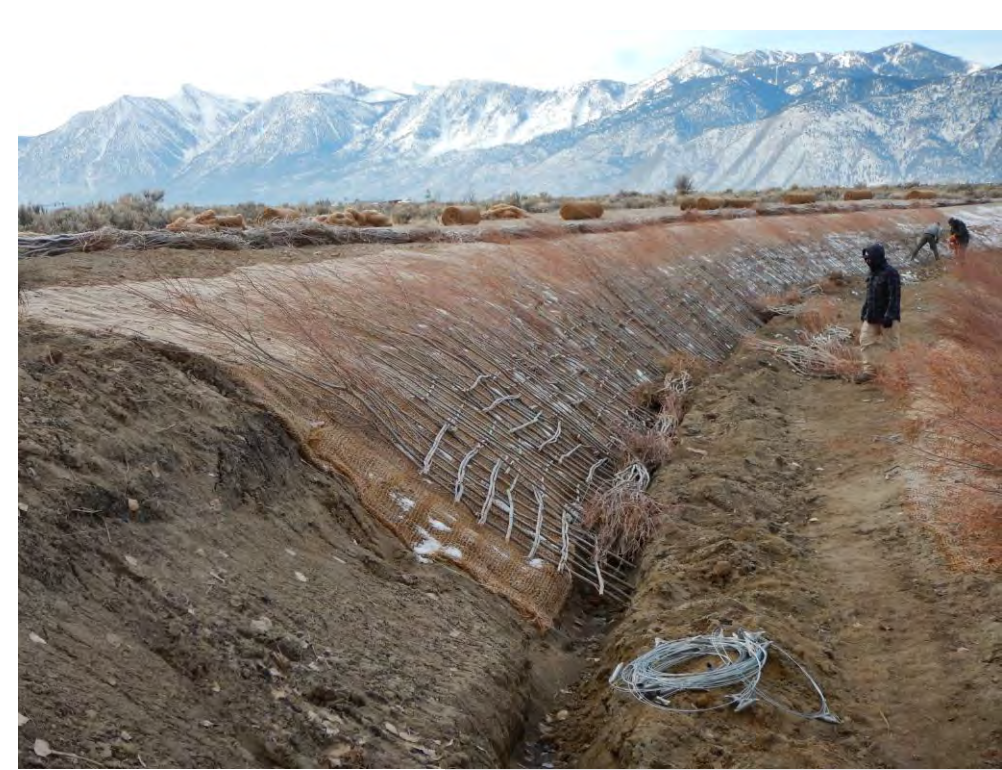
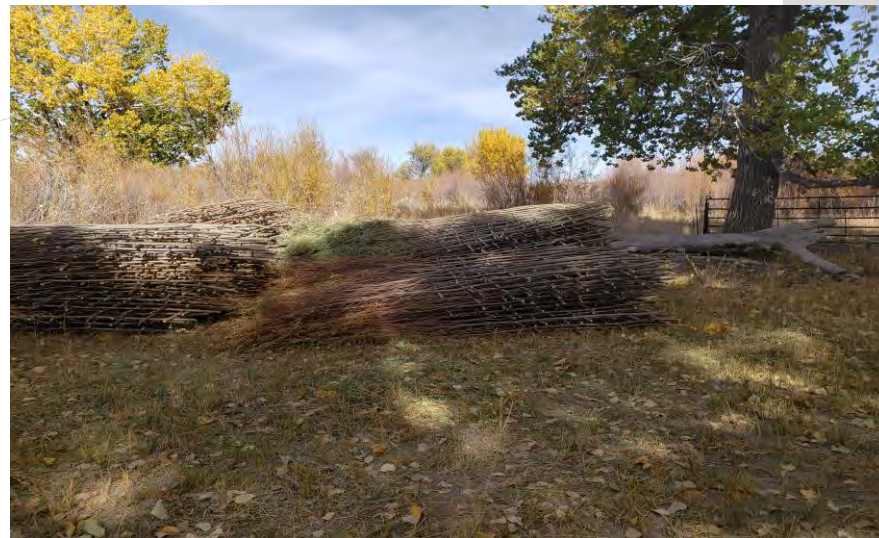
# BIOENGINEERING

- Stone Toe Trench
- Willow Poles
- Willow Fascines
- Willow Bundles
- Streambank Sloping
- Seeding
- Willow Stakes
- Coir Fabric Mats & Logs
- Live Plants

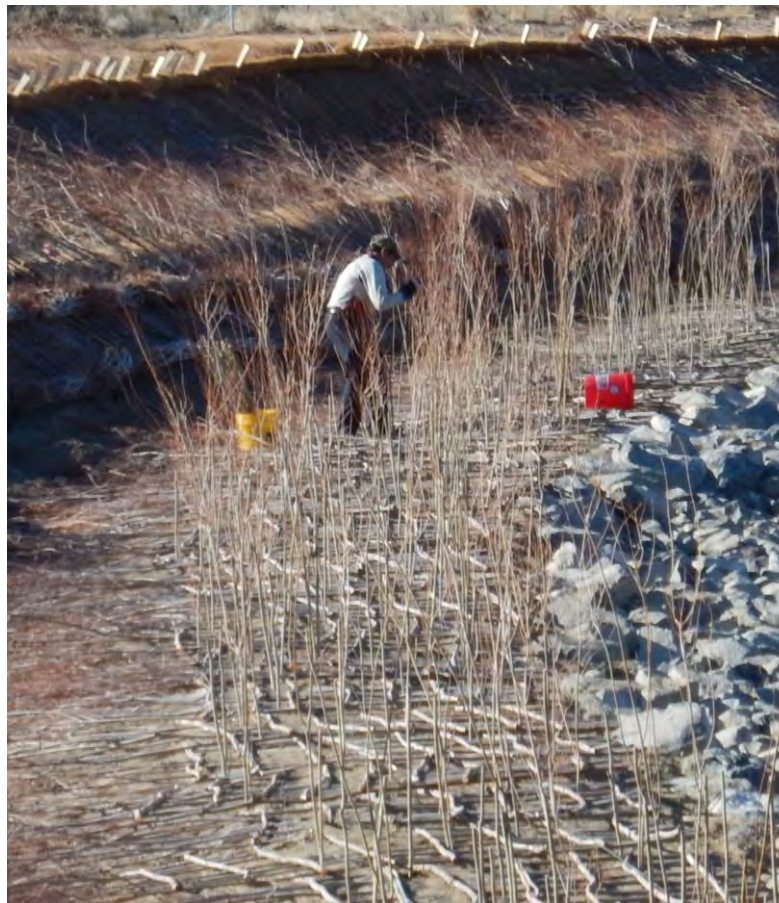
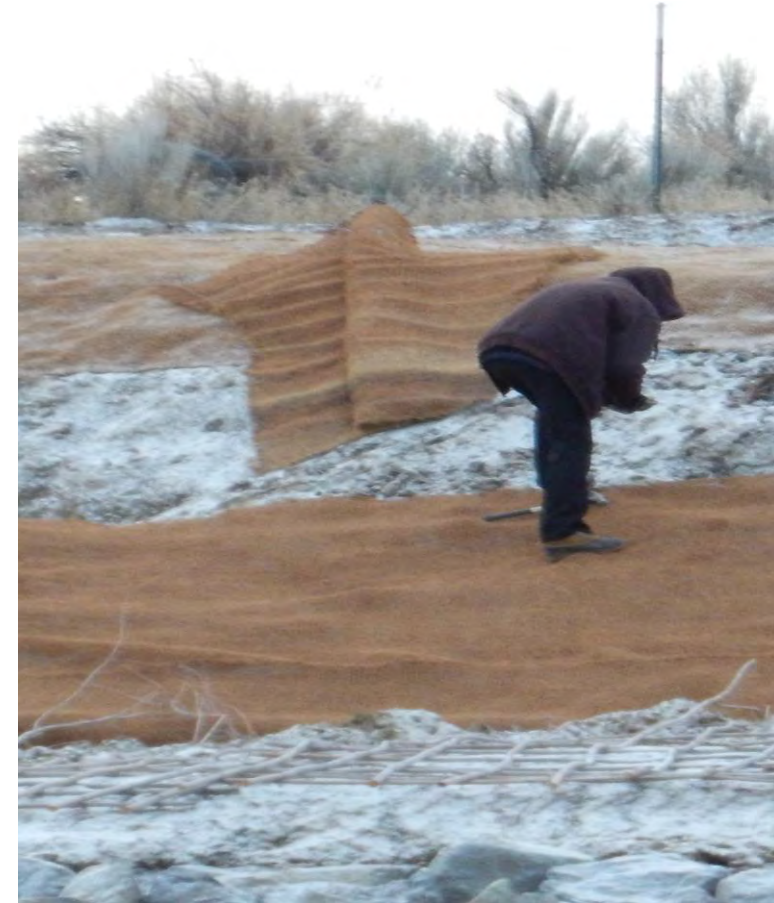
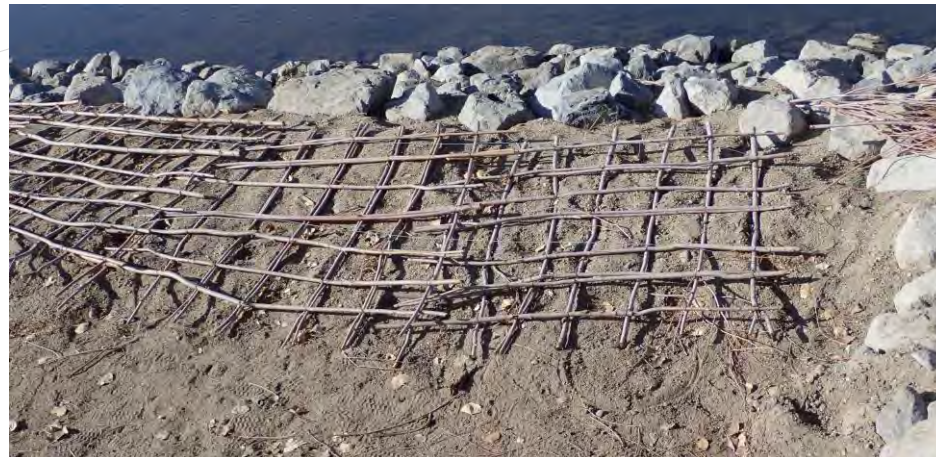
# BIOENGINEERING

- Stone Toe Trench
- Willow Poles
- Willow Fascines
- Willow Bundles
- Streambank Sloping
- Seeding
- Willow Stakes
- Coir Fabric Mats & Logs
- Live Plants
