# **CRADLEBAUGH BRIDGE STREAMBANK RESTORATION**

CARSON VALLEY  
CONSERVATION DISTRICT

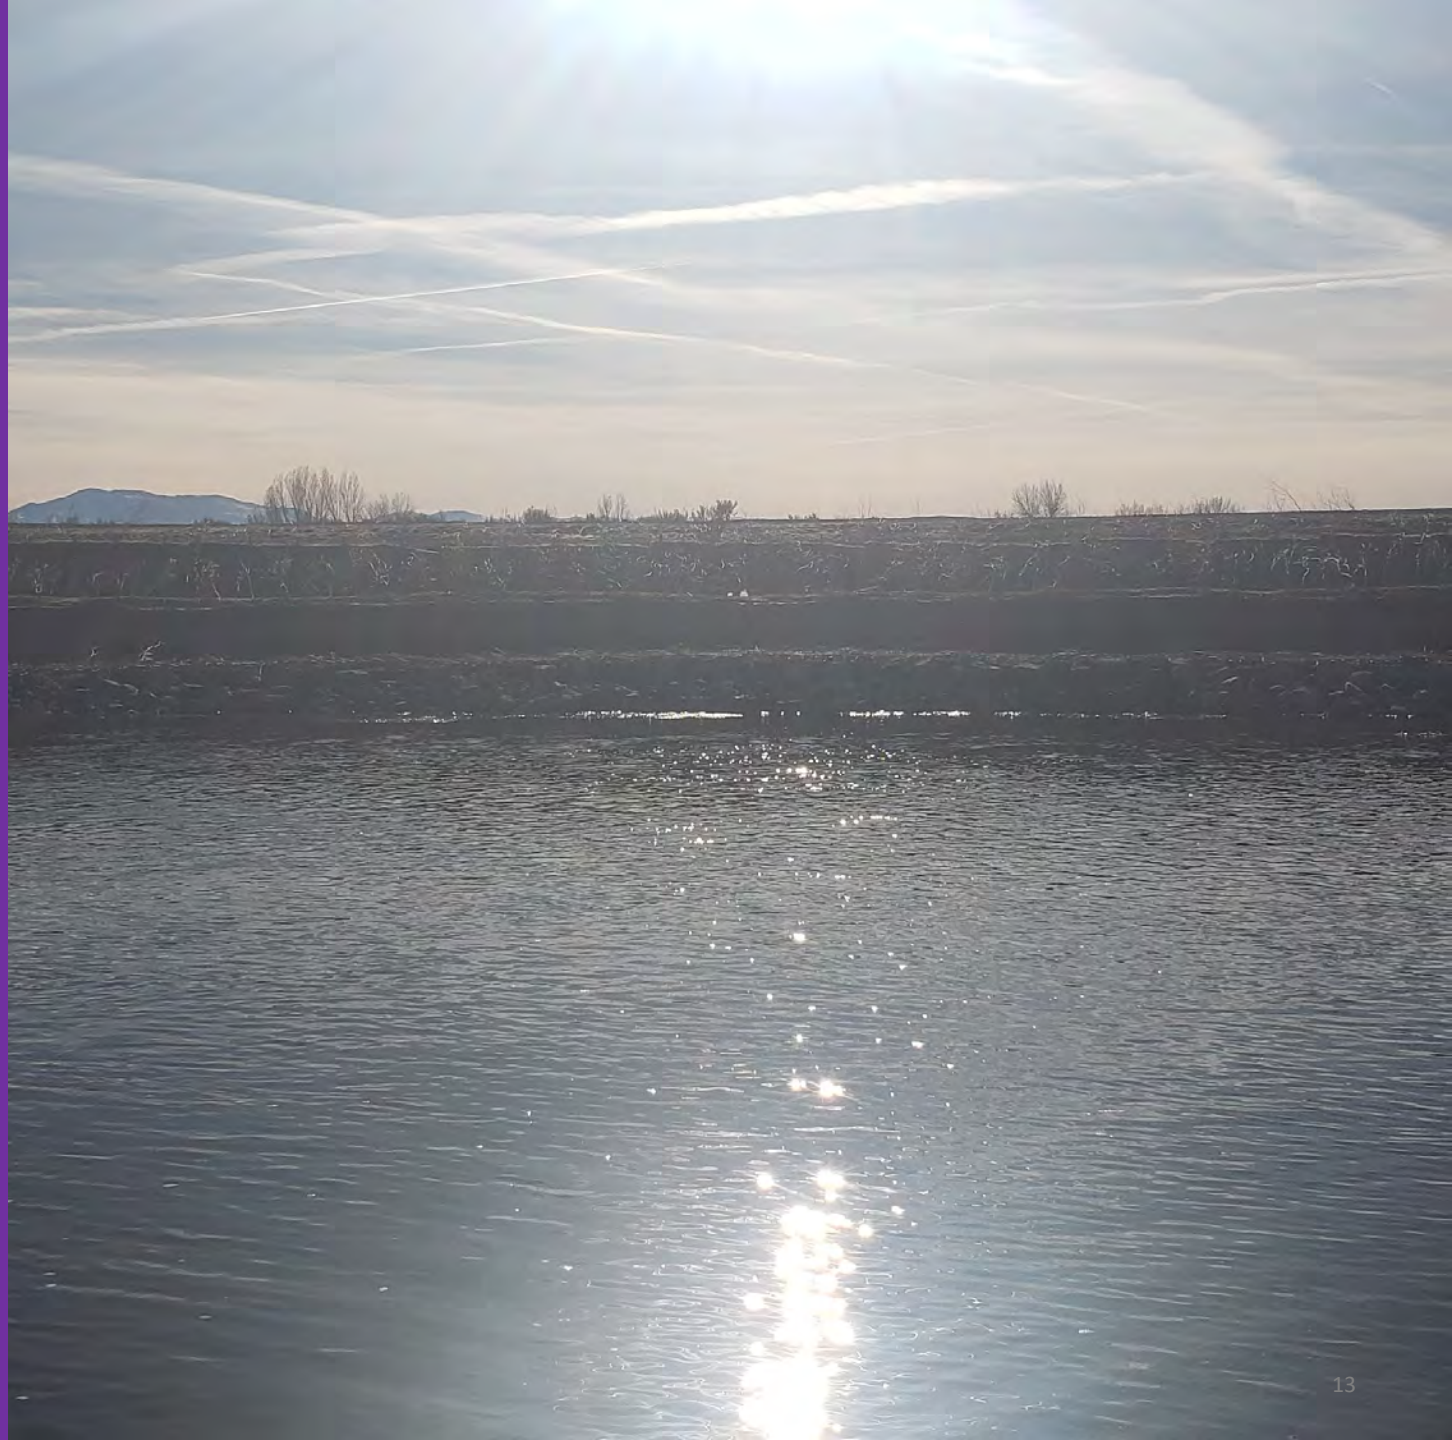
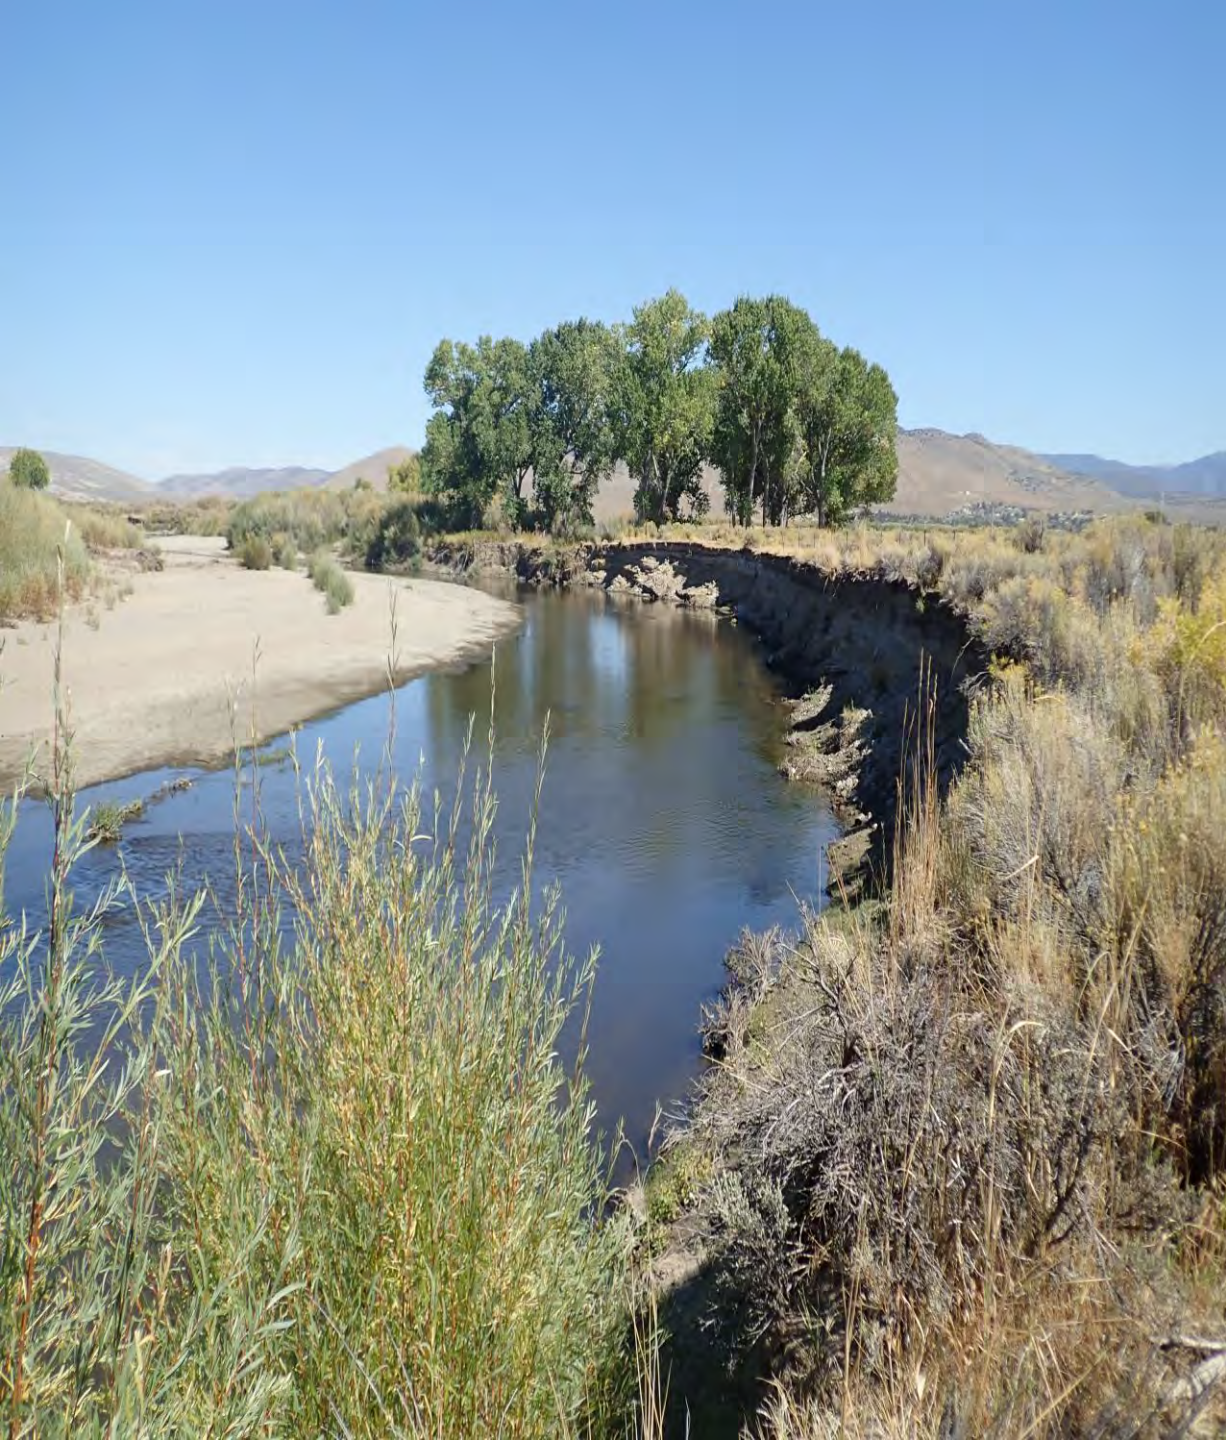
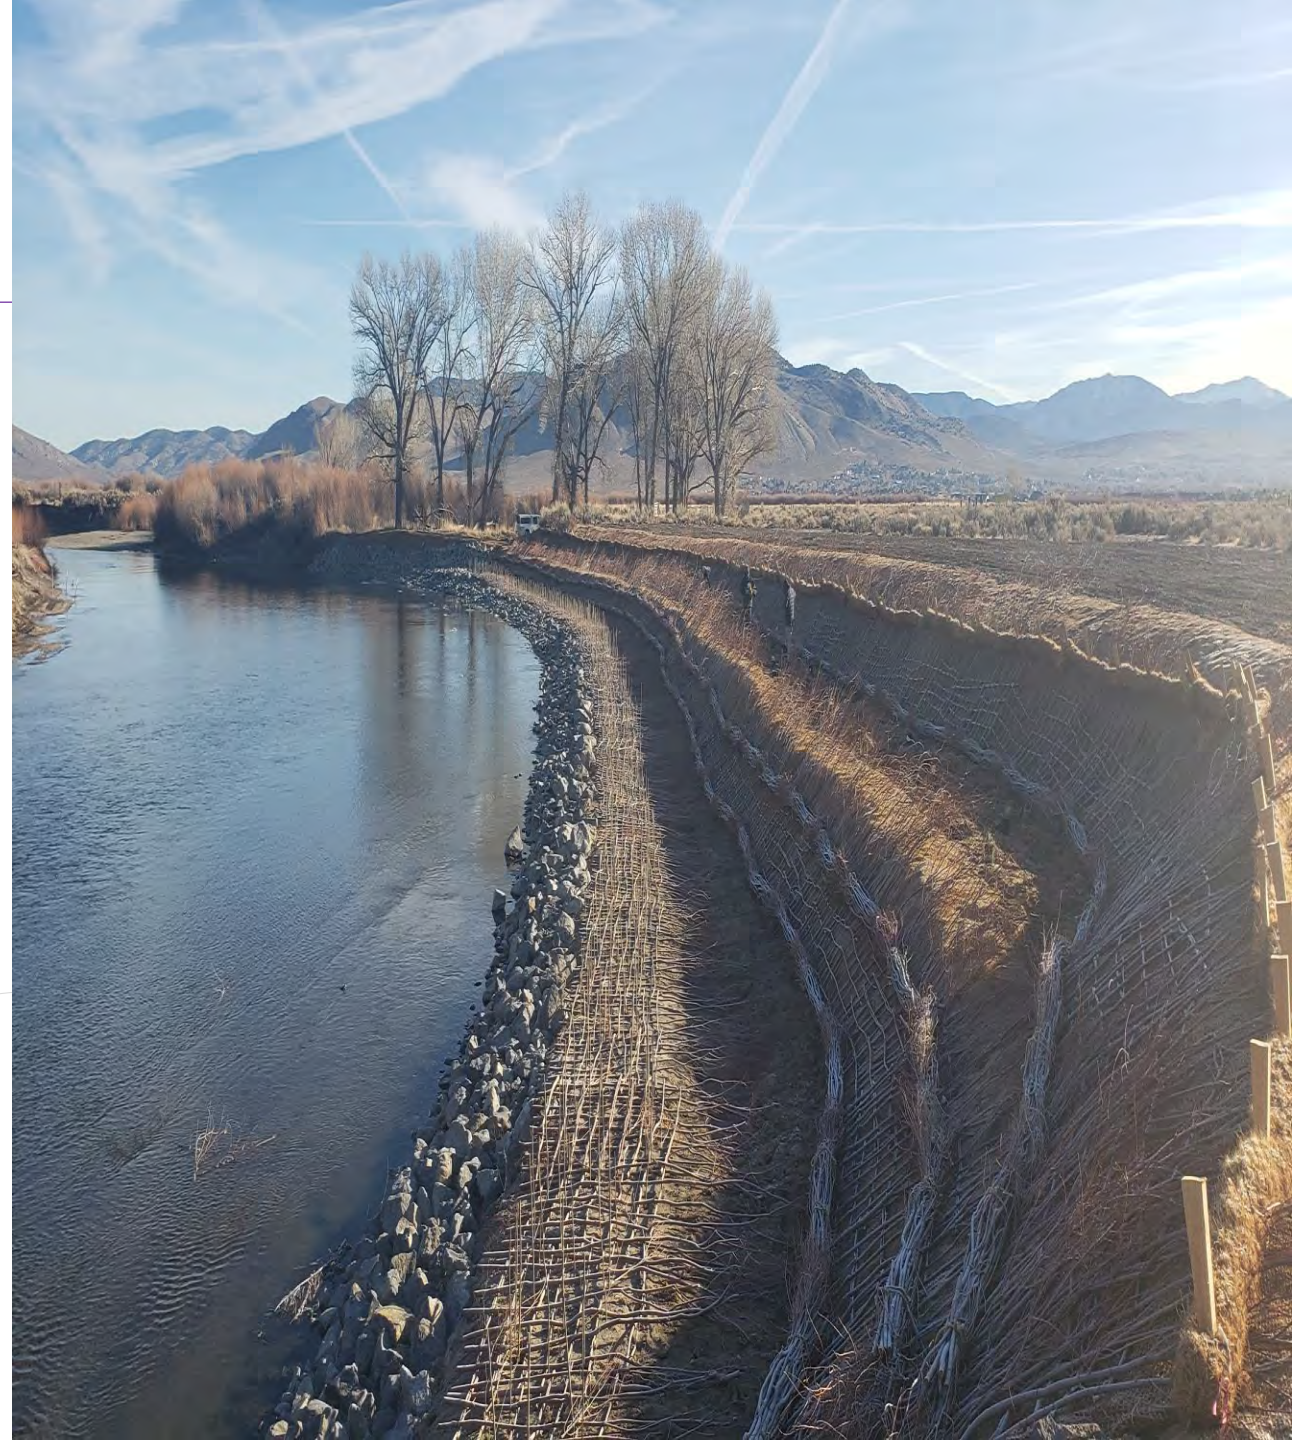
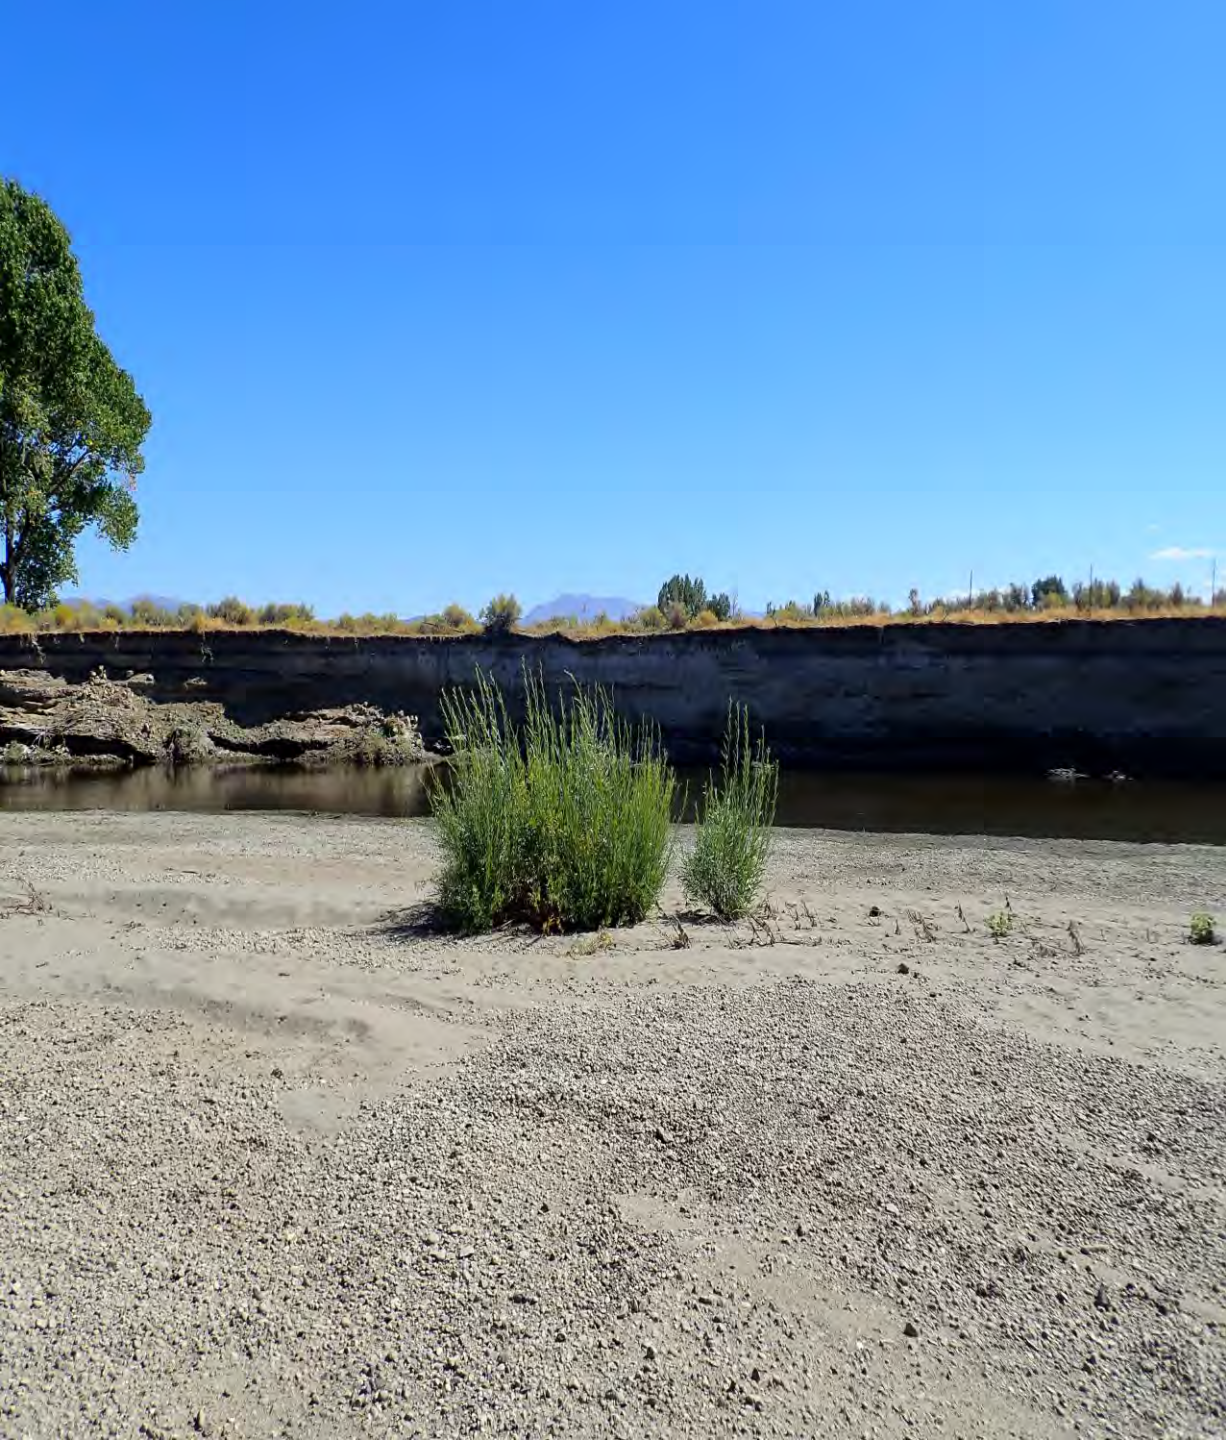
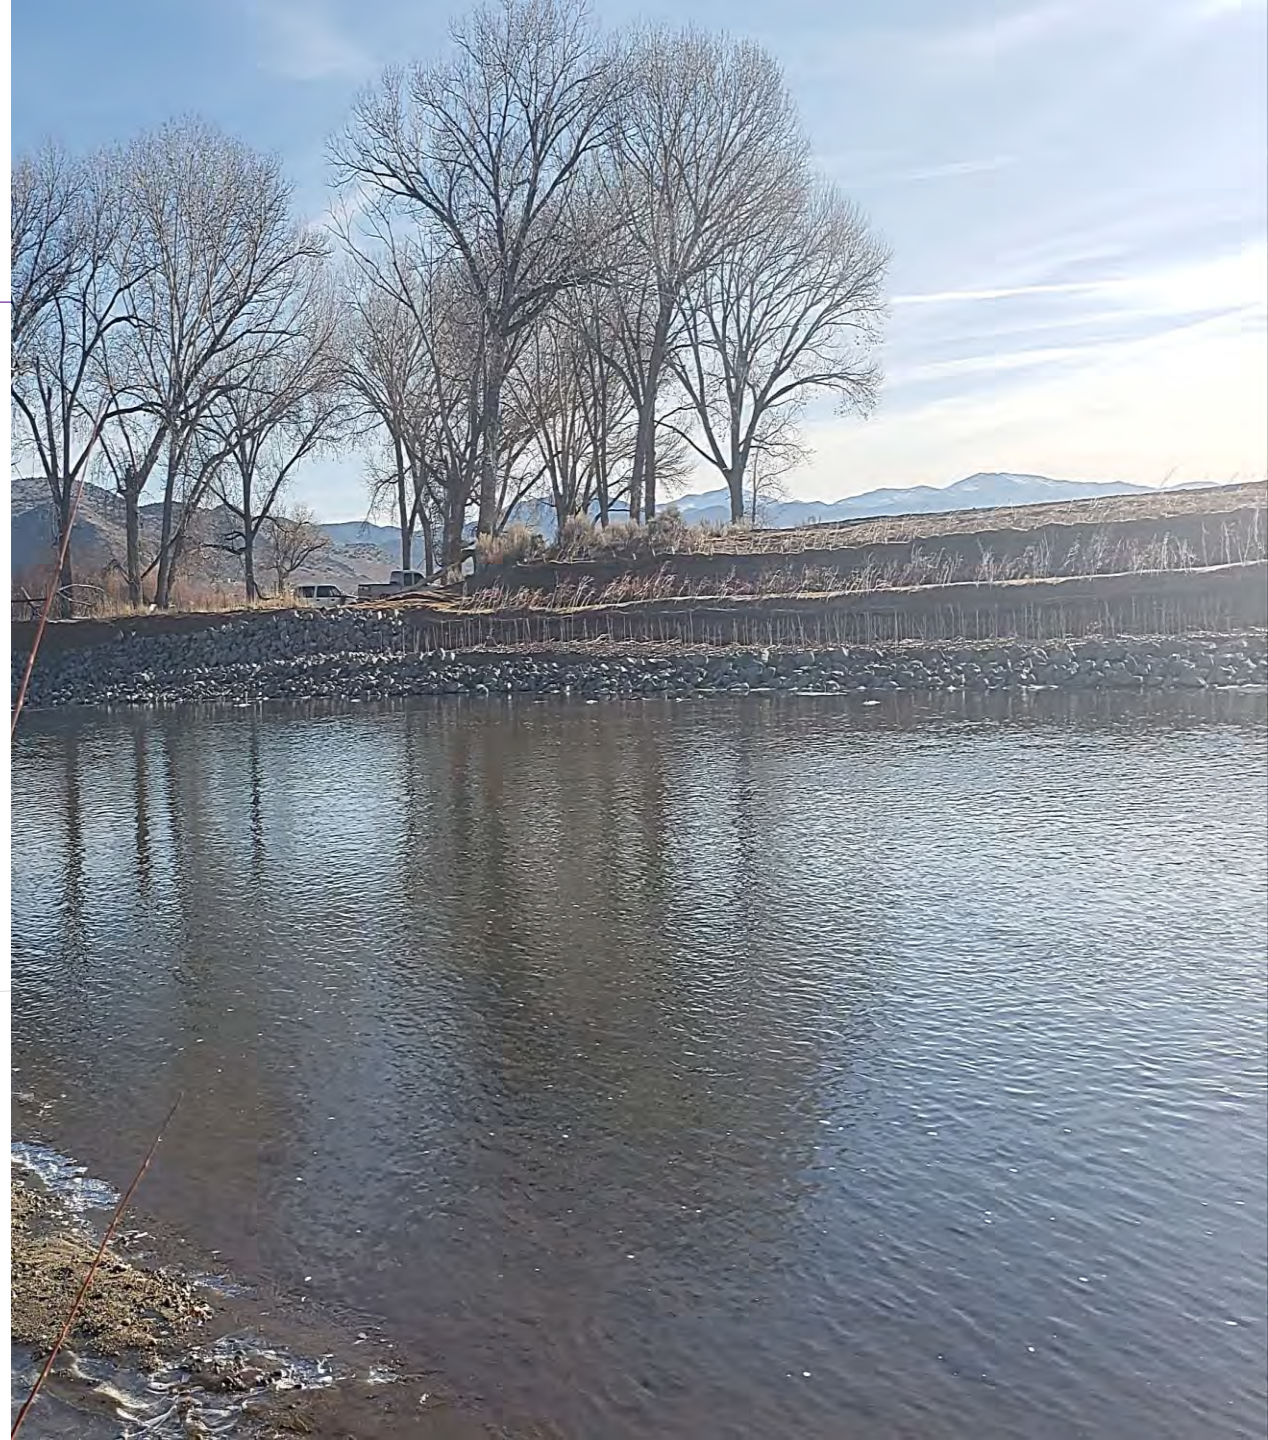
# ANNUAL MONITORING

Annual photo monitoring using GPS  
photo way-points.
