CARSON RIVERBANK STABILIZATION PROJECTS

April 19, 2023 Carson Watershed Forum

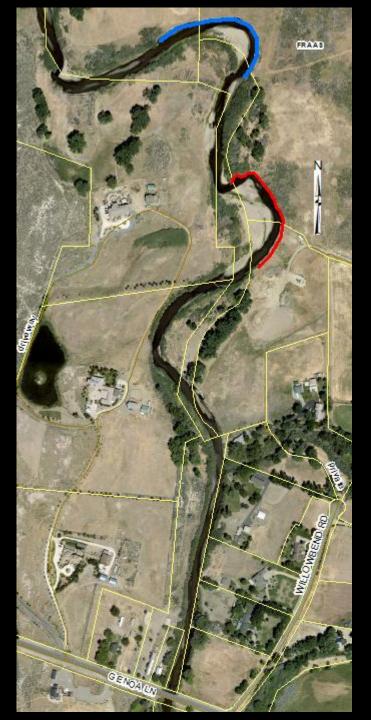
SELECTED PROJECT SITES

CHARNEY Legend Carson Riverbank Stabilaztion Projects Construction Phases Phase 1 - 2,630 LF Phase 2 - 1,960 LF Phase 3 - 2,400 LF (Est.) CARSON VALLEY CHARNEY CONSERVATION DISTRICT

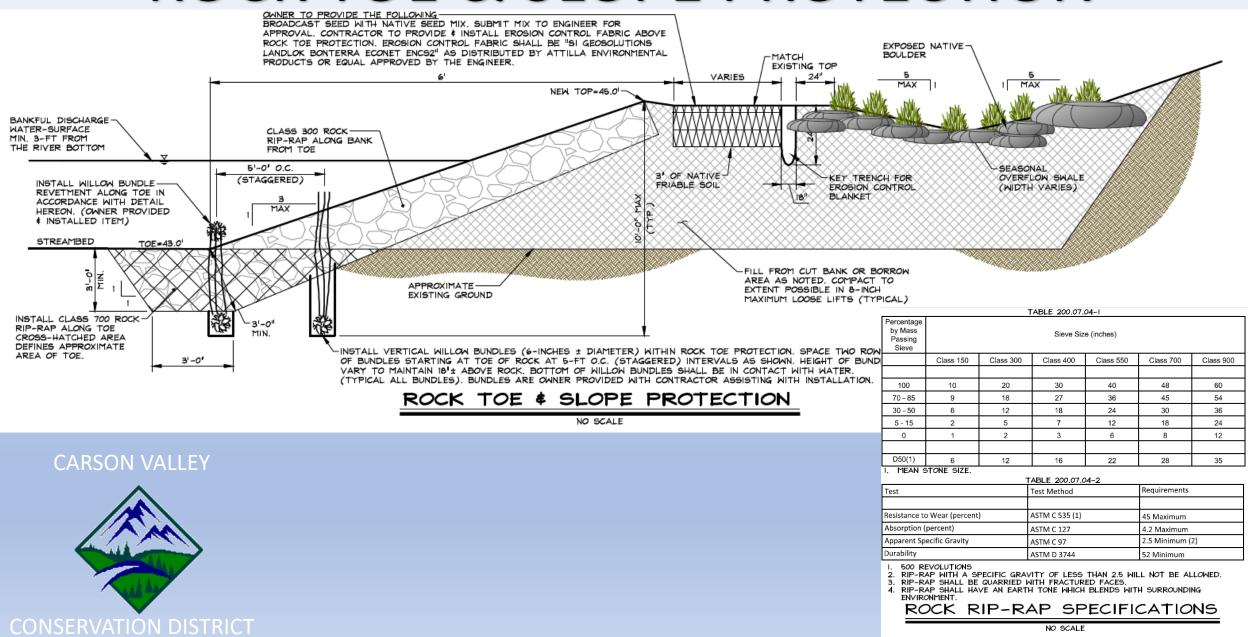
ROCK TOE & SLOPE PROTECTION

- CONSTRUCT DEWATERING CHANNEL
- BREACH IRRIGATION CONTROL STRUCTURES
- DIG MIN 3FT DEEP TRENCH ALONG THE NEW TOE
- INSTALL CLASS 700 RIPRAP ALONG THE TOE OF THE RIVERBANK
- SHAPE FAILED BANKS NO STEEPER THAN 2H:1V, PREFERRED 3H:1V

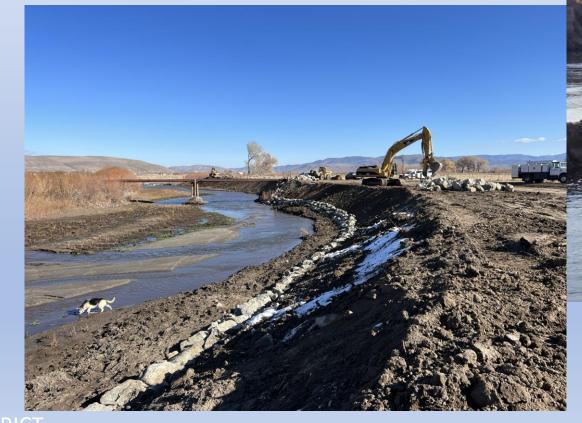
DEWATERING, SITE PREP AND GRADING

• CLEAR & GRUB

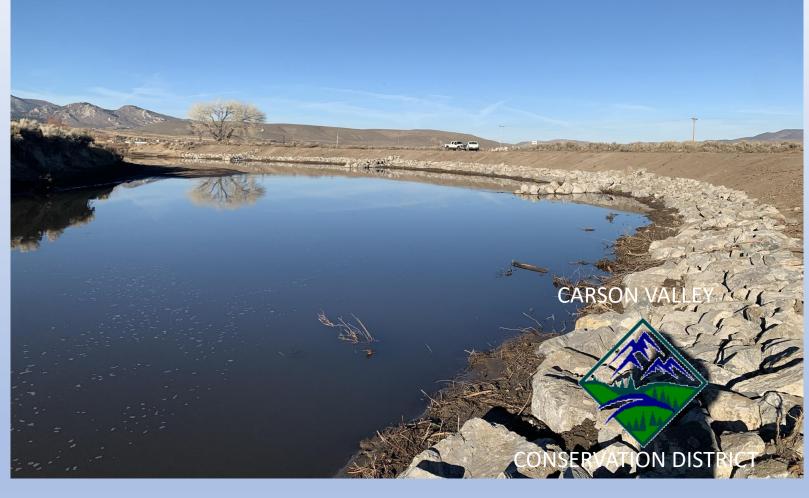
INSTALL STRUCTURAL MEASURES

- COMPACT RESHAPED RIVERBANKS
- CONSTRUCT ROCK REFUSAL TRENCH WITH CLASS 700 RIPRAP
- CONSTRUCT STREAM BARBS/LOG VEINS
- COVER BANKS WITH CLASS 500 & 300 RIPRAP

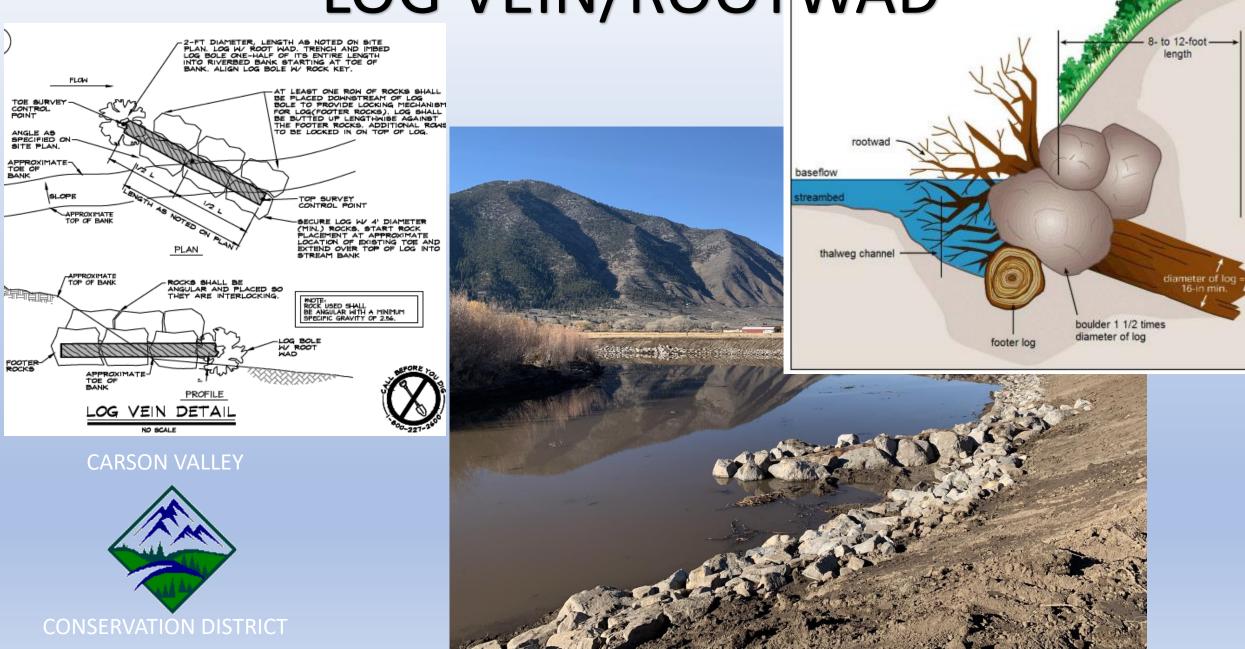
LOG VEIN/ROOT WAD

existing vegetation, plantings or soil bioengineerint systems

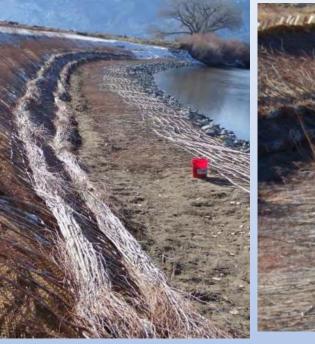
BIO ENGINEERING METHODS

- WILLOW CUTTINGS TO BE HARVEST FROM LOCAL SOURCE AS AVAILABLE.
- 2. CLEANLY DETACH WILLON CUTTING MATERIAL I' FROM EXISTING GROUND AT THE PLANT BASE, REMOVE SIDE AND TERMINAL BRANCHES, ASSURE NO BARK DAMAGE OCCURS TO REMAINING WILLOW BASE. PRESERVE AND
- PROTECT BASE IN PLACE. SIGURE NILLON BURDLE WITH 2 POLY TWINE PIECES PER BURDLE. PROTECT HARVEST SITE FROM PERTANENT DISTURBANCE. UPON
- COMPLETION OF HARVEST ACTIVITY, RESTORE SITE TO NATIVE CONDITIONS. BOAK WILLOW CUTTINGS FOR 5-7 DAYS, BEFORE ROOTS BEGIN TO
- EMERGE FROM CUTTING.
- ALTERNATE DIRECTION OF WILLOW BUNDLE TO PRODUCE AN EVEN NOTH AT THE OVERLAP LOCATION.

EXISTING MATERIAL TO BE REMOVED. WILLOW CUTTING WITHIN AND BEHND FIBERSCHNE 10 TO 12 GAUGE WIRE TO SECURE ROLL TO STAKES 121-181 DIA COCONUT-FIBER -ROLL OR BIOLOG 36 WODDEN STAKES WITH TWINE NOTCHES AT & O.C. (TYP) BACKFILL TOE OF STREAMBANK
