# Douglas County Floods of 2023, Lessons Learned & Stormwater Master Planning

## Douglas County Stormwater Master Plan and Capital Improvement Projects List

# Douglas County Stormwater Master Plan

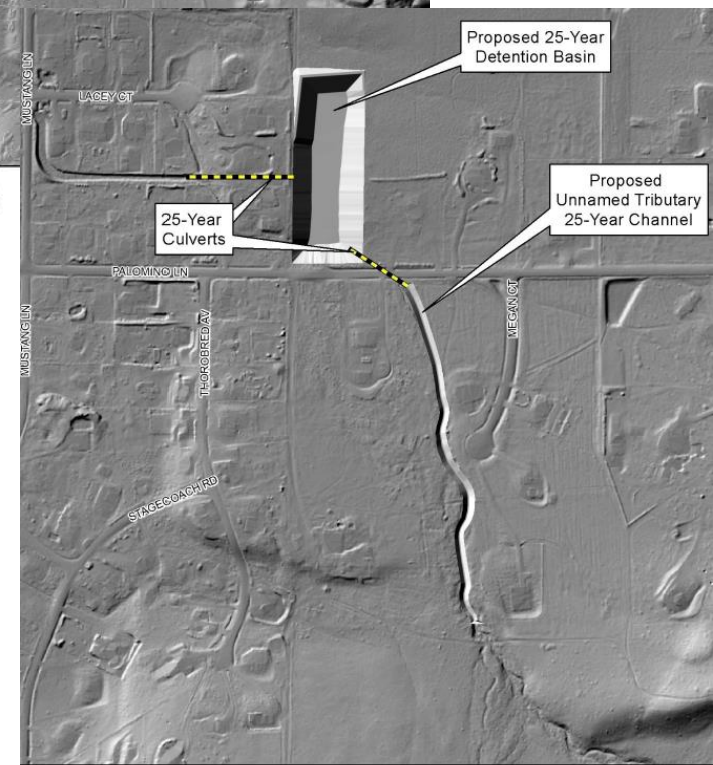
**Smelter Creek Mitigation Alternatives**

Proposed New 25-year Culverts

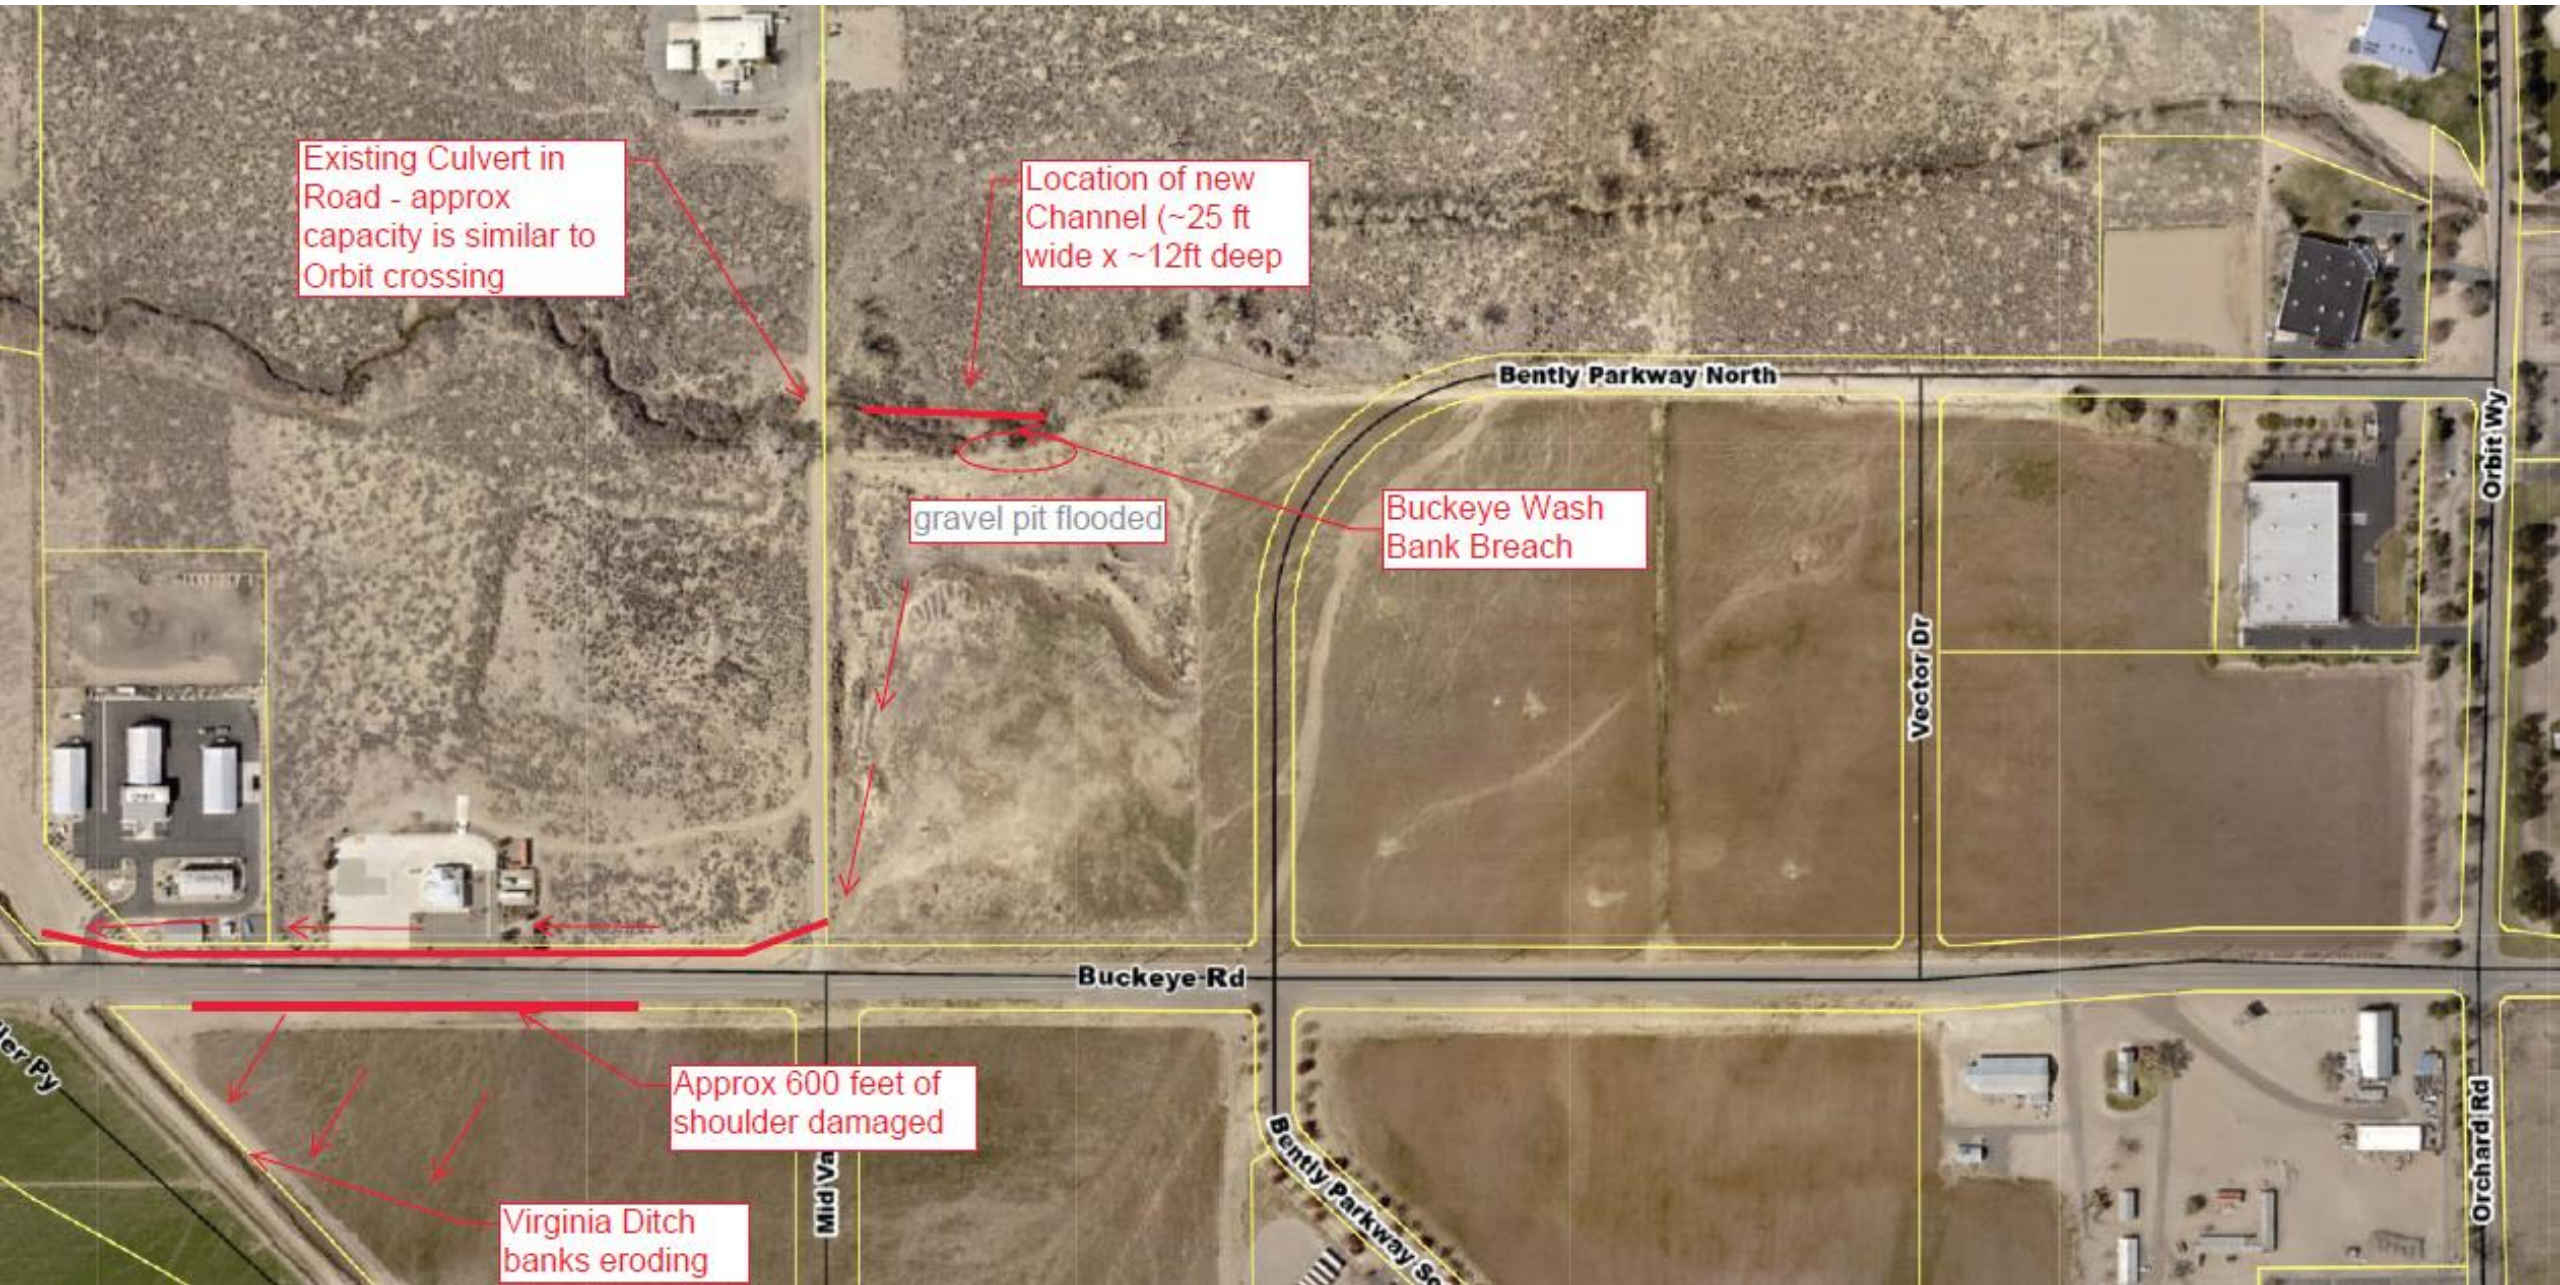
Existing Culvert in Road - approx capacity is similar to Orbit crossing

Location of new Channel (~25 ft wide x ~12ft deep)

gravel pit flooded

Buckeye Wash Bank Breach

Approx 600 feet of shoulder damaged

Virginia Ditch banks eroding

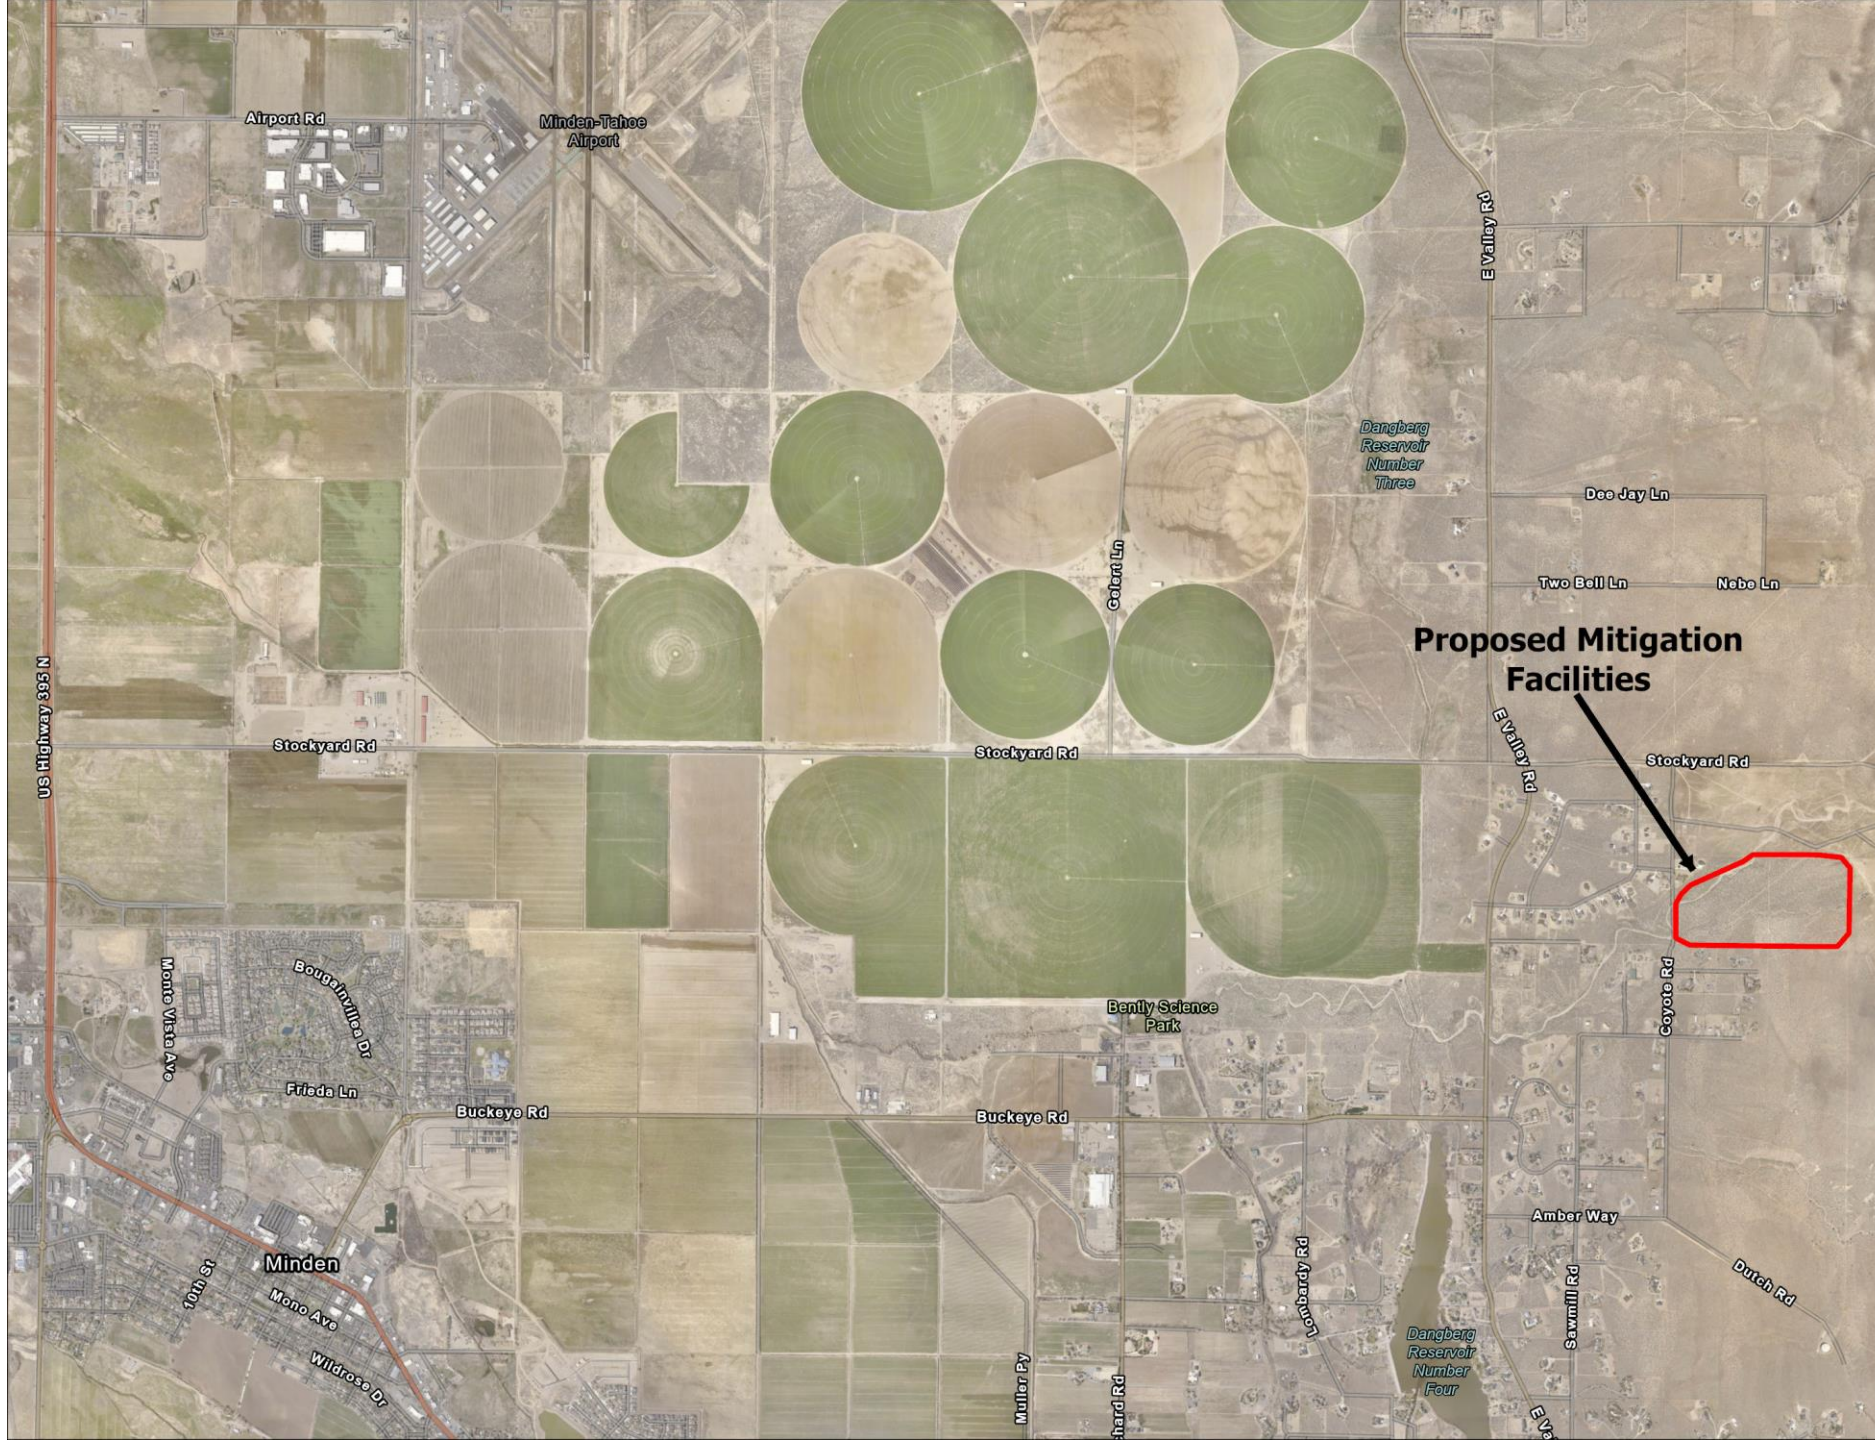
**Proposed  
Mitigation  
Facilities  
Location**

Buckeye Creek  
Flood Mitigation  
Assessment

**Proposed Mitigation  
Facilities**

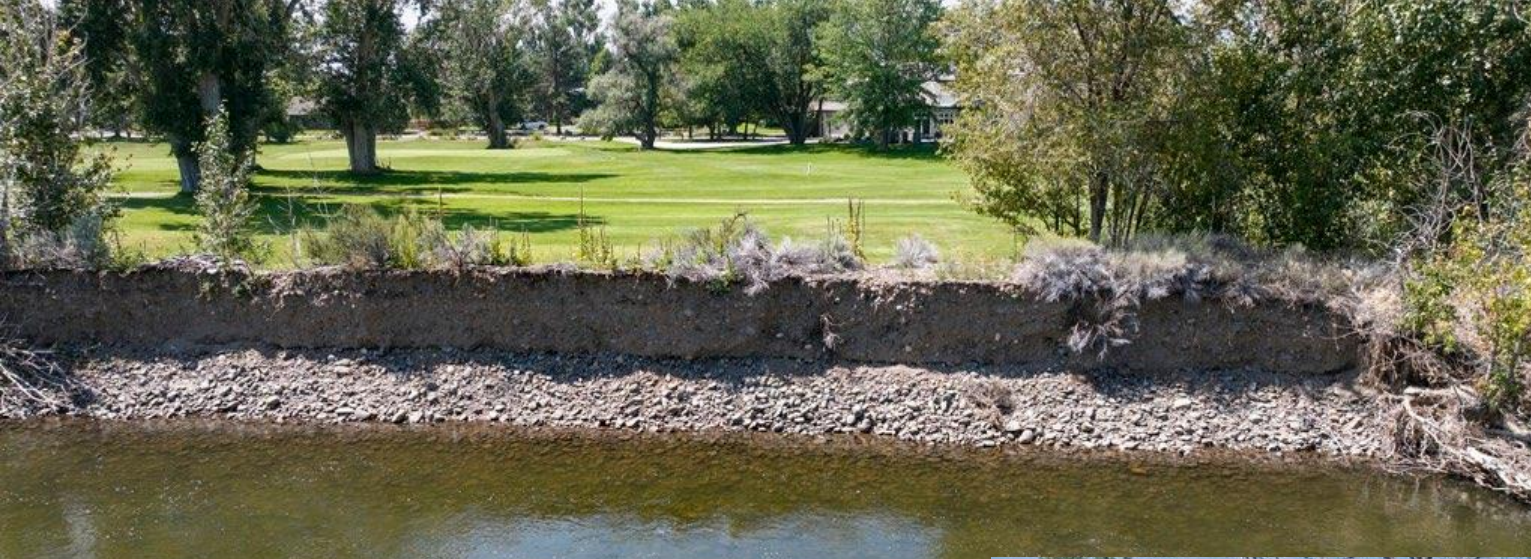
## Levee Erosion East Fork Carson River

Downstream of levee is a  
golf course and residential  
neighborhood.

## 4.2.1 East Fork Carson River Levee Issue

Significant riverine flooding in 1997 and again in 2023 raised awareness of the potential failure of a levee structure of unknown origin or ownership. Conflicting opinions of ownership (residents, the Carson Valley Golf Course) resulted in numerous entities contributing to repairing the breached levee in 1997, and again in 2023 to prevent another compromise of this structure that would have flooding of many homes, businesses and roads. The levee is located along the East Fork Carson River adjacent to the Carson Valley Golf Course in the Gardnerville Ranchos. Initial research concluded that the levee was constructed by a rancher in the late 1800's to avoid their fields from being flooded by the river.

Currently there exists a neighborhood that has a subdivision map that dates back to 1965. After the January 1, 1997 flood event, the levee failed, resulting in the severe flooding of several homes in that subdivision. Douglas County, in conjunction with the Carson Water Subconservancy District (CWSD), Nevada Division of State Lands (NDSL), Gardnerville Ranchos GID, and Nevada Division of Environmental Protection worked together to secure funds to perform emergency repairs on the levee prior to the spring melt off that year. In addition, some homeowners were able to structurally raise their homes out of the floodplain. Research shows that repairs were made once again in 2005-06 to repair the compromised levee once again due to damage caused by the high sustained flows on the Carson River. The levee was once again repaired in January 2024 due to sustained high flows during the 2022-23 winter runoff.
