C-1 REACH SUMMARY

LOCATION: Genoa Road to Cradlebaugh Bridge

Geomorphic Setting

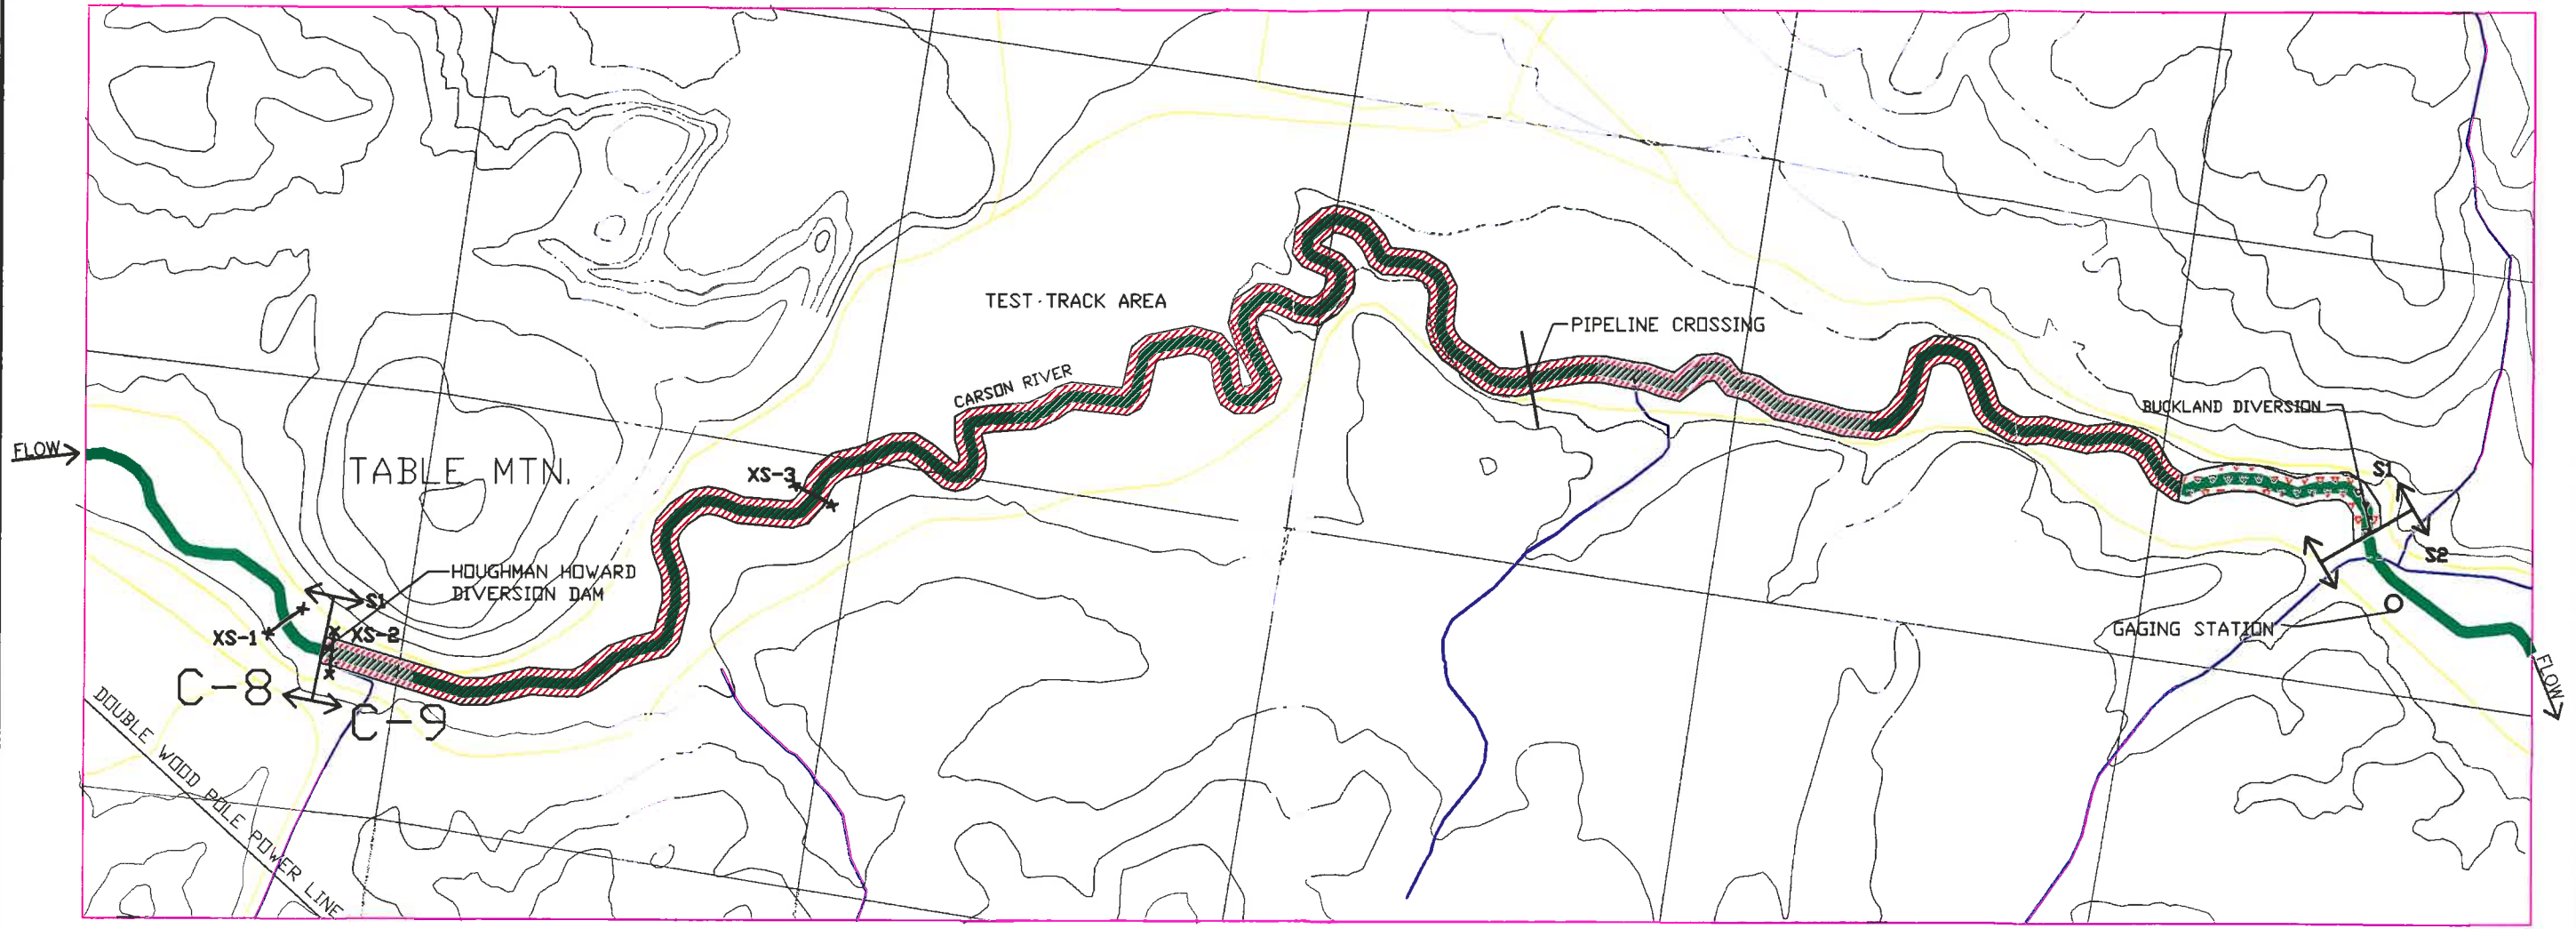
REACH C-9, S1
 APPROX. SCALE: 1" = 2100'

Banks throughout C-9 are unstable, on both sides of the channel. Bank heights range from 3 to 4 feet above diversions, to 15 feet in incised sections. The majority of banks are 1:1 or steeper and largely unvegetated due to their steepness, regularity in failure, and elevation above the active channel. Some isolated areas of riprap exist, which exhibit varying degrees of effectiveness and utility. While the majority of bank erosion and instability occurs at outside bends, inside bend banks are unstable and lacking in vegetation regeneration. Inside bends have large depositional bars and show some regeneration, but are generally backed by steep, eroded banks.

- C-9 is relatively undeveloped, and consequently little is threatened by channel migration or instability. However, one area of bank instability adjacent to a road near the test track may threaten this road over time. Existing riprap appears undersized and ineffective. Bank instability at the location of the pipeline crossing also should be addressed to protect the pipeline. We recommend both grade control and bank riprap to protect the pipeline crossing.
