## TECHNICAL MEMORANDUM

Alluvial Fan Evaluation:  
Fans 44, 45, 78, 79, 81, 82, 115 and 116  
Carson City and Douglas Counties, Nevada

**To:** Carson City Subconservancy District (CWSD)

**Date:** 27 March 2020

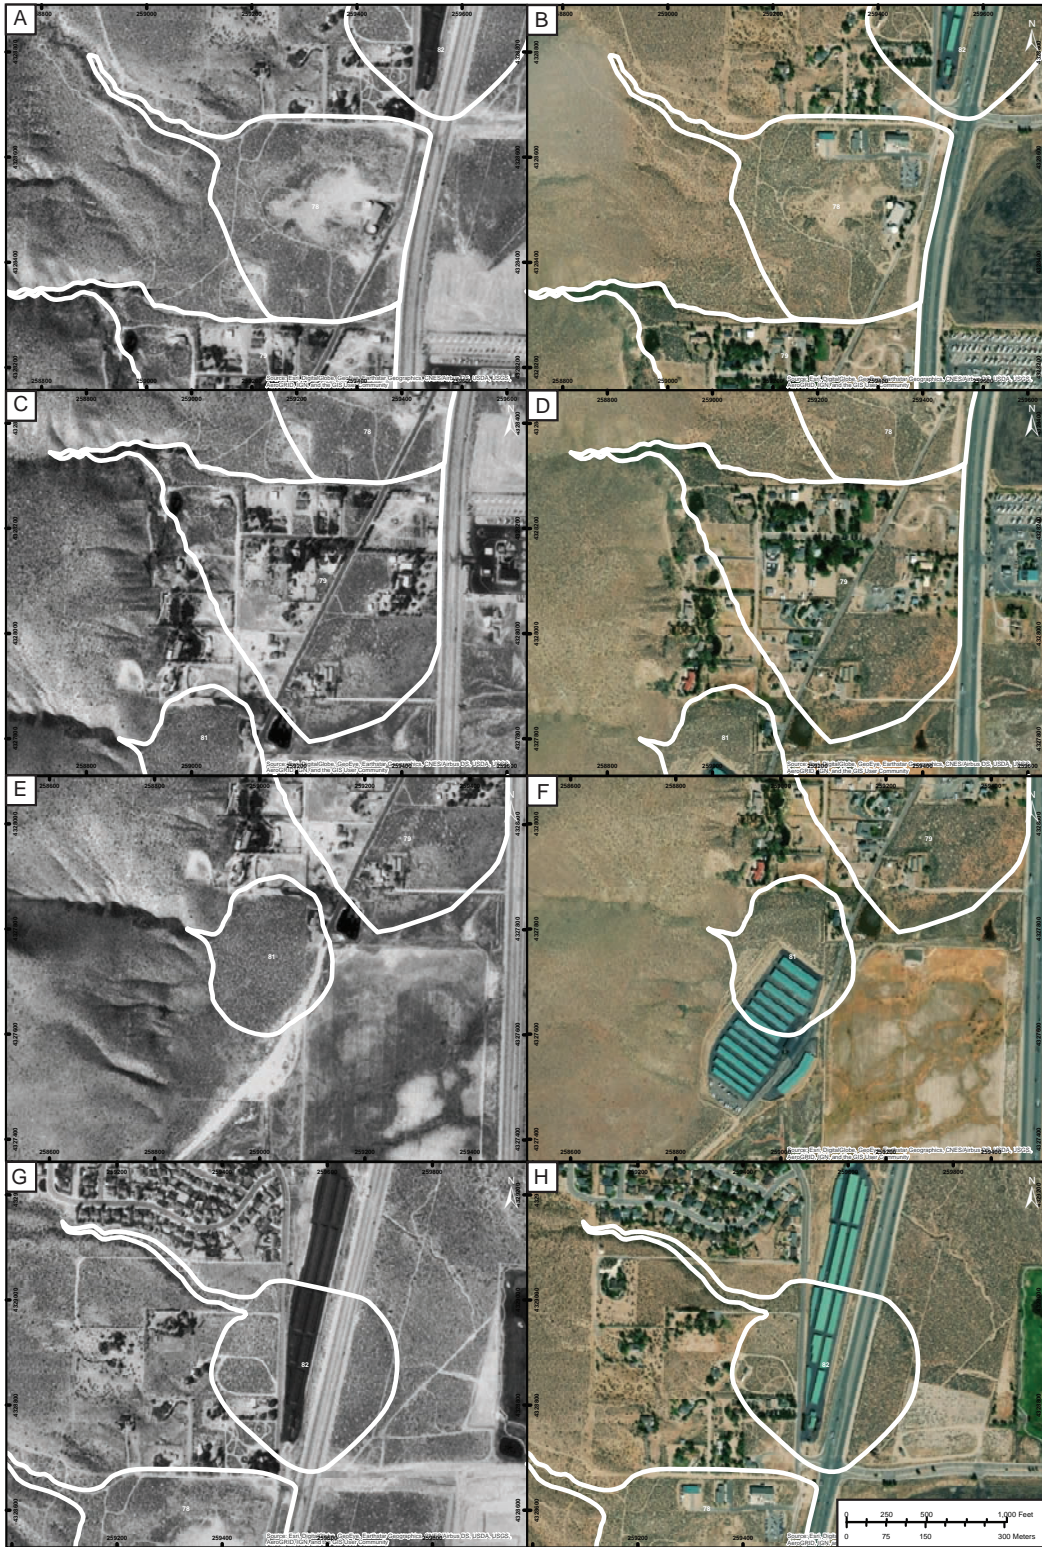
**Figure 3.** Indian Hills alluvial fans. Fan 78 A) in 1999 and B) 2018; Fan 79 C) in 1999 and D) in 2018; Fan 81 E) in 1999 and F) in 2018; and Fan 82 G) in 1999 and H) in 2018.

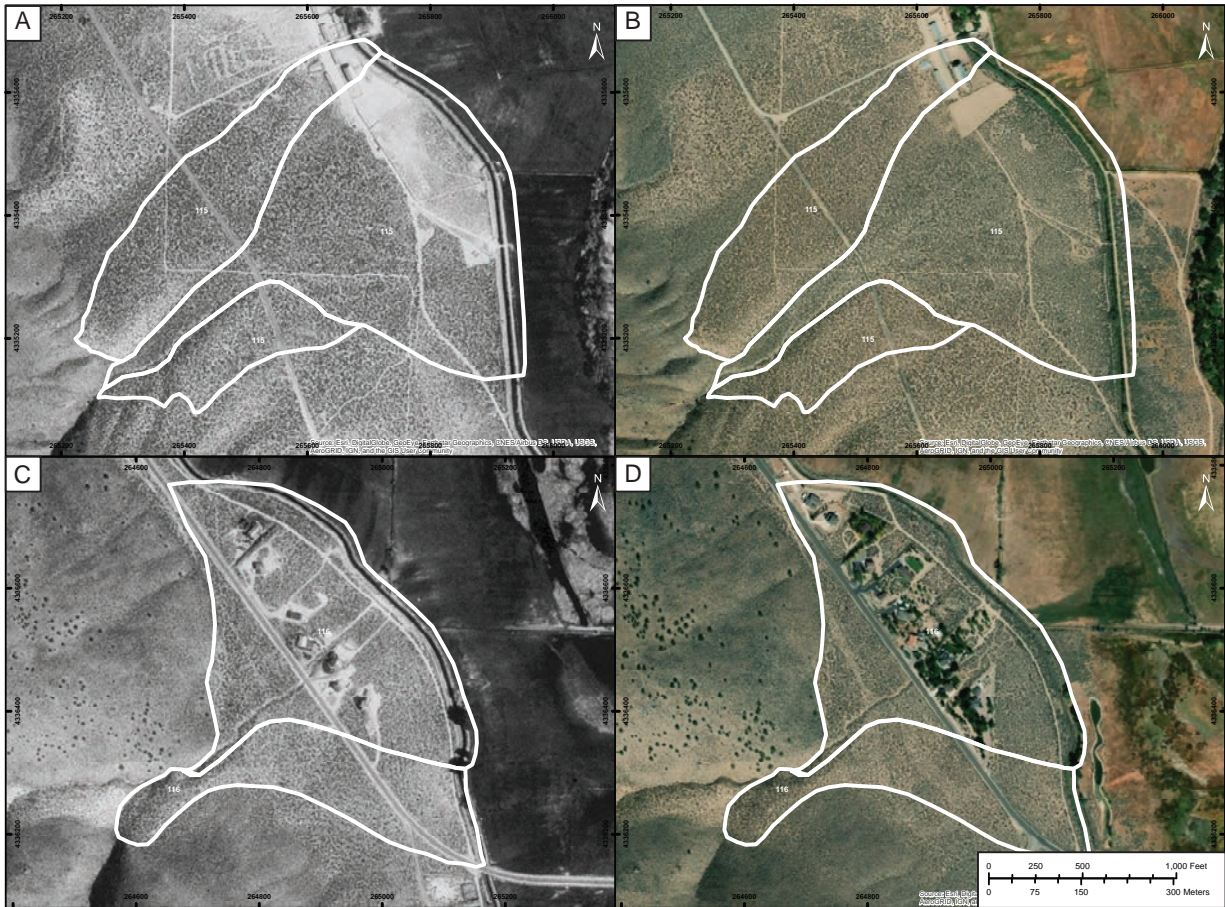
**Figure 4.** Prison Hill alluvial fans. Fan 115 A) in 1999 and B) in 2018; and Fan 116 C) in 1999 and D) in 2018.

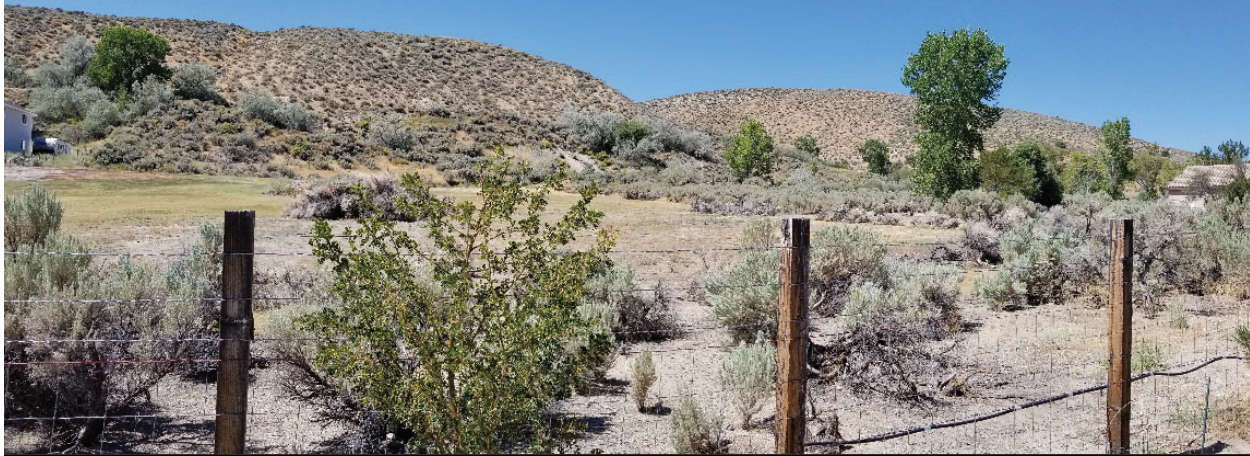
**Figure 14.** Photograph from intersection of Powers Ave and Washoe Springs Rd looking to the west-northwest on Fan 79. Field is well manicured with gently rolling surface. There is no indication of surface flow across field.

home plots. Washoe Springs Road was visited during the site visit but access to the fan was limited by fences and gates on the road leading up to private properties. **Figure 14** was taken from Washoe Springs Road looking in the direction of the fan apex and reveals a gently rolling topography and well-manicured field with no apparent indication of recent alluvial activity.

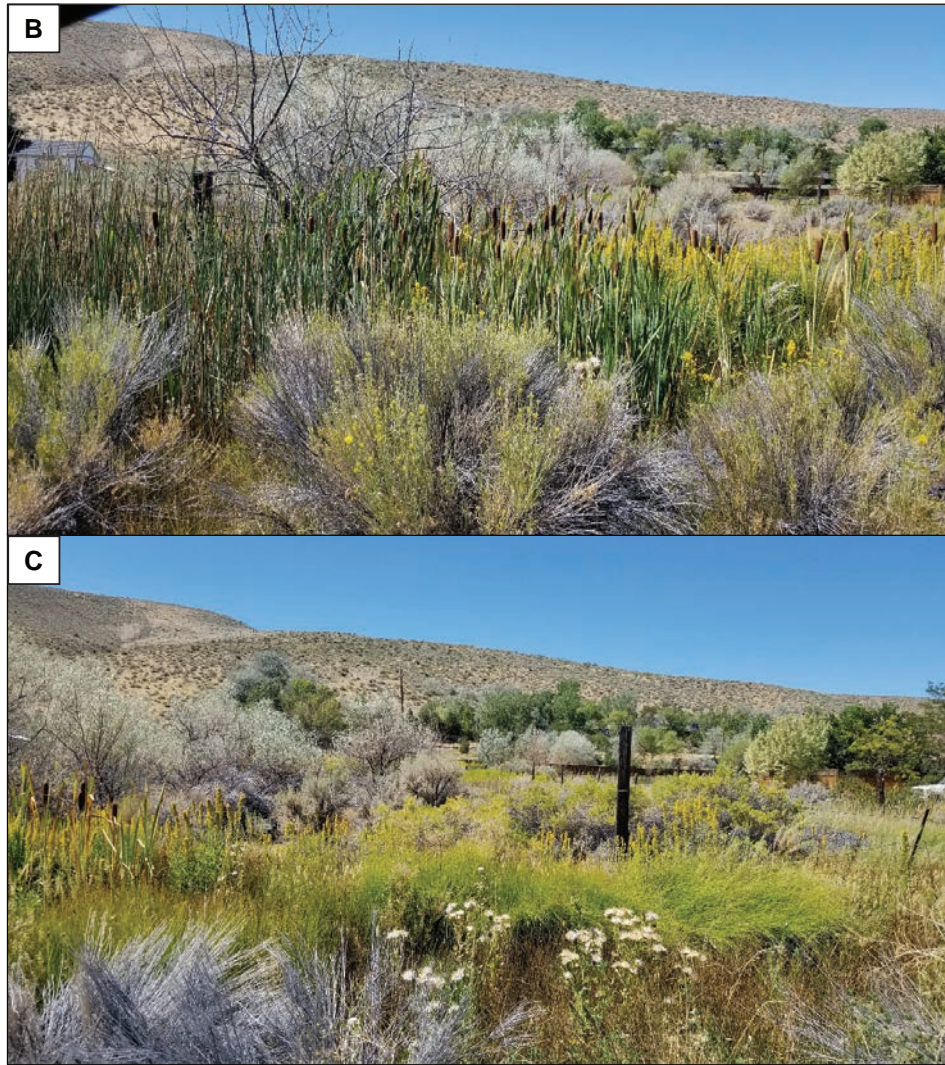
**Figure 16.** Wetland vegetation along the boundary of Fans 79 and 81.

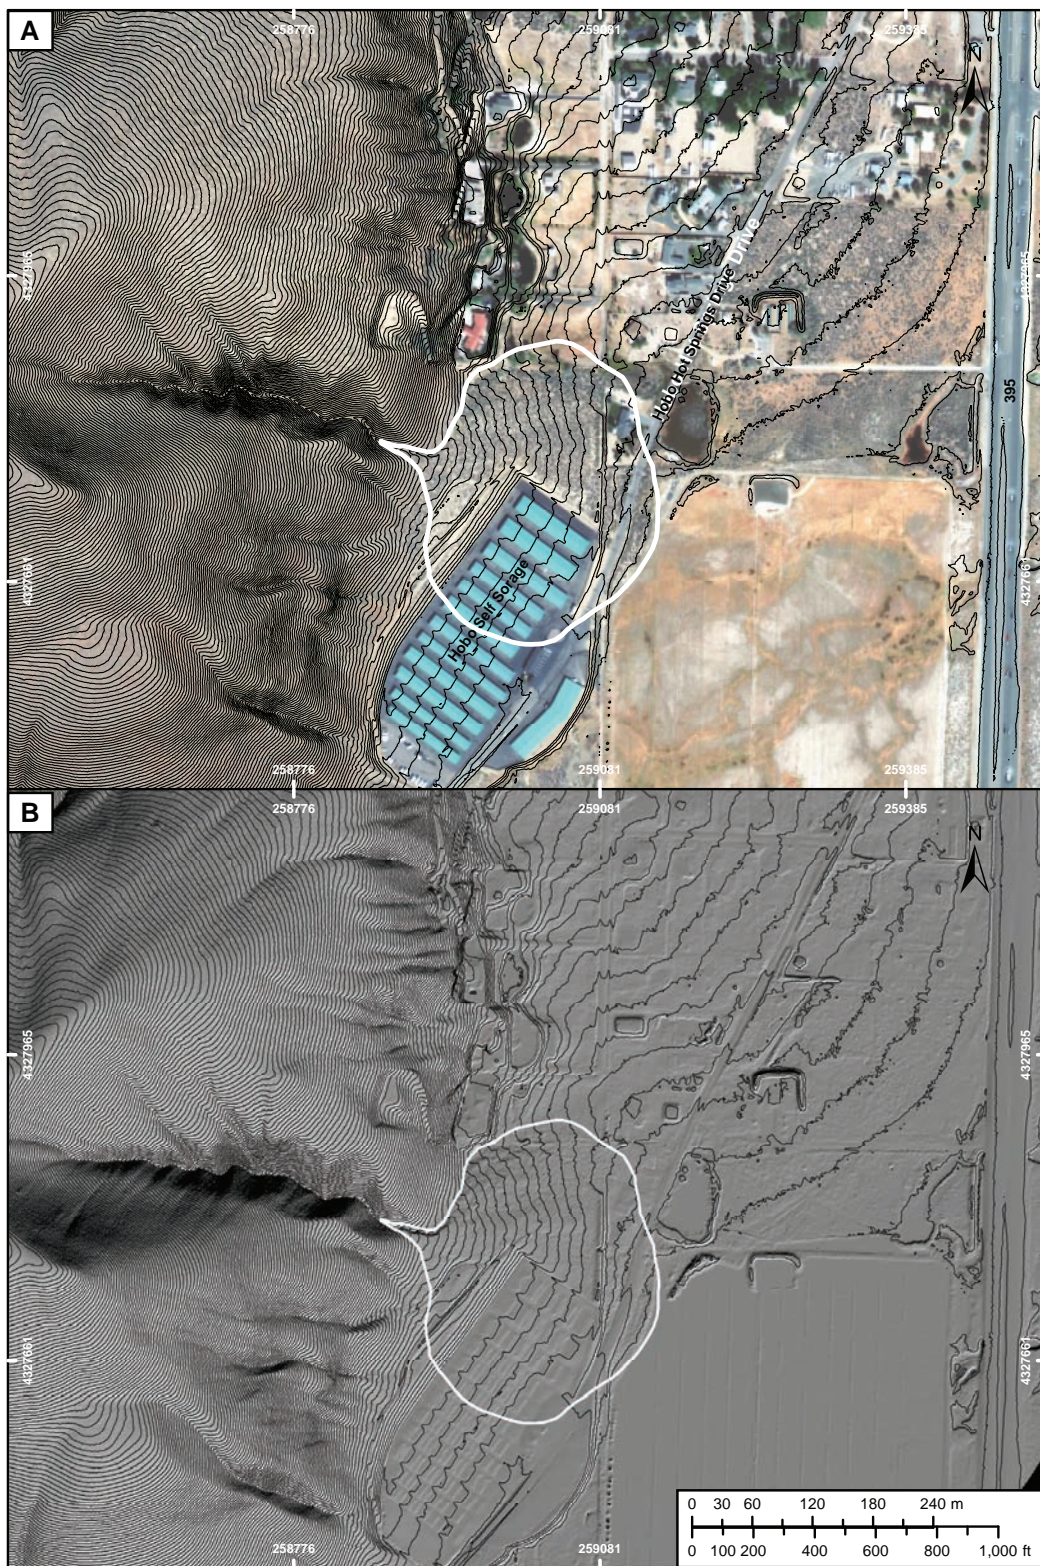
located west of Highway 395 and has undergone significant modification with the building of the Hobo Self Storage facility (**Figure 17**). Away from the storage facility the fan surface is generally smooth, with low relief and a shrub vegetation cover (**Figure 18**). In 1999, the fan was relatively undeveloped, except for a farmhouse in the northwest corner. The fan and slopes are between  $4^{\circ}$  and  $9^{\circ}$  (**Figure 2a**) and the fan is fed by a single feeder channel constrained within the walls of the bedrock valley. Just above the topographic apex, the feeder channel is 7 m (23 ft) wide and 1.6 m (5.3 ft) deep. Below the topographic apex, most of the drainage is diverted into a channel that runs along the northern edge of the fan. This drainage wraps around to the east and feeds a low laying, active alluvial surface adjacent to the farm. Along the berm just north of the storage facility surface material is characterized by medium to coarse sand with angular granules to cobbles. There is also a large boulder on the fan surface north of the facility that was likely excavated during construction. This

**Figure 17.** Fan 81. A) With aerial photograph base from the ESRI World Imagery coverage sourced by Digital Globe. B) Hillshade elevation model generated in Quick Terrain Modeler. Both images show 1-m contours generated by Quick Terrain Modeler.

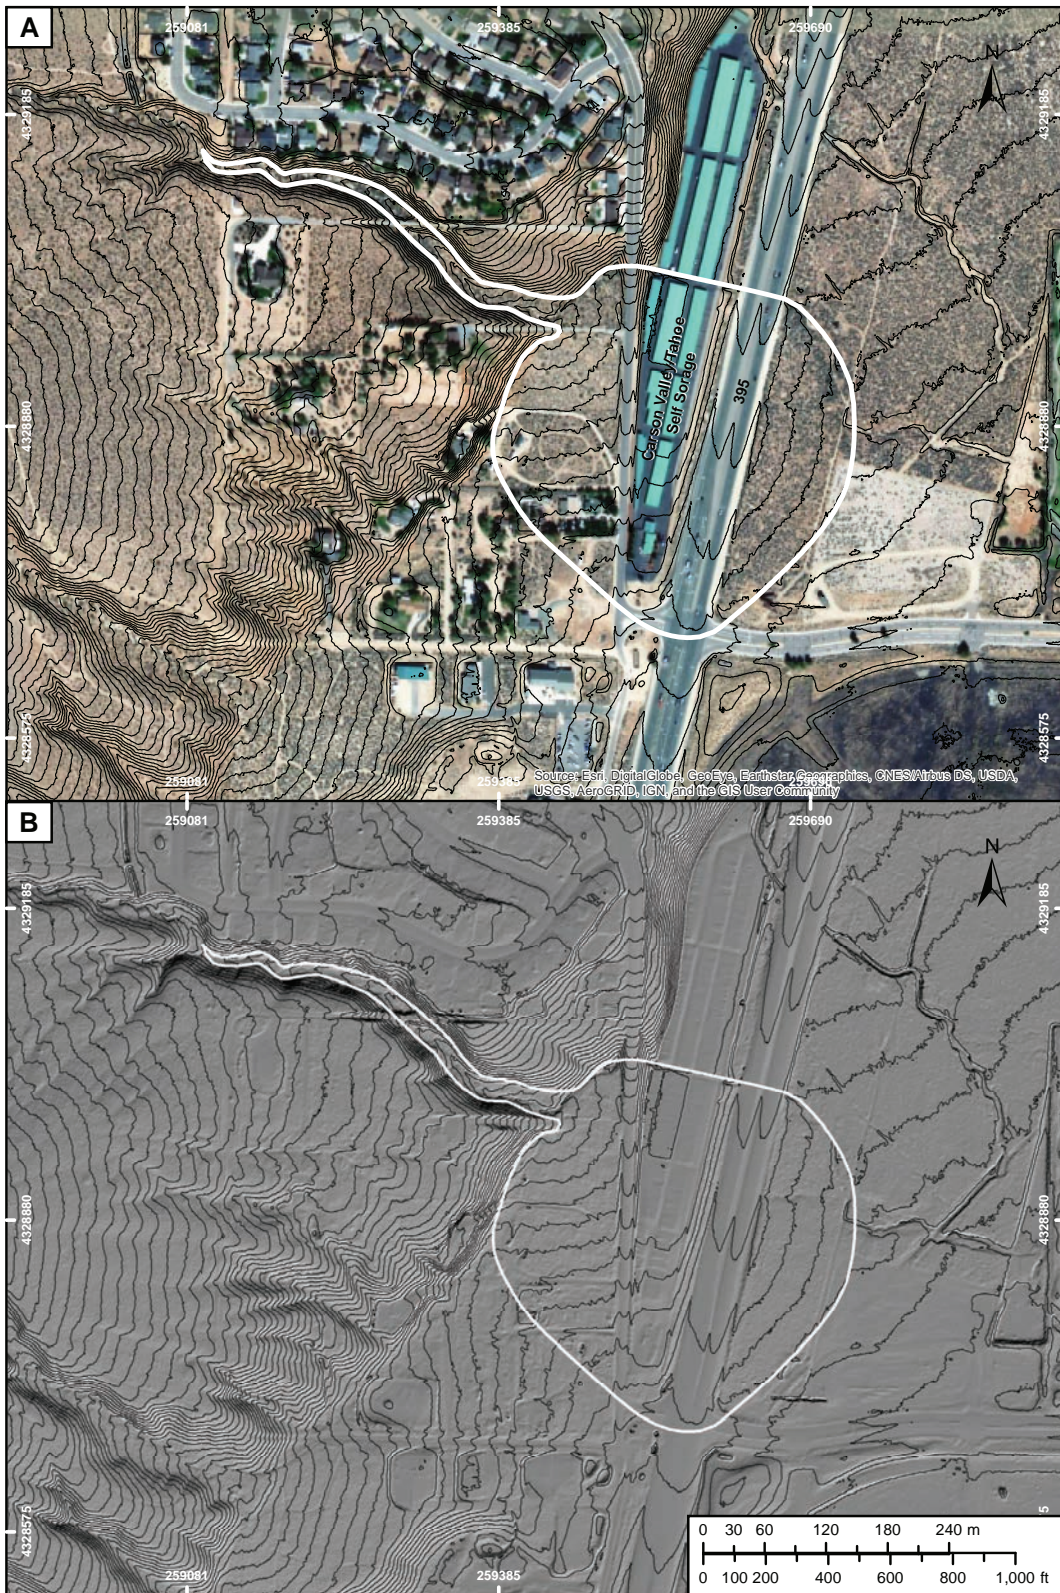
Fan 82 is the northernmost fan evaluated in the Indian Hills area. The fan is located on the west side of Highway 395 and is nearly bisected by the Carson Valley/Tahoe Self Storage facility on Plymouth Road (**Figure 21**). The fan is fed by a long, deeply incised feeder channel that cuts into ancient terrace deposits mapped as *Older Quaternary alluvium* (Qoa) and *Tertiary sediment* (Ts; Pease 1980; **Figure 7a**). The feeder channel is bracketed by these terrace deposits with little or no availability for channel avulsion. The topographic apex is located along a fault mapped at the edge of these deposits. East of the fault trace, the fan is generally circular in planview. The Carson Valley/Tahoe Self Storage facility and Highway 395 cover a significant portion of the fan, cutting across its mid-fan region in a roughly north – south orientation. There are also a few houses located on the southwestern portion of the fan. Only the upper portion of the fan near the topographic apex and the distal portion east of the highway are relatively undisturbed. There also appears to be minor relict drainage channels within 50 m (~164 ft) of the topographic apex. These channels are wide (10 to 14 m [32.8 – 46 ft]) and shallow (0.15 to 0.25 m [0.5 – 0.8 ft]) with no apparent recent (since engineered channel built) activity. In those areas, the ground is covered by low vegetation. Surface materials are composed of sand and slopes generally fall in the range of 4° – 6°.

The LiDAR data appears to show an engineered channel along the northern edge of the fan but this was not be verified in the field. This ditch is about 2.5 m (8.2 ft) wide and 0.5 m

**Figure 21.** Fan 82. A) With aerial photograph base from the ESRI World Imagery coverage sourced by Digital Globe. B) Hillshade elevation model generated in Quick Terrain Modeler. Both images show 1-m contours generated by Quick Terrain Modeler.

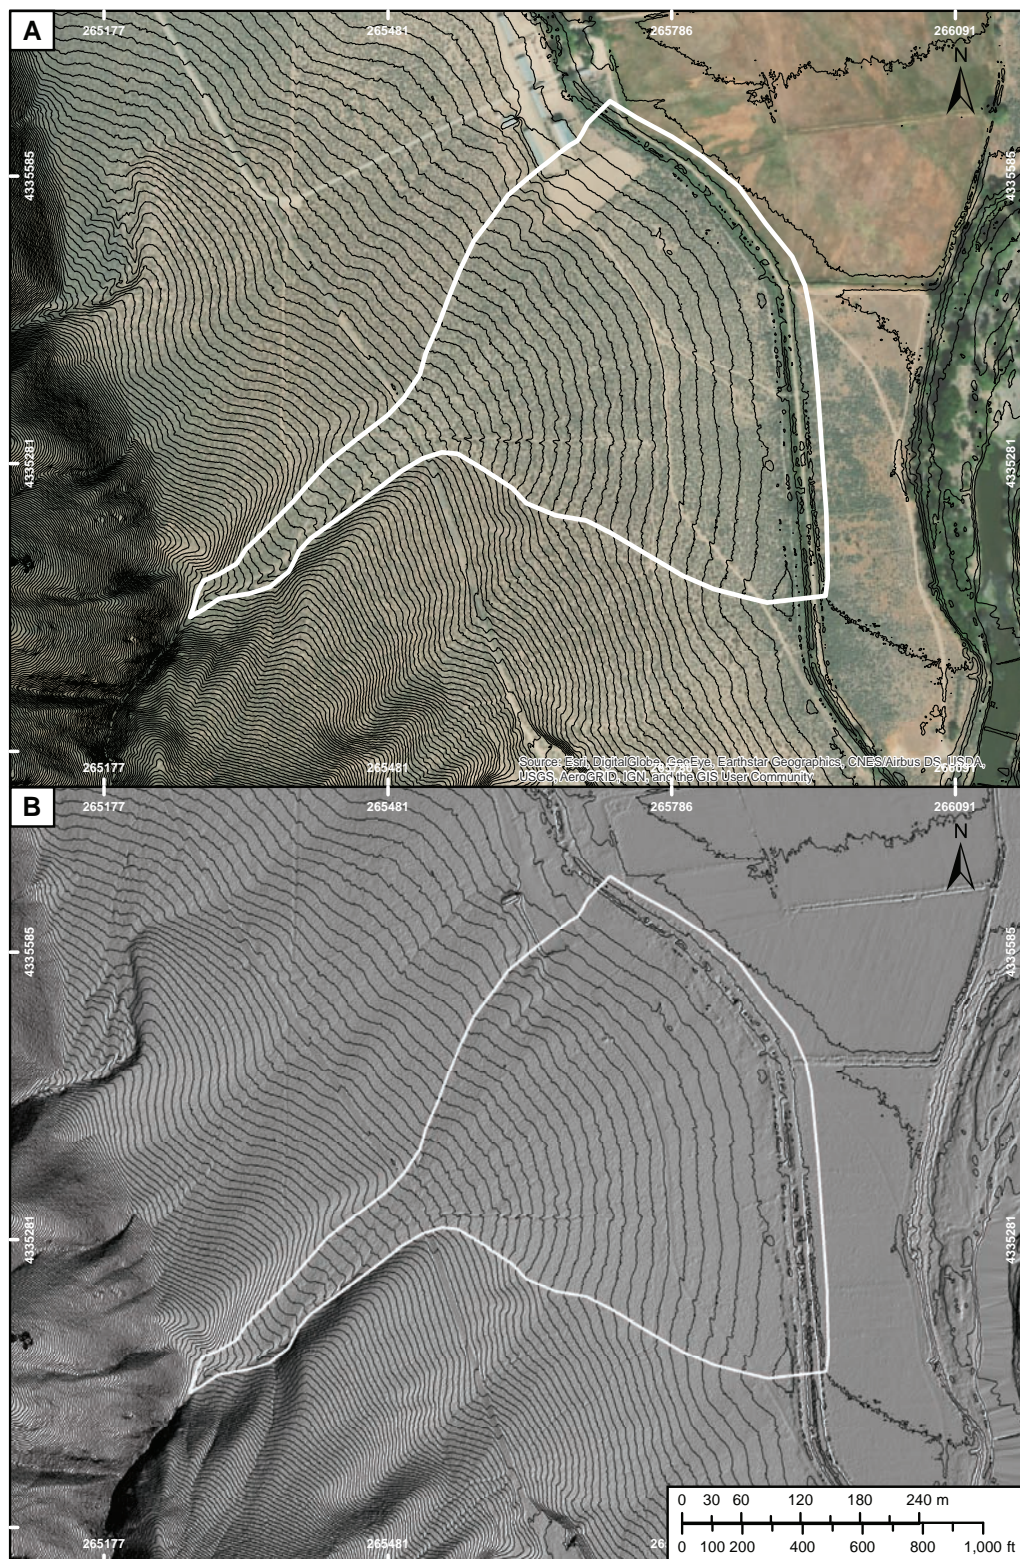
Fan 115 is located on Silver Saddle Ranch, which is accessed from Carson River Road (**Figure 23**) and is the southern fan investigated along the eastern face of Prison Hill (**Figure 4**). As mapped, the fan covers 171,496 m<sup>2</sup> (42.4 acres) and is almost completely covered by sage brush that is up to 4 – 5 ft tall (**Figure 24a-b; Table 2**). There appears to be remnants of an older alluvial fan surface that Fan 115 is incised into, forming a nested fan

**Figure 23.** Fan 115. A) With aerial photograph base from the ESRI World Imagery coverage sourced by Digital Globe. B) Hillshade elevation model generated in Quick Terrain Modeler. Both images show 1-m contours generated by Quick Terrain Modeler.

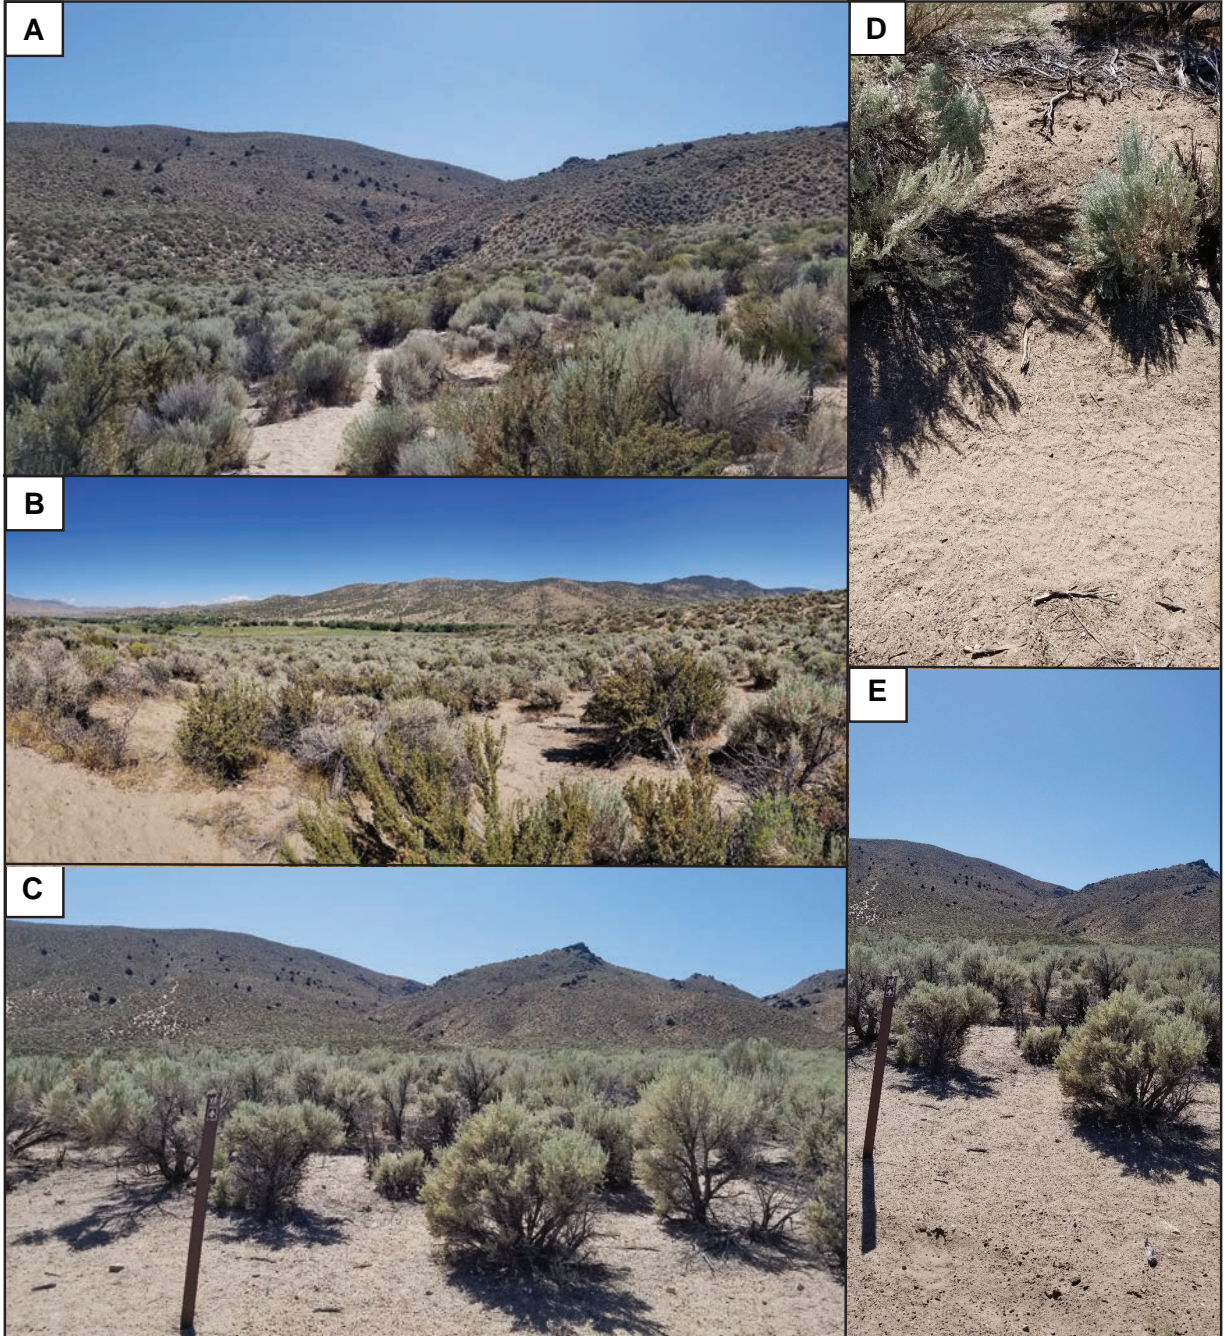
**Figure 24.** Fan 115. View from upper fan showing sandy soil and desert shrub vegetation. (A) View from path looking southeast toward gulley that feeds fan and (B) looking down fan towards the Carson River floodplain. The lower fan is shown in panels C-D. (C –D) Surface of fan consists of sage brush often over 4 ft high growing out of sandy soil (mostly medium sized sand). Channel that feeds fan can be seen in center of panel A.

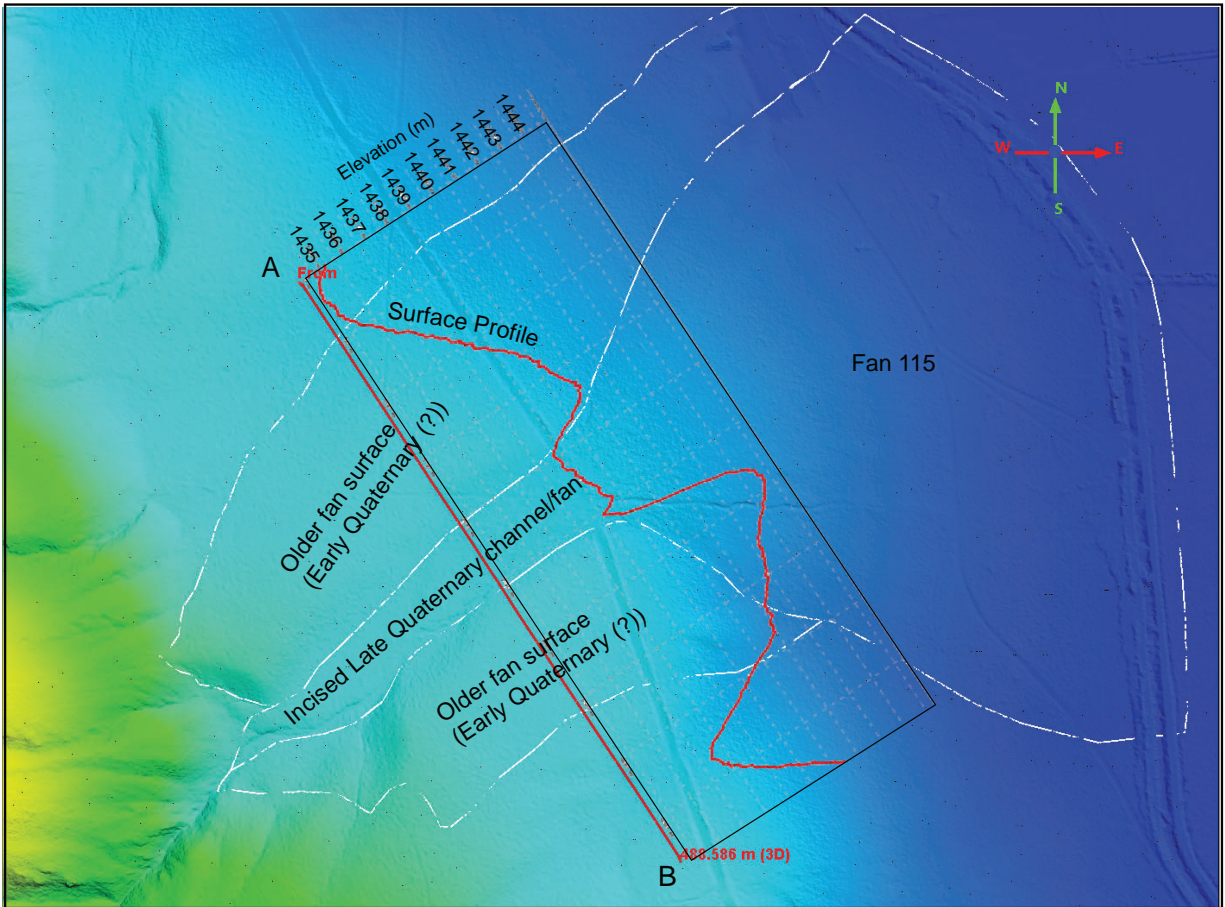
**Figure 25.** Color shaded relief map of Fan 115. White lines show the mapped fan boundaries. There are two distinct phases of fan development expressed in this image. An older fan (assumed to be early Quaternary) formed under a different climatic regime with significantly higher sediment output with a more recent (Late Quaternary) feature incised into it forming a nested fan complex. Modern drainage is confined in the Late Quaternary channel that feeds Fan 115. The topographic profile shown in red highlights the difference in elevation between the two phases of fan development.

complex (**Figure 25**). These older deposits were mapped by Bingler (1977) as *Quaternary older alluvium* (Qop) pediment deposits. The upper parts of the fan are constrained within an overfit channel (Note: fitness refers to the relationship of the channel relative to the stream within. An overfit channel is one where the banks are much wider than would be expected based on current conditions) that is incised into the older alluvium. Local relief is up to 0.3 to 0.6 ft (1 – 2 ft) and its surface gradient falls between 4° – 9°. Review of the historic aerial photography on GoogleEarth revealed possible evidence of recent activity seen on the April 2015 photograph that was not evident on the April 2014 photograph (**Figure 26**). The mid- to lower-fan soil at the surface is composed of sand with a minor component of pebbles and cobbles (angular to subangular). From the table top evaluation these would indicate that hyperconcentrated flows discharged over the upper reaches

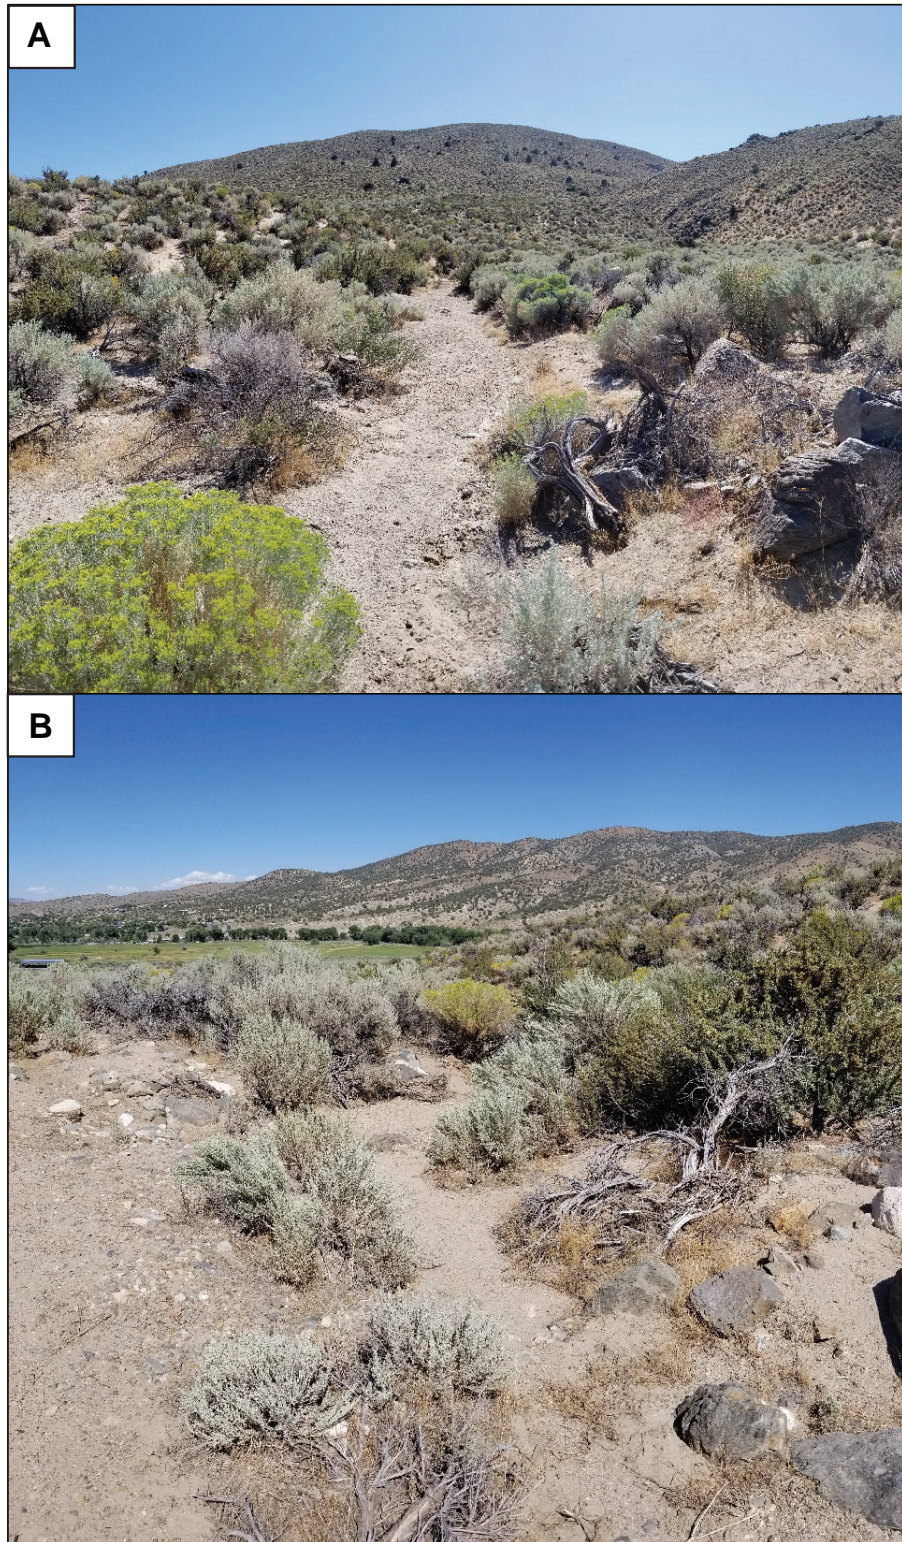
The surface of the relict fan deposits north of the incised channel is characterized by relatively tall sage brush and sandy soil. A “ribbon” of modern alluvium exists in the center of the overfit channel (**Figure 27**). Recent alluvial deposits are composed of medium to coarse sand, granules and pebble gravel. Boulders and cobbles shown in **Figure 28** are angular and weathered. As described previously, the flow responsible for the modern alluvium does not have the competence to transport cobbles and boulders. The boulders and cobbles may be clustered or isolated. Where clustered they give the appearance of forming a lag deposit armoring channel bars. As such, the coarse material is believed to be eroded material, possibly lag deposits that originated from debris flow deposits transported downgradient under different climatic conditions.

**Figure 27.** Looking at active channel deposits upstream of hydrologic apex. This reach is confined by older alluvial deposits mapped as relict. (A) View from path looking southeast toward the gully that feeds fan and (B) looking down fan towards the Carson River floodplain.

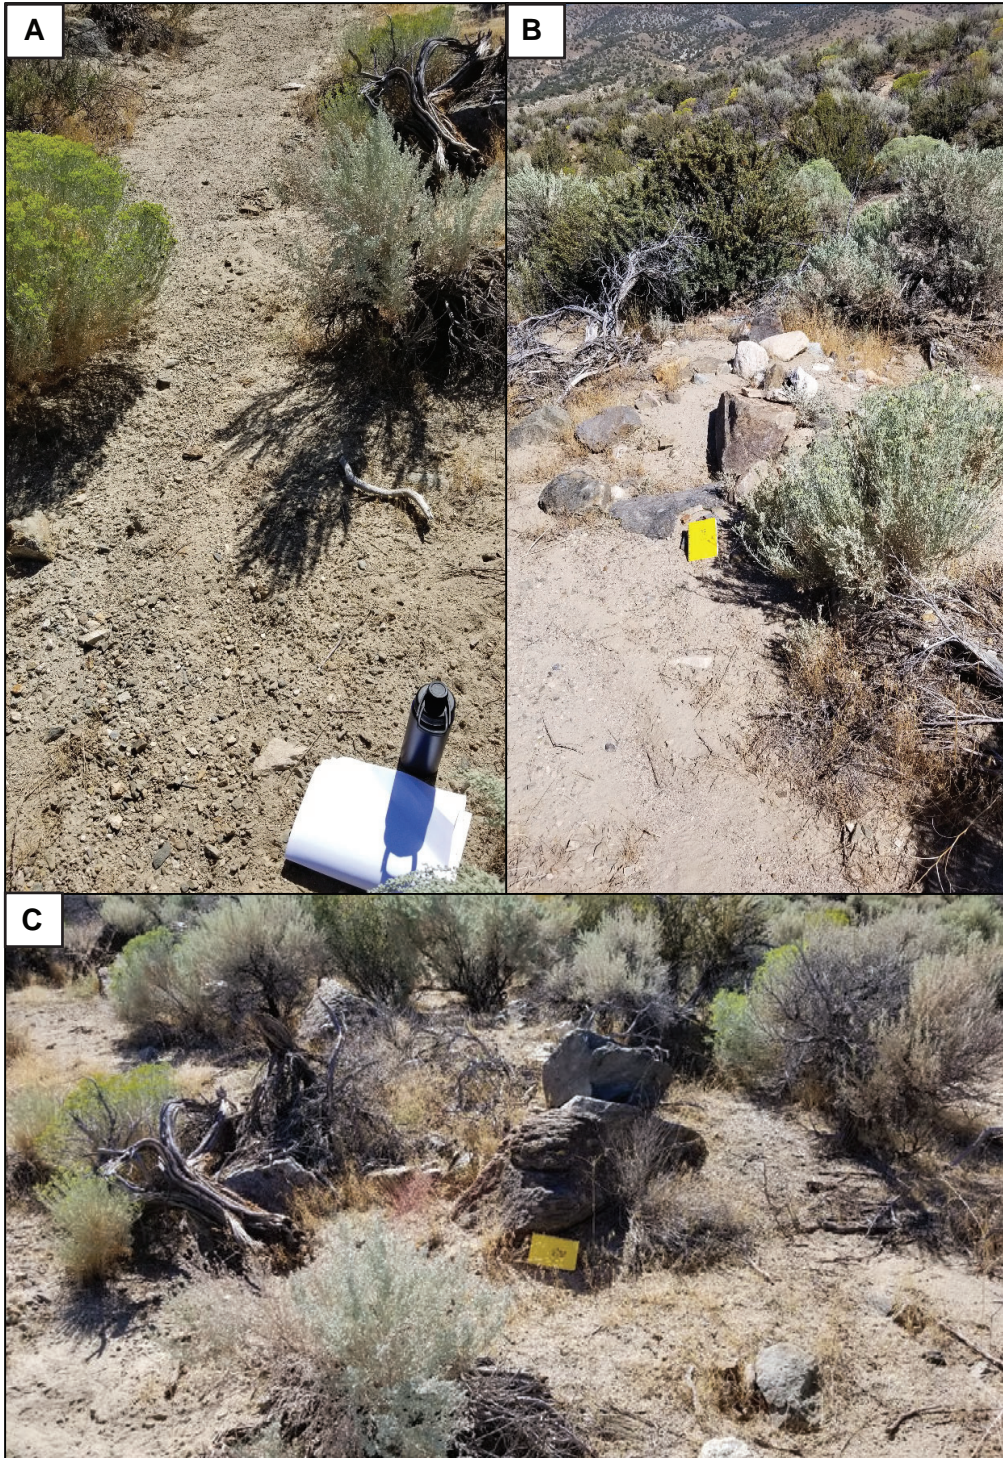
**Figure 28.** Within active channel above hydrologic apex and bounded by older alluvial deposits. (A) Medium to coarse sand with granule to pebble sized gravel. Larger clasts are angular and appear to be an erosional log. B – C show large angular boulders along banks of active channel. Boulders and cobbles are angular to subangular and considerably larger than sandy alluvial deposits. Boulders/cobbles represent older debris flow deposits.

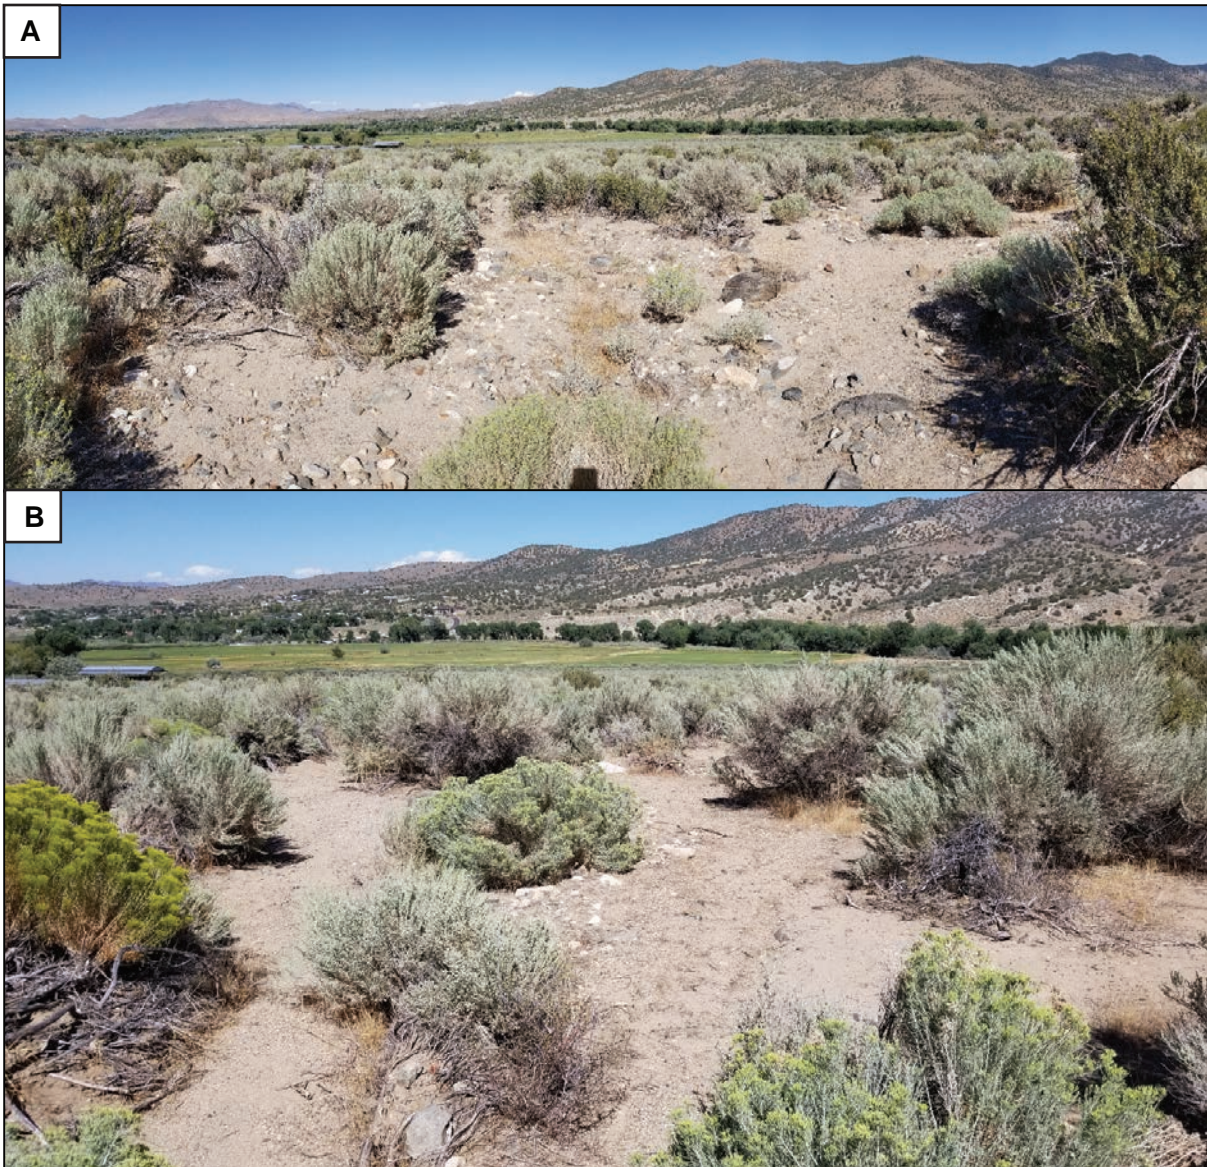
In the area around the hydrologic apex, flows appear to spread out as sheetflows. This is recorded by patches or sheets of sand that spread out into the sage brush (**Figure 29**). The ribbons of sand seen further upgradient gradually disappear where the channel is no longer incised. As such, the sand patches likely represent deposition from sheetflows as storm flows spread out and lose competence.

**Figure 29.** Both photographs were taken at the approximate location of the hydrologic apex. Photograph B was taken slightly downstream from A. Note how the sand appears to spread out. This area is fed by “channelized” stream deposits upgradient. At this location, the flow appears to spread out representing distributary flow and sediment dispersal as flow exits confined reach.

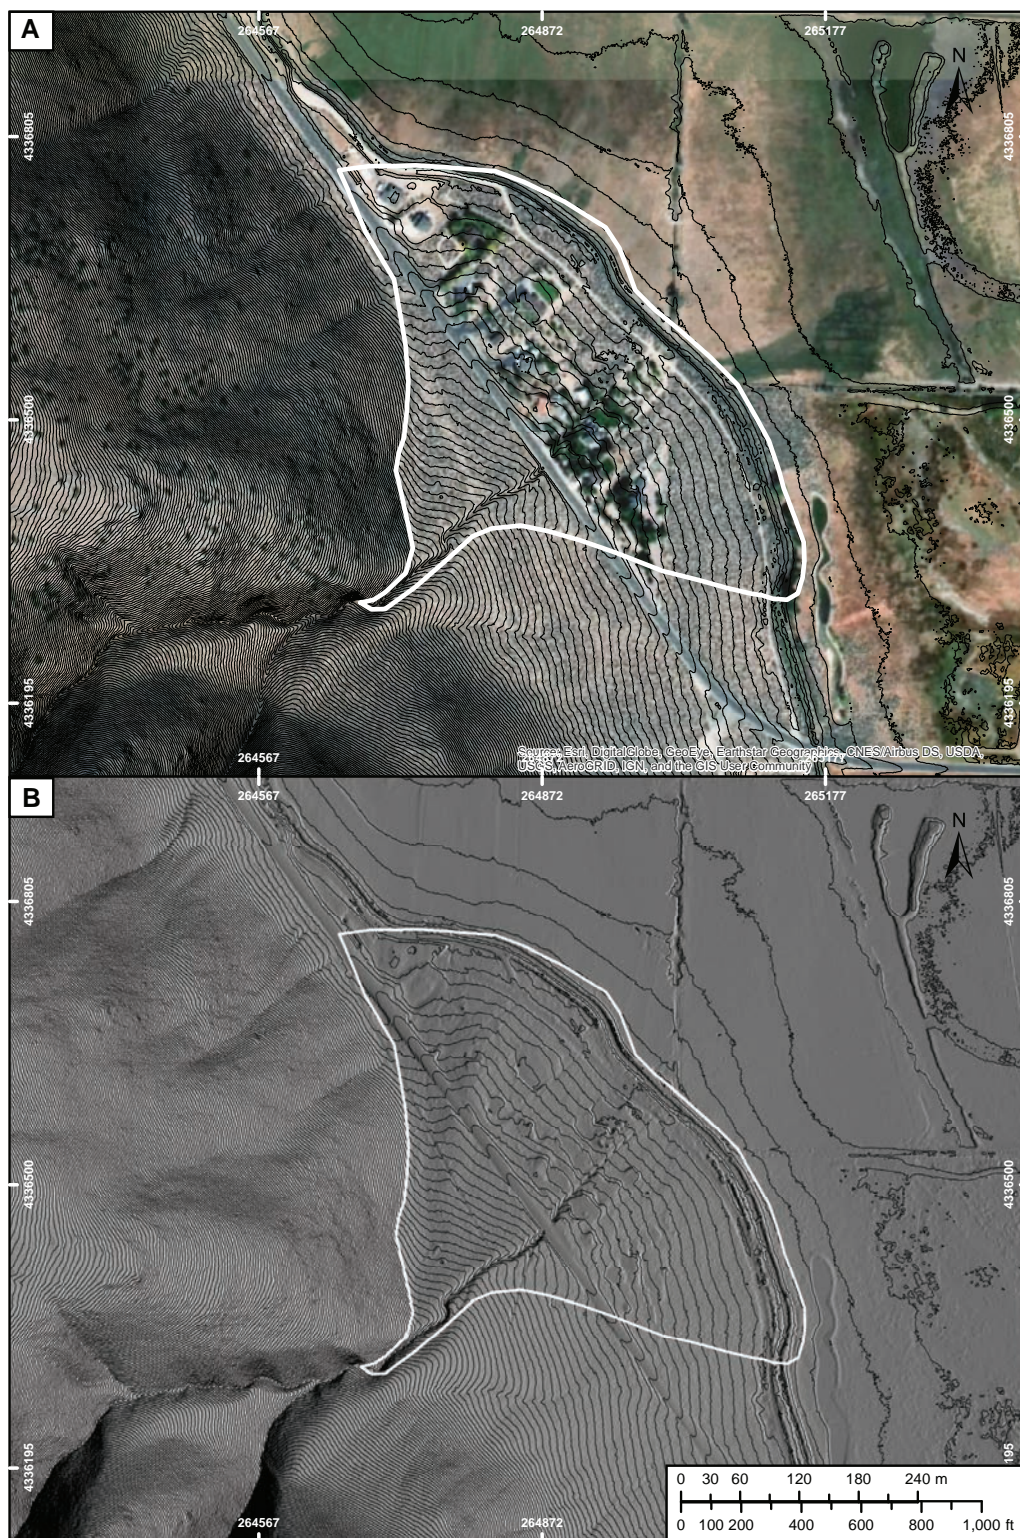
Fan 116 is located along Carson River Road north of Fan 115 and emanates from Prison Hill in an area composed of Jurassic Dacite (**Figures 7 and 30**). The fan covers 139,539 m<sup>2</sup> (34.5 acres; **Table 2**). The upper portion of the fan is generally undisturbed with a single incised channel running just north of center. This channel routes storm water through a small community east of Carson River Road. The single channel is tightly constrained for about 245 m (800 ft) before it reaches a culvert that takes flow under a road. The photographs in **Figure 31** show the incised channel with abundant angular boulders along the channel sides and floor. Modern deposits in the channel are sand and fine gravel (pebbles). The drainage is routed under Carson River Road via a corrugated metal culvert that then discharges into a well maintained channel lined with sand that routes flow through the housing community.

**Figure 30.** Fan 116. A) With aerial photograph base from the ESRI World Imagery coverage sourced by Digital Globe. B) Hillshade elevation model generated in Quick Terrain Modeler. Both images show 1-m contours generated by Quick Terrain Modeler.

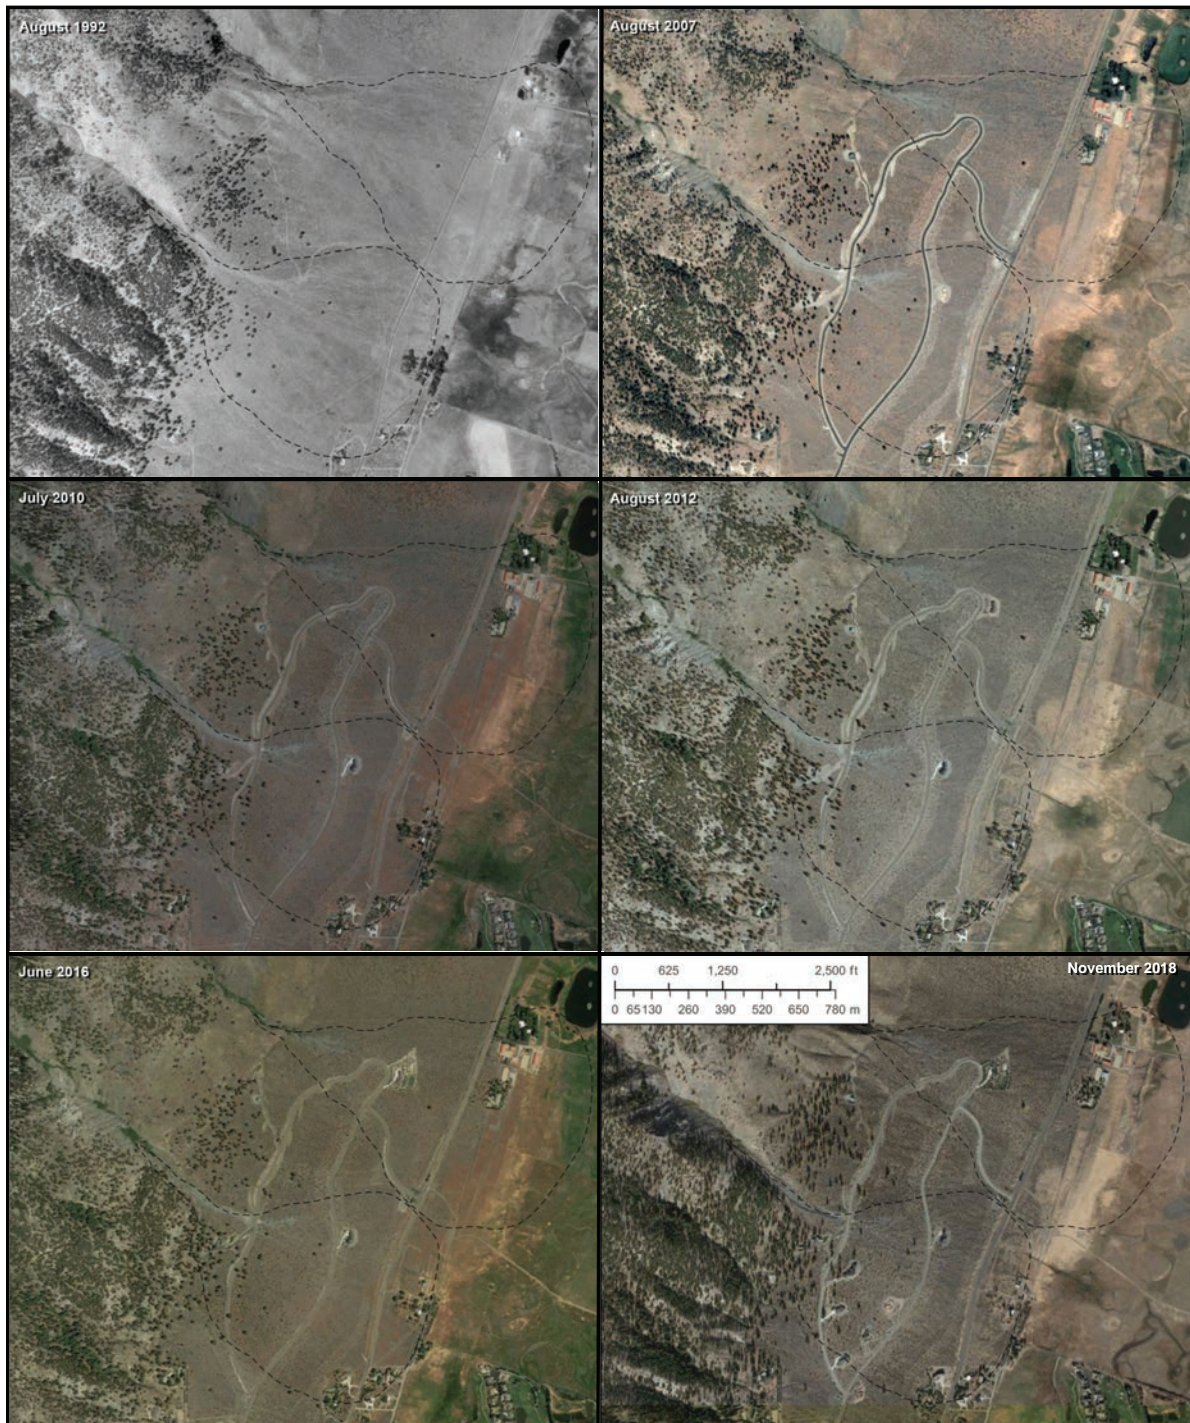
Fans 44 and 45 have experienced significant growth over the past two decades (**Figures 34 and 35**). Historic aerial photography shows that as recently as 1992 there were only a few structures located on the mid- to distal-fan portions of the fans (**Figure 34**). Development can be seen starting around 2007 by which time Eagle Ridge Road has been installed, forming a loop connecting both fans and at least two building platforms had been built at that time. By November 2018, there is one house built on the mid-fan region of Fan 45 and seven new houses in the upper- to mid-fan regions of Fan 44. The development of the fans starting in 1992 and extending to present is shown on **Figure 35**.

**Figure 34.** Development of Fans 44 and 45. In 1992 there appear to have been 5 farms with numerous structures located along the toes of both fans. This remained until 2007 when a looped road had been installed and two construction sites can be seen on Fan 44 with a water tank located between the fans. In 2012 another construction site is located in the mid-fan region of Fan 44. This level of development remained until 2018 when five additional houses were built in the mid-fan region of Fan 44.
