## TECHNICAL MEMORANDUM

Alluvial Fan Evaluation:  
Fans 44, 45, 78, 79, 81, 82, 115 and 116  
Carson City and Douglas Counties, Nevada

**To:** Carson City Subconservancy District (CWSD)

**Date:** 27 March 2020

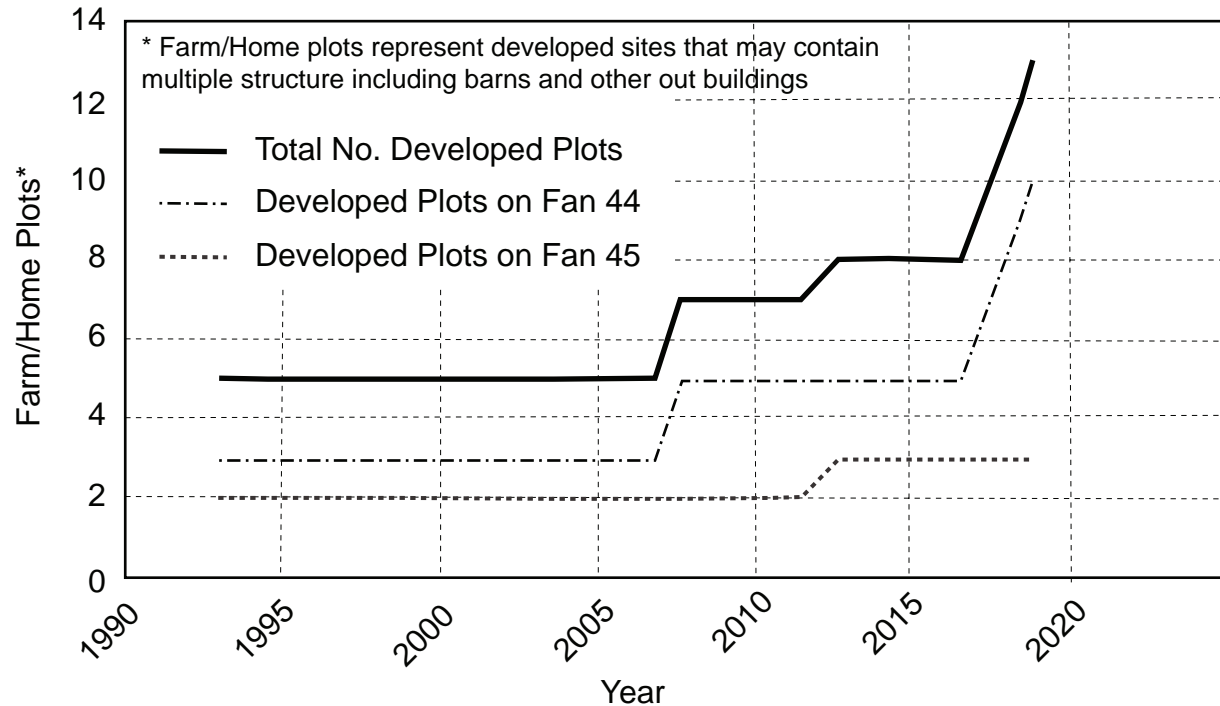
**Figure 35.** Plot showing the development of Fans 44 and 45 since 1992. Five well-established farms were located along the toes of the fans until 2007 when the middle and upper regions of the fans experienced development. Rapid development of Fan 44 occurred in 2017-2018.

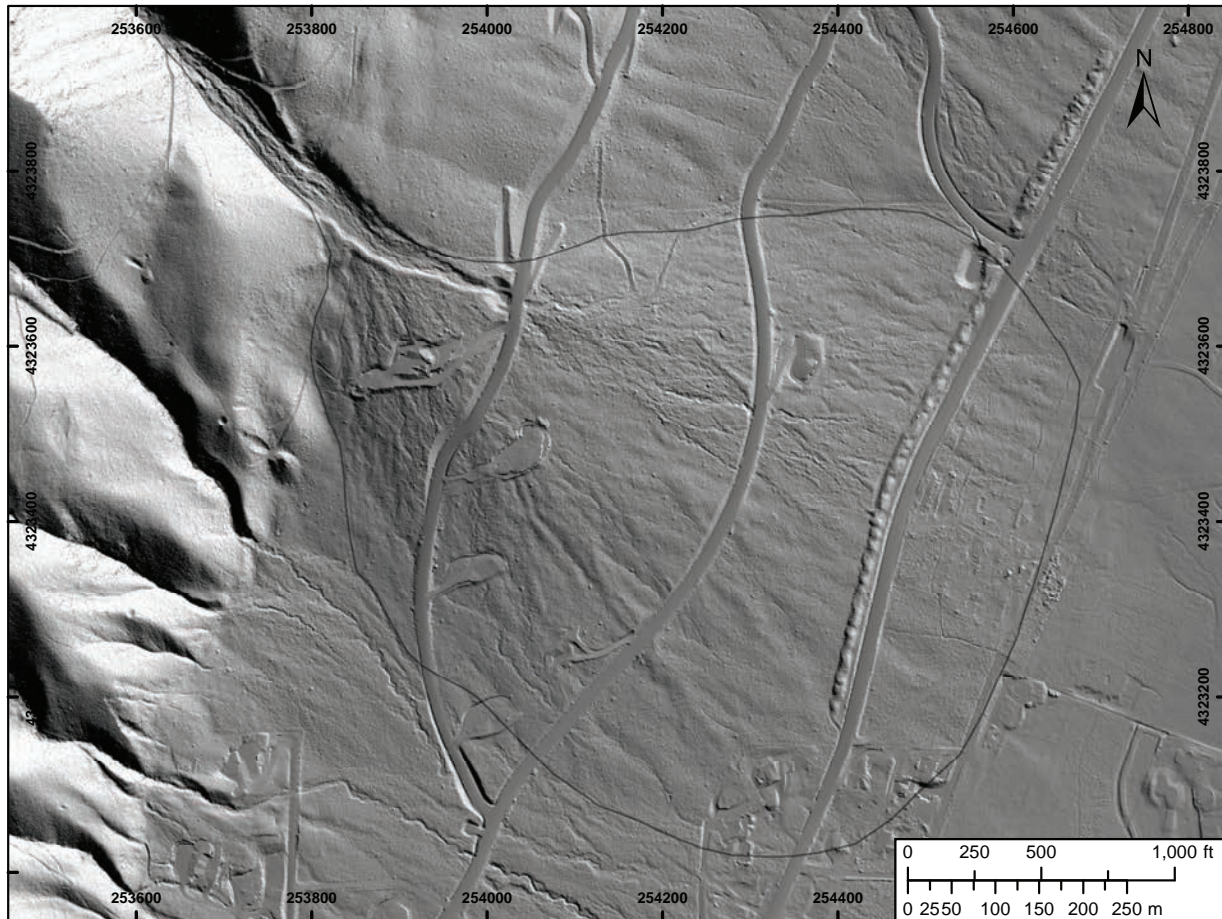
Childs Canyon at the apex of Fan 44 is approximately 45 m (148 ft) wide and occupied by a braided stream (**Figure 36**). The canyon occupies a narrow, V-shaped valley incised into bedrock that extends nearly 2.4 km (1.5 mi) into the Carson Range. The catchment area feeding Fan 44 is 1,155,043 m<sup>2</sup> (285.4 acres) and the lobate fan covers 501,041 m<sup>2</sup> (123.8 acres: **Table 2**). The incised braided channel extends nearly 280 m downgradient to where it converges to a single incised channel just upgradient of a drainage culvert that diverts water under the upper crossing of the loop road. The channel in this reach is bound to the south by a 1.5 m (5 ft) high levee as it exits Adams Canyon. The levee gradually tapers to

**Figure 36.** Fan 44. Shaded relief hillshade image made using 2017 LiDAR data imported at a cell resolution of 0.29 m (0.95 ft) using the software Quick Terrain Modeler. Illumination is from the north to accentuate channels on the alluvial fan surface. Note fine, branching nature of channels on the northern half of the fan with gentler, smoothed surface in southern portion. Flat pads represent building foundations.

The north to northeastern half of the fan is generally characterized by a series of elongate, rounded ridges, except for a narrow zone directly along the border that has relatively sharp banks indicating recent activity. The remainder of the area appears to be semi-relict (older but still active), abandoned braided channel deposits. The structure build at the bend in the loop road is located in this older surface with active channels both to the north and south.

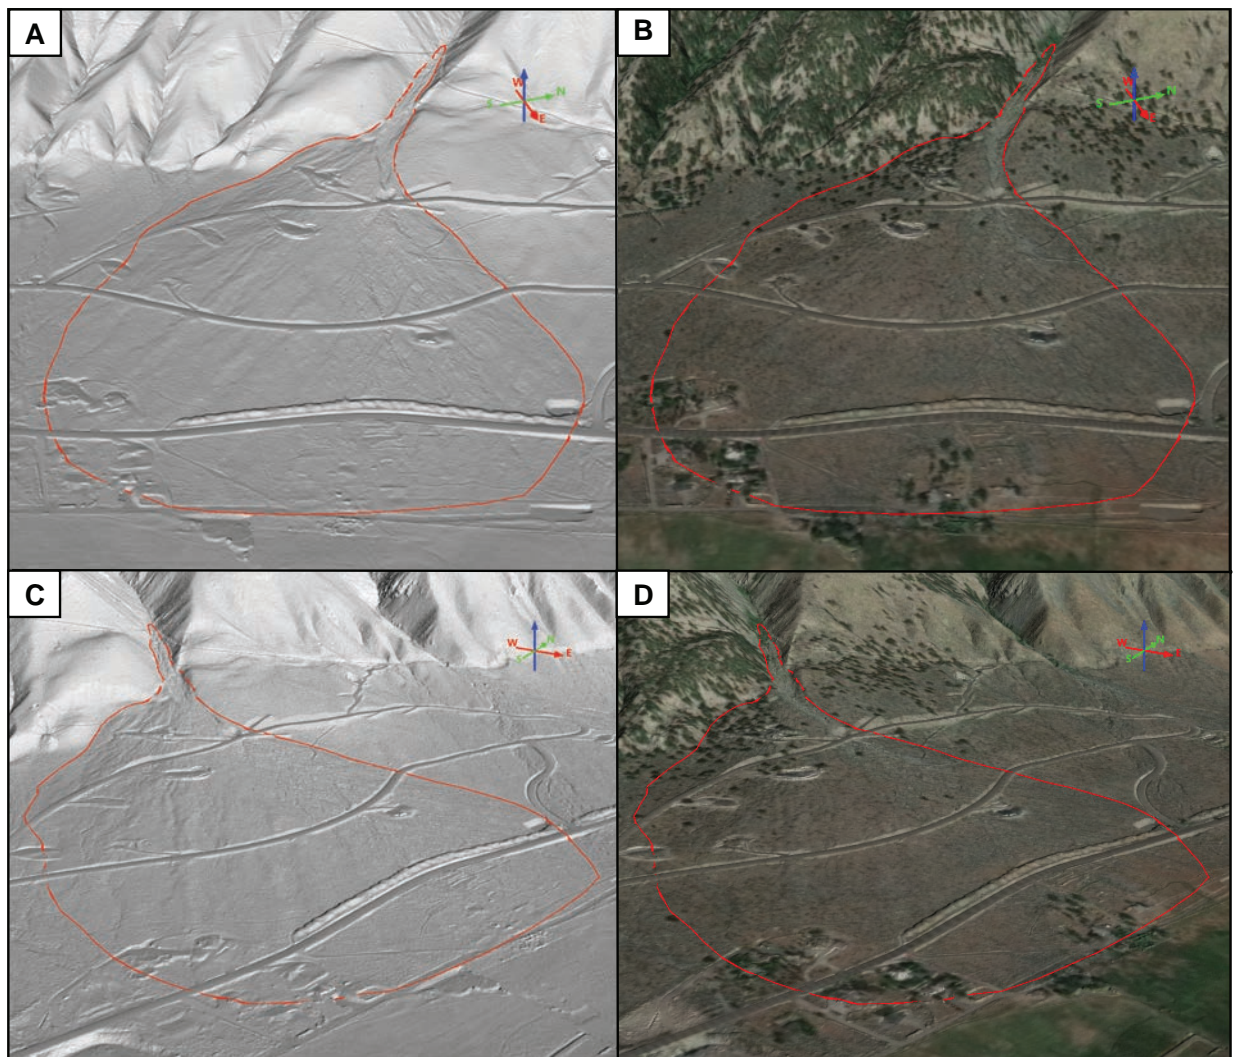
Active drainage appears to be directed by the levee towards the culvert, below which flow diverges downgradient (**Figures 36 and 37**). Braided channels span approximately 60 m (197 ft) in width on the east side of the upper loop road and broadens to 240 m (787 ft) wide by the lower loop road, about 280 m (2,674 ft) down gradient. Outside of the active channel, and primarily to the south of the levee, the surface is characterized by a series of low relief (<0.5 m [1.6 ft]) ridges that form an anastomosing and divergent pattern. These represent former braided stream channels and bar deposits, presumably abandoned since building of the levee just downgradient of the topographic apex. It may also represent Holocene activity and abandonment as the current channel became incised.

**Figure 37.** Oblique views of Fan 44. A) Looking towards the west-northwest and B) with aerial photograph superimposed. C) Looking towards the northwest and D) with aerial photograph superimposed. The “diamond-shaped” pattern in the shadows in the northern portions of the fan represent channel boundaries in the braided channels. The upper portion of this area corresponds with the grey zone when the aerial photograph is superimposed (Plate B) indicating areas of recent deposition. The surface is much smoother and more continuously covered by vegetation to the south as shown in Plates C & D.

Fan 44 exhibits a classic fan shaped outline that is minimally constrained along its northern and southern boundaries (**Figure 37**). There appears to be a man-made levee on the south side of the feeder channel that extends from the topographic apex to the hydrologic apex where flow is conveyed under Eagle Ridge Road via a culvert (**Figure 42**). The levee appears to have been built to protect a house just to the south of the topographic apex. The

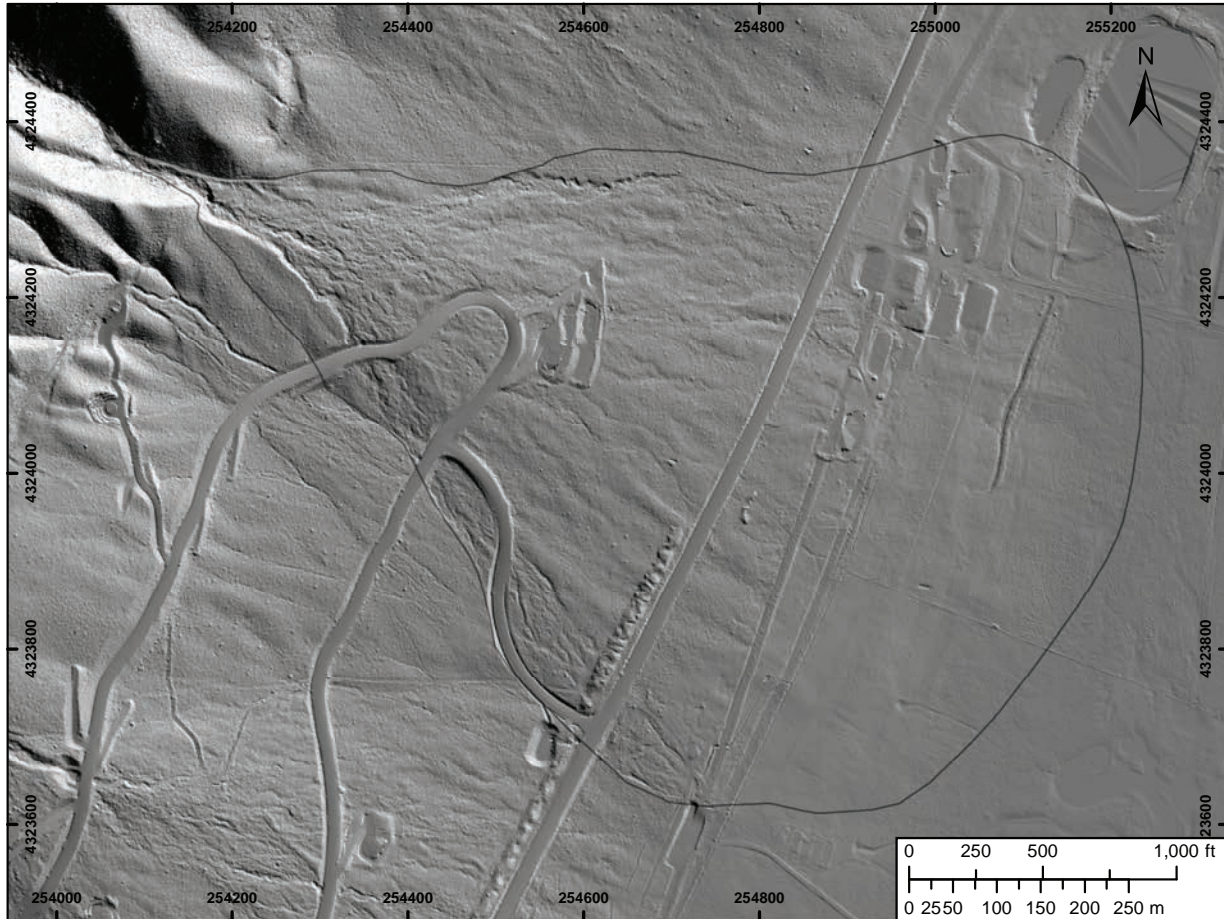
Childs Canyon extends nearly 2.5 km (1.55 mi) into the Carson Range and is nearly 55 m (180 ft) wide where it crosses the Genoa Fault at the mouth of the canyon (**Figure 38**). The canyon is a little over 10 m (33 ft) wide where it discharges to the apex of Fan 45. The topographic and hydrologic apices coincide with the crossing of the Genoa Fault. Below the apex the channel becomes braided and diverges across the fan. The catchment area feeding Fan 45 is 1,151,927 m<sup>2</sup> (284.6 acres) and the lobate fan covers 568,586 m<sup>2</sup> (140.5 acres; **Table 2**). The topographic apex is located about 650 m (2,132 ft) west of Eagle Ridge Road and the slope from the apex to the road averages 10.2°.

**Figure 38.** Fan 45. Shaded relief hillshade image made using 2017 LiDAR data imported at a cell resolution of 0.29 m (0.95 ft) using the software Quick Terrain Modeler. Illumination is from the north to accentuate channels on the alluvial fan surface. Note fine, branching nature of channels on the northern half of the fan and along the southern fan boundary. Flat, semi-rectangular pads represent building foundations.

As with Fan 44, Fan 45 exhibits a classic fan shaped outline that is minimally constrained along its northern and southern boundaries (**Figure 38**). The LiDAR imagery shows that surface flow diverges (Active) slightly below the topographic apex redistributing water

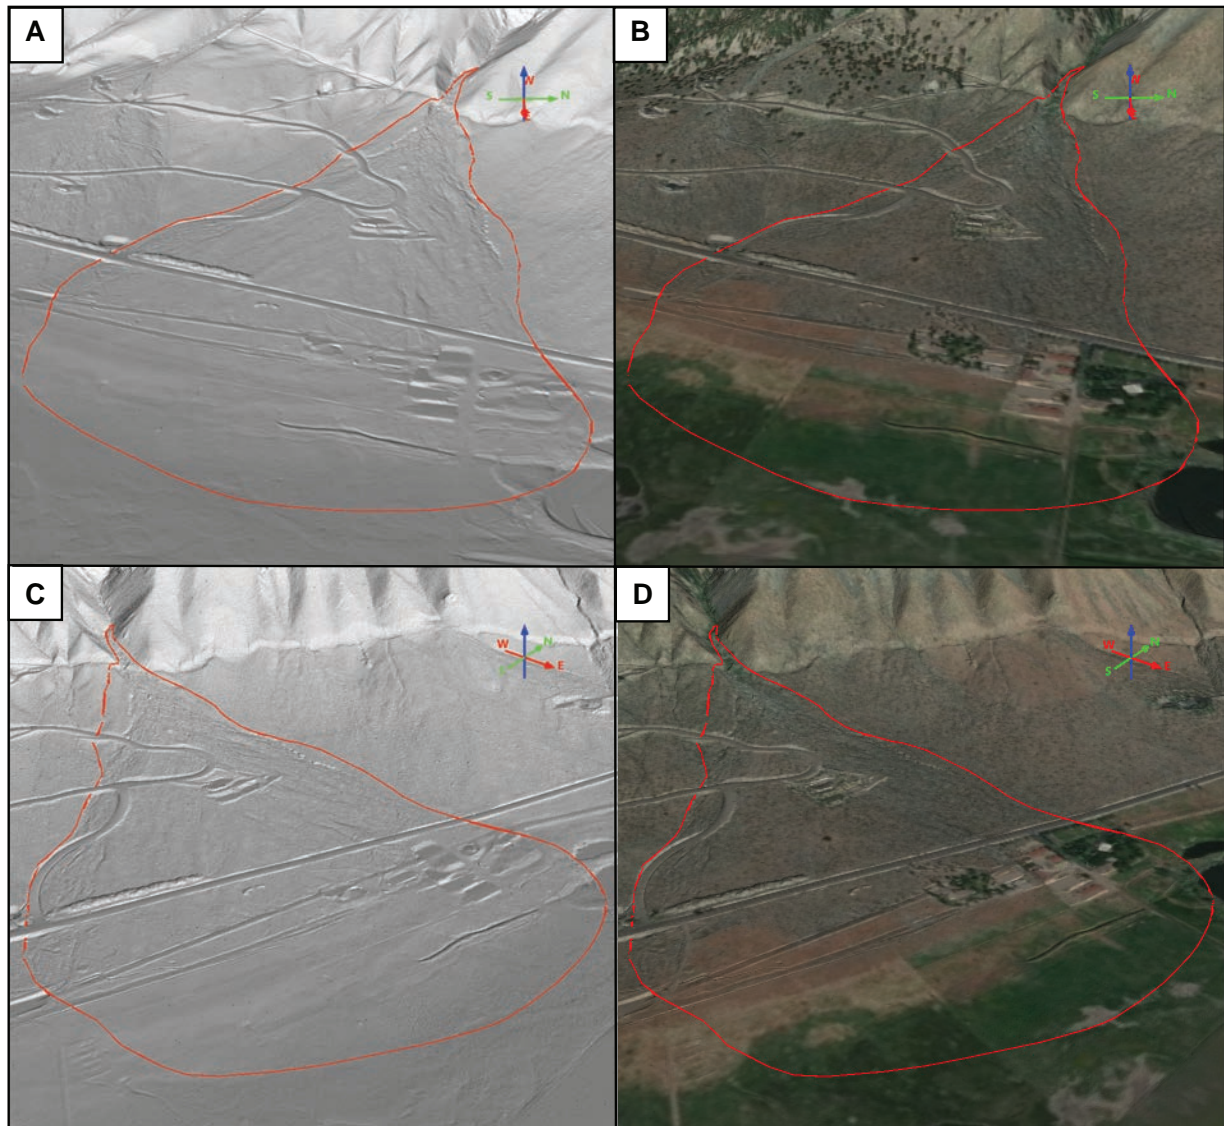
Approximately 200 m (660 ft) downgradient from the fan apex braided channels span the width of the fan, but to the southeast (downgradient) these diverge into two zones (**Figures 38 and 39**). The best preserved channels (presumably most recently active) occur in a zone 70 – 77 m (230 – 253 ft) wide along the southern (or southwestern) edge of the fan. In this zone, numerous anastomosing (and braided) channels run along the fan boundary, which the access road to the looped road roughly follows. This zone continues to the southeast to the outer boundary of the fan toe. There is also a berm built along a crossing road that extends from the southern third of the fan and across most of Fan 44. This berm represents an engineering effort to protect the road from flooding (thus fan activity).

**Figure 39.** Oblique views of Fan 45. A) Looking towards the west-northwest and B) with aerial photograph superimposed. C) Looking towards the northwest and D) with aerial photograph superimposed. Grey tones associated with recent deposition can be seen near the fan apex on both B and D. Active channels appear present in the mid-fan region along the northern border and along the length of the southern border (A & C).
