CARSON WATER SUBCONSERVANCY DISTRICT ALLUVIAL FAN MAPPING STUDY

Lew Hunter, Ph.D., P.G. – Sr. Geologist, Army Corps of Engineers

Ed James, General Manager, Carson Water Subconservancy District

John Newton, Ph.D., P.E. – Hydraulic Engineer, Army Corps of Engineers

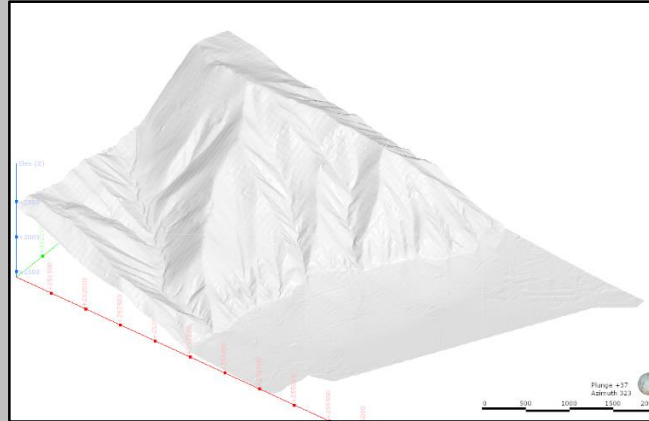
Digital elevation model

- Only use bare earth data
- Digital elevation models
- Generated contours (1m, 2m, & 5m)
- Slope maps
 - Surface morphology
 - Calculate gradients
 - Define outer toe (distal edge) : 1° - 2°

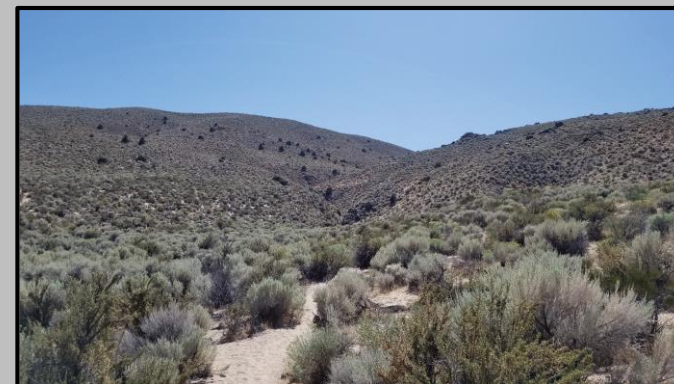
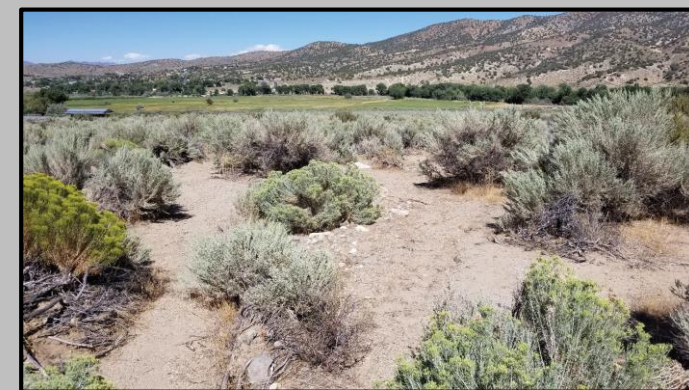
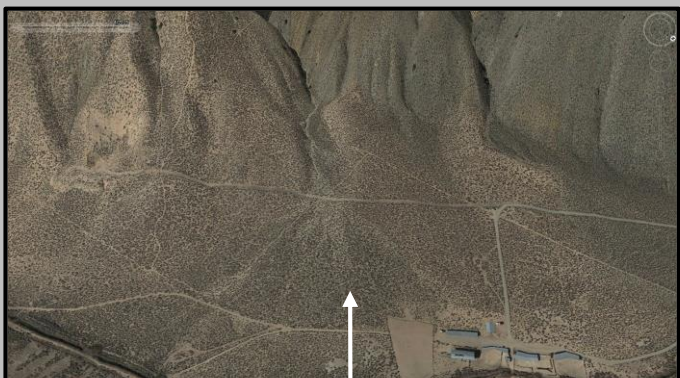
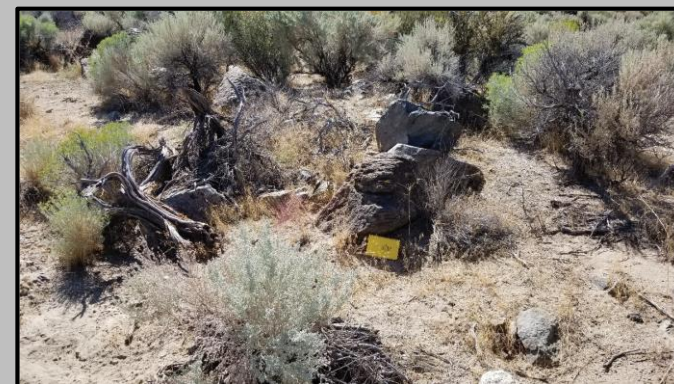
Fan 115

Relict fan surfaces

Incised channel where it exits mountains and cuts relict fan surfaces

Sheet flow deposits downgradient of where channel exits confined reach

Light coloration inferred as zones where recent deposition has occurred

Active channel

Old, weathered boulders. Not deposited under current conditions

- Relict
- Channel lag
- Old debris flow deposits

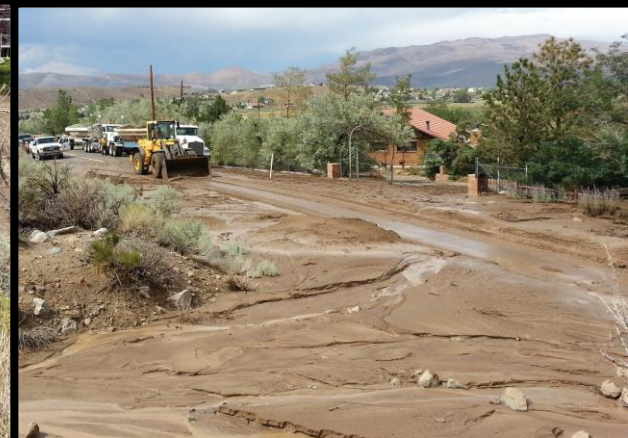
2014 Flooding Event Fan 116: Carson River Road

- Culvert inundated/overwhelmed by discharge
- Became blocked and road flooded
- LiDAR data & aerial photo review channel looked like it should pass flow
- Hydrologic modeling suggests culvert too small

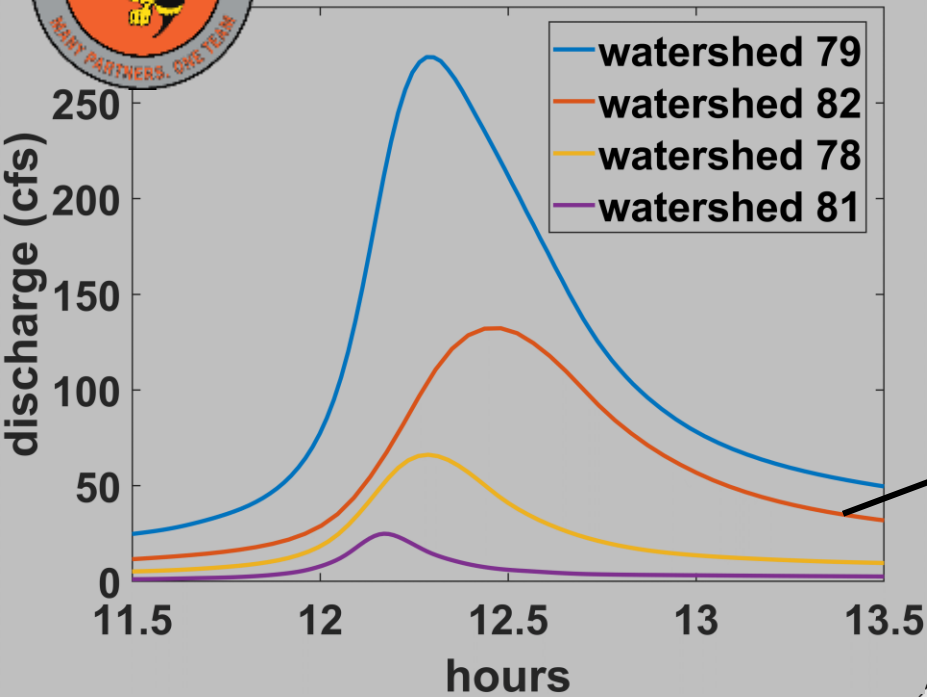
- Curve Number Method
- 100-yr rainfall event
- NOAA Atlas 14 gridded precipitation
- Nevada West rainfall distribution

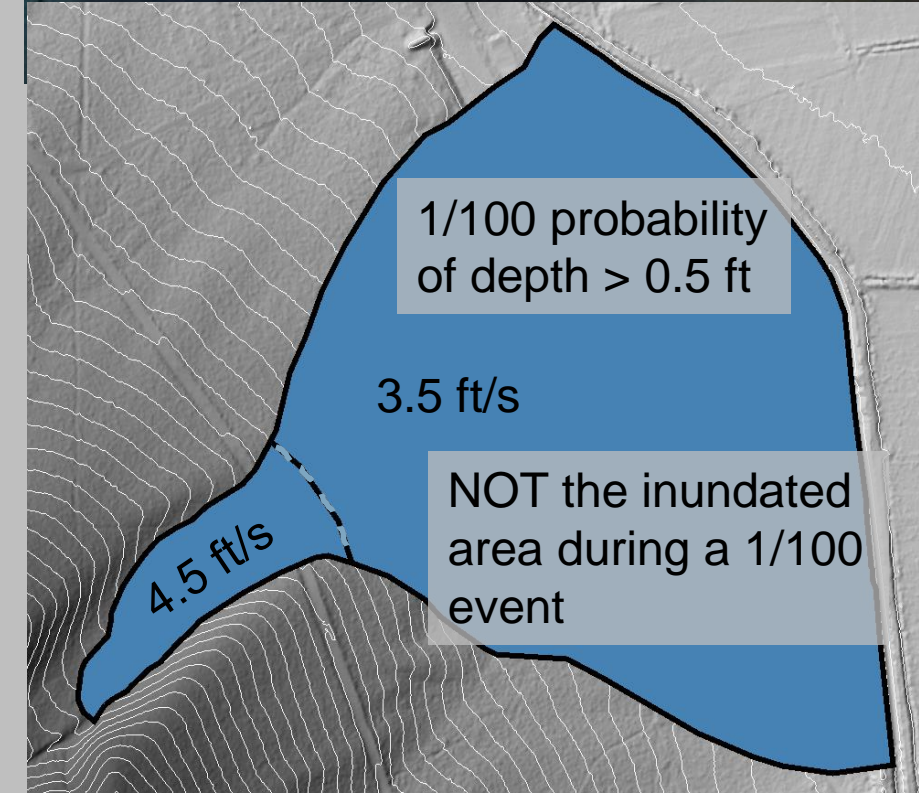
FEMA FAN Program

- Any location in the zone has a probability of 1/100 of being inundated at the specified depth, or greater, during any given year
- Program solves for the contour length of the depth and velocity boundaries

- Highly active alluvial fans
- Flow paths are allowed to move randomly
- Simple relationship between depth and flow
- Not valid for debris flow
- Negligible urbanization
